PERFORMANCE OF TRADITIONAL ARCHES, VAULTS AND DOMES IN THE 2003 BAM EARTHQUAKE

T. Mahdi*

Department of Structural Engineering, Building and Housing Research Center, Tehran, Iran

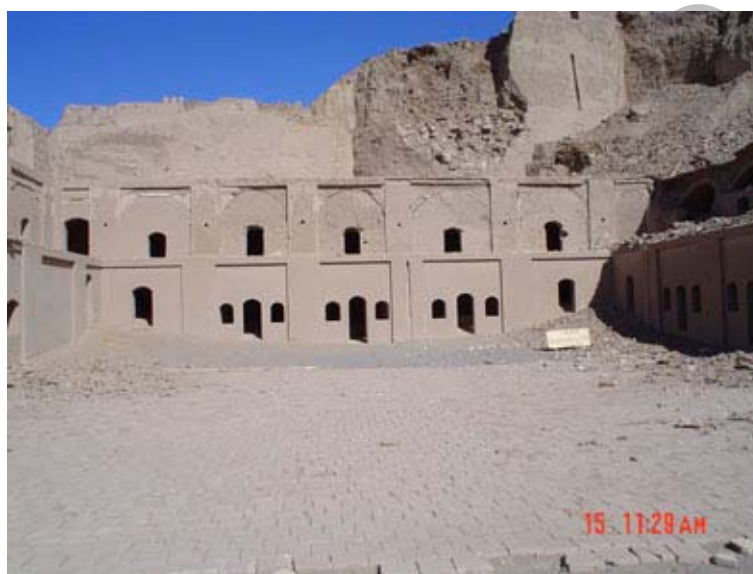
Figure 2. The east-west wall of the Military citadel in Arg-e-Bam.

architectural system, arches are used to face the central courtyard of the building, as shown in Figure 2. The small arches shown in this figure is merely a facade that is hiding the main structure behind it and merely worked as a shear wall. For the arches perpendicular to this direction, a complete separation between the facade wall and original structure had occurred, which led to partial failure of these walls as shown in Figure 3. As a structural component, and as shown in Figure 4, arches are used to transfer loads from a dome to its pillars. In this structure, arches of different sizes and shapes have been assembled to fulfill this function. It is clear from this figure that earthquake forces had led to serious sliding and opening of joints in the pillars. This partial failure was caused by the unbalanced thrust transmitted from the adjacent arches. This problem was observed in single-span vaulted roofs as well. To resist the horizontal seismic movement, the joint between the arch and the pillar must be inclined and the pillar must have enough width to keep the resultant forces within the central part. It is clear from Figure 4 that this later condition has not been met. Many of the buildings that survive the earthquake have successfully fulfilled these rules as shown in Figure 3.

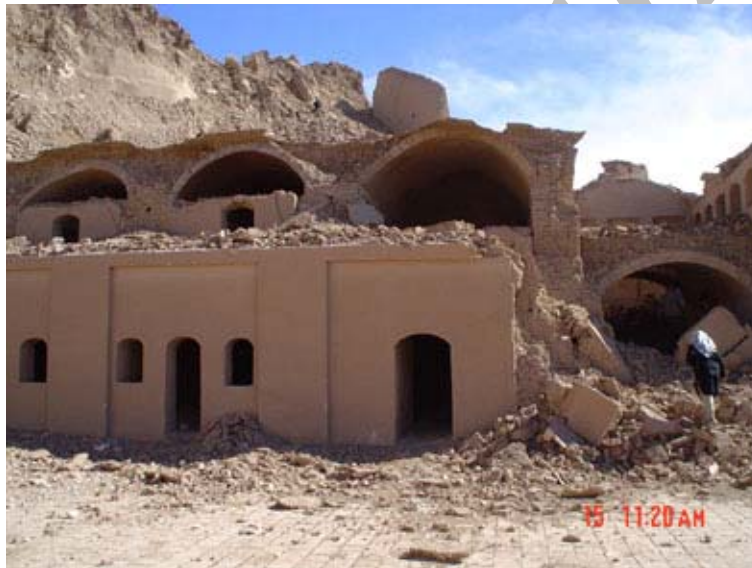
Figure 3. The north-south wall of the military citadel in Arg-e-Bam.

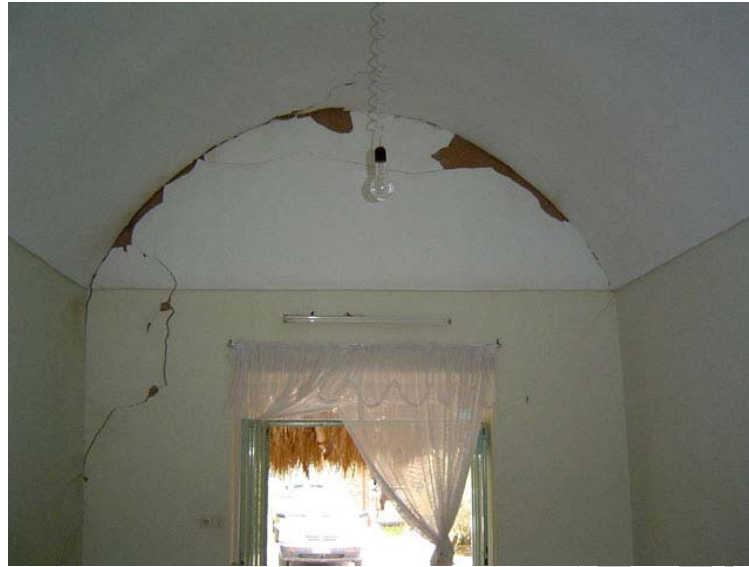
The failure of these types of structures is resulted when excessive displacements perpendicular to the vault generator occurred. However, when the displacement is relatively small as shown in Figure 6, only minor cracks occurs at the intersection of the roof with the end plates.

Figure 6. Cracks at the intersection line of the vault with the end plate

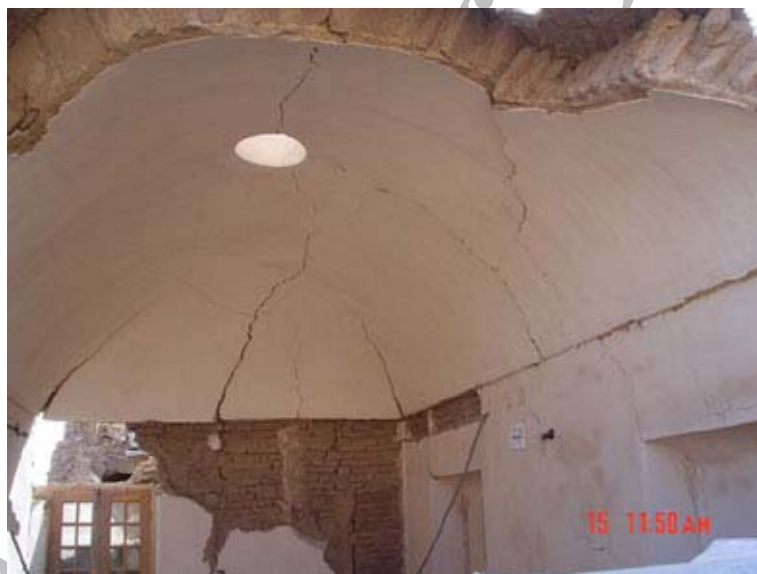
Figure 7. A vault with cracks in Arg-e-Bam

located on rock. Figure 7 shows another example of such roofs. It can be seen from this figure that bearing walls had minor cracks compared to those appeared in the roof. The pattern of cracks in the roof indicates clearly that some vertical forces were applied to it. That can be explained by the high vertical acceleration component of this earthquake.

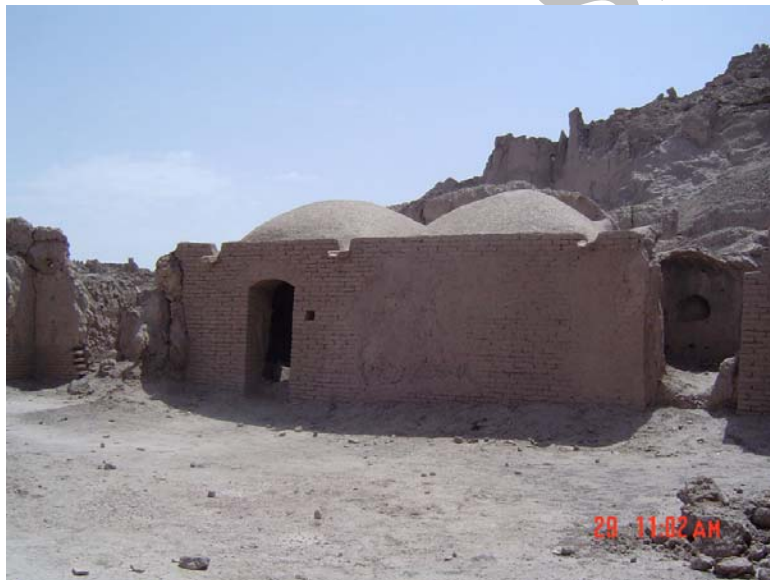
In the majority of cases, a complete destruction of adobe buildings including their domes was observed. However, example of good performance of domes can be also seen as shown in Figure 8. The building shown in the figure is located at Konari neighborhood in Arg-e-Bam and it has two domes. With the exception of some cracks at the Intersection of perpendicular walls, no other failure has been observed. On the other hand, many examples of massive and wide destruction had been observed few meters from the structure of Figure 8. As an example, the stable courtyard inside Arg-e-Bam is shown in Figure 9. Around the courtyard, many surrounding buildings are shown before and after the earthquake. The majority of domes shown in Figure 9a were destroyed completely as shown in Figure 9b. Supporting walls were also destroyed partially or completely. For walls situated parallel to

Figure 8. Domes located in Konari neighborhood in Arg-e-Bam

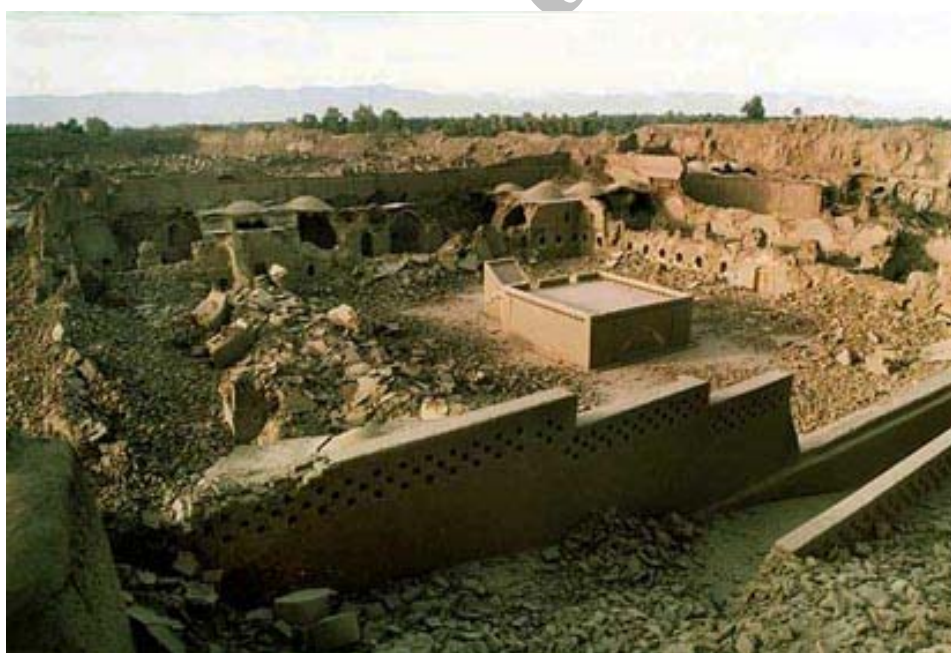
Figure 9b. A courtyard in Arg-e-Bam after earthquake

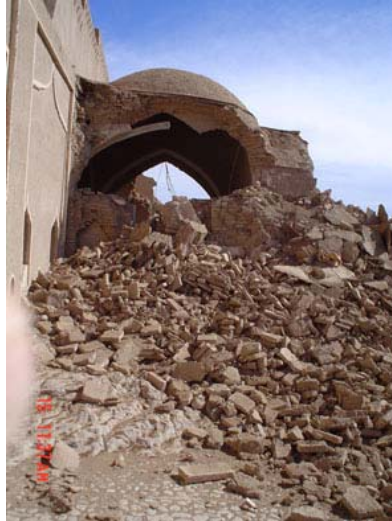
the earthquake direction, and due to the presence of vertical forces, the ability of these walls to resist shear forces has been reduced considerably. However, for walls perpendicular to the earthquake direction, it is believed that the combination of the normal forces to the wall plane and the vertical acceleration forces had caused their failures. However, it is interesting to note that some of these buildings that are located in the right corner of Figure 9 had survived the earthquake by taking advantage of their adjacency to two relatively rigid walls. In the author's opinion, the reaction applied by these two walls during the earthquake had increased the capacity of these parts to resist vertical forces applied by the vertical acceleration component. Prominent among the surviving domes in the stable courtyard, are those shown in Figures 10. The vaulted roof shown in Figure 10 has been used to support some of these domes. In this figure, additional arched panels had been added to this structure in order to relieve the bearing walls from parts of their loads. Accordingly, two arches and two walls support each dome. In Bam's earthquake, the forces applied were perpendicular to the plane of the arched panels and parallel to the wall. Arches in this case had fulfilled the role of bracings in inactive walls and distributed the loads between active walls to prevent partial failure. As it is clear from Figure 10, one of the arches had suffered minor failures. This failure reflects the disability of the arch panel to transfer forces between active walls.

Figure 10. A dome supported by two walls and two arch panels.

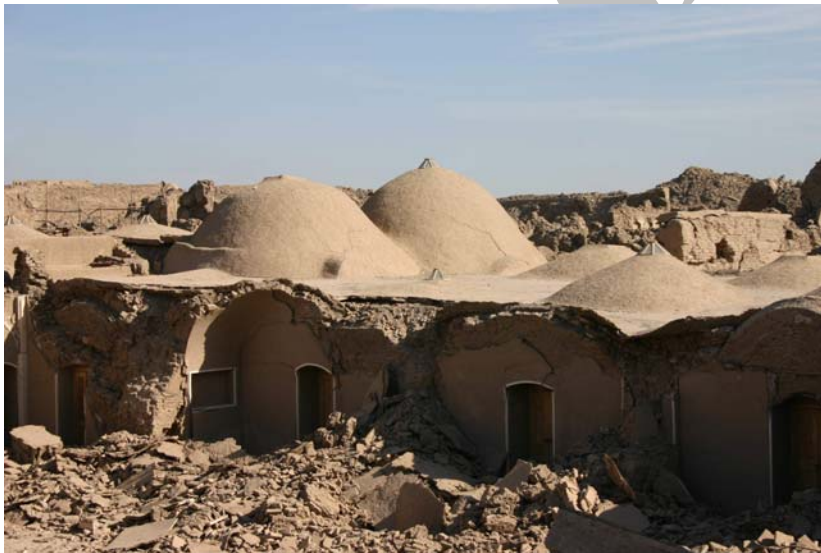
In general, the main problem with a dome placed over a square plan is the transition from the square below to the circle above. In historical buildings of Iran, different solutions for this problem can be found [5,6]. However, these solutions have not been implemented fully in constructing the domes found in the earthquake-stricken area. As a result, approximately all surviving domes had sustained some cracks. The typical pattern of the cracks observed in most cases is that of a meridian crack, as shown in Figure 11. In most cases, such cracks had

been initiated at points closer to the intersection line of dome and flat roof. Accordingly it can be safely stated that in addition to the wall-to-wall and roof-to-wall intersections, this line of intersection can be considered as another weakness point of these structures.

Figure 11. A meridian cracks in the dome
