DESTRUCTIVE EFFECTS OF THE 2003 BAM EARTHQUAKE ON STRUCTURES

S.M. Zahrai* and M. Heidarzadeh

Center of Excellence in infrastructural Engineering and Management, School of Civil
Engineering, University of Tehran, Tehran, Iran

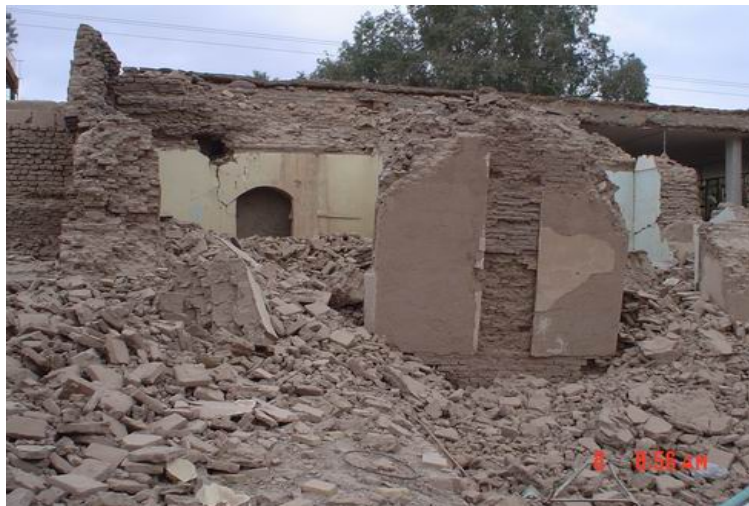
Most houses in the epicentral area are adobe construction, usually one-story made of sun-dried brick walls, and domed roofs or vaults with clay or mud mortar. This type of construction is common in the dry areas of Iran because adobe houses need only local materials and can be built by farmers when their work is lax. The walls and roofs of these houses are thick (usually 40 to 80 cm) and heavy so that they easily protect their inhabitants from the cold and hot weather, but they are very weak in resisting horizontal vibrations particularly at the junctions of vertical walls and domed roof (Figure 4). Based on the reconnaissance visit, most adobe houses in the epicentral region are either partially or totally collapsed. Their failure normally started in a corner by separation of the walls from the

domed roof. In some region the ground shaking was so severe that the abode houses were turned into their original sun-dried bricks.

Figure 4. Heavy walls-thickness of wall in some adobe houses is around 1 m

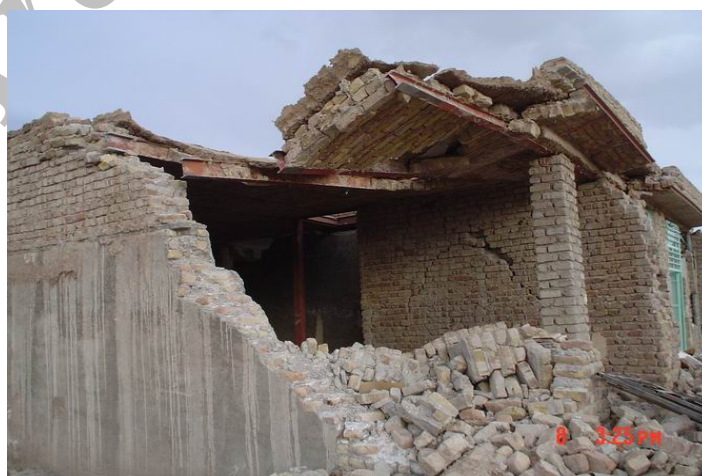
Masonry buildings are the second most common type of buildings in the earthquake-affected area. They normally consist of brick walls with shallow Jack arch roofs supported by steel I shaped beams which is discussed before. The mortar used in these buildings is sand-lime-cement, or sometimes sand-cement. The performance of un-reinforced masonry buildings which lack tie beam or jack arch tie rods was not so better than adobe buildings. The common modes of failure of these buildings were shear failure of walls, separation of walls from the roof, and separation of roof beams from each other (Figure 5). In most cases the steel beams of the roof were not braced together by steel bars or joists. As a result, dropping of the bricks between them during the earthquake could be expected.

Figure 5. Shear failure of walls, separation of walls from the roof, and separation of roof beams from each other are observed in typical brick buildings

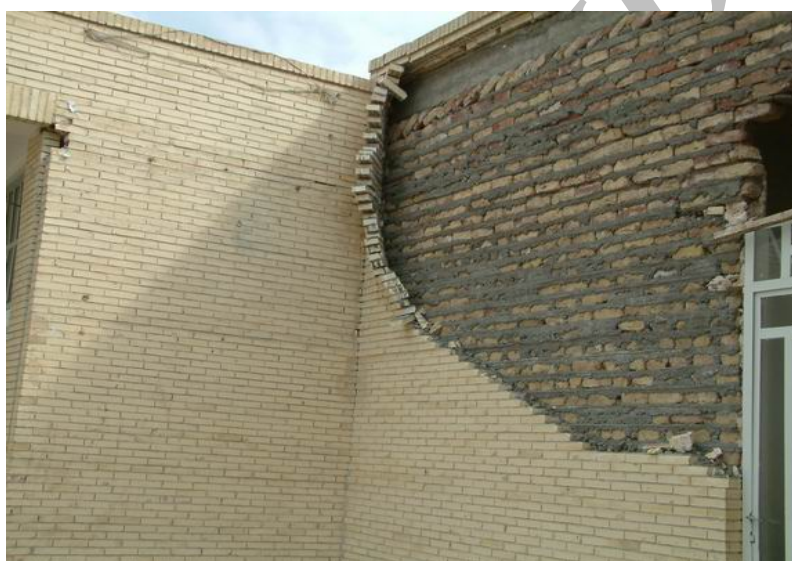
A number of reinforced masonry buildings, with vertical and horizontal reinforcing tie beams, were recently built in the city. The performance of these structures was good and in many cases saved the lives of their inhabitants (Figure 6). In many cases the material used for tie beams or their execution quality was so bad that the element hardly could resist earthquake. It is found that the philosophy of the tie beam to protect the unity and integrity of the walls was not understood well. For example in some cases the bond between tie beams at the wall corners has poor conditions. However, wherever the tie beam had a relatively good condition, the performance was satisfactory.

Figure 6. An example of reinforced brick buildings in the earthquake-affected area with a relatively good performance

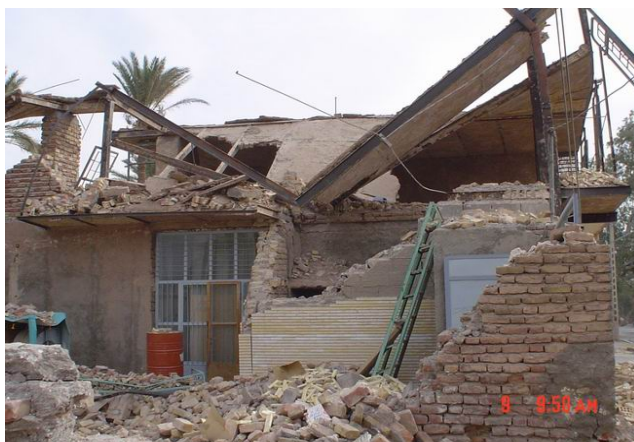
Many modern residential and office buildings in Bam are steel building structures that can be divided into two groups. The first group includes buildings with steel internal columns, load-bearing external brick walls, and roofs, often, made of shallow Jack arches with steel I-beams. The performance of this type of construction as a sort of un-reinforced masonry structure was very poor. The flexible steel columns tended to displace much more than the rigid external walls resulting in inclining of the steel columns and mostly the collapse of the whole structure (Figure 7). This earthquake clearly demonstrated that the combination of relatively rigid load-bearing external brick walls and flexible internal steel columns is very hazardous. This type of structure is not limited to Bam, and it can be easily observed in most of the cities in the country.

Figure 7. First group of steel buildings, combination of steel internal columns and load-bearing external brick-walls

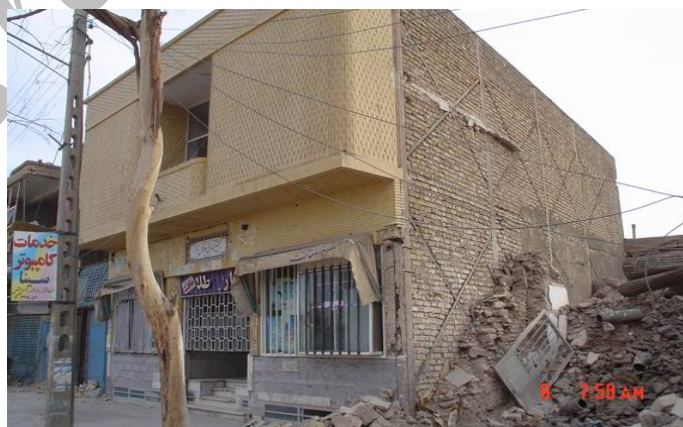
The second group of steel buildings consists of steel frames just in one direction with bracing in one or two directions. They are actually designed for some horizontal forces. The performance of this type of construction was generally satisfactory (Figure 8). Exceptions are made when the bracing were placed non-symmetrically or incorrectly. In these cases, the infill or curtain walls usually experienced severe damage; i.e. due to the weakness of the lateral load bearing element, the infill or curtain walls had been activated during the earthquake and resisted the applied loads resulting in their severe damage. In braced steel structures, the bracing and their connections had different defects like insufficient cross section area, insufficient connection plate, improper connection execution, and so on. Therefore most of them could not effectively resist applied loads. In fact this earthquake proved that use of steel beams and columns in building structures without observing proper seismic code provisions for earthquake resistance showed no improvement over non-engineered buildings.

Figure 8. Steel building with good performance during the Bam 26.12.2003 earthquake

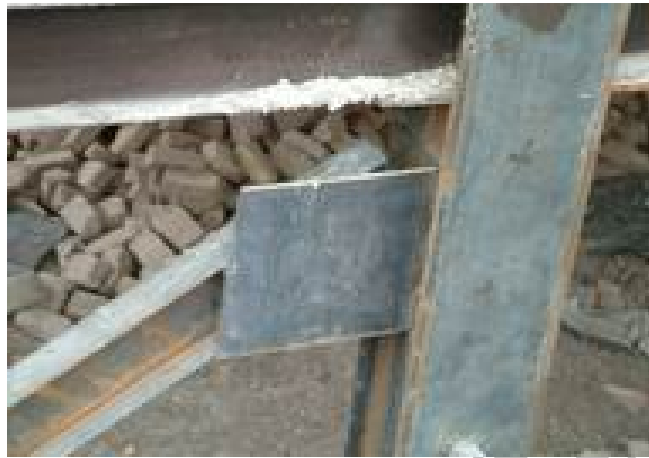
Figure 9. Incorrectly bracing with single I shaped brace only connected to the column

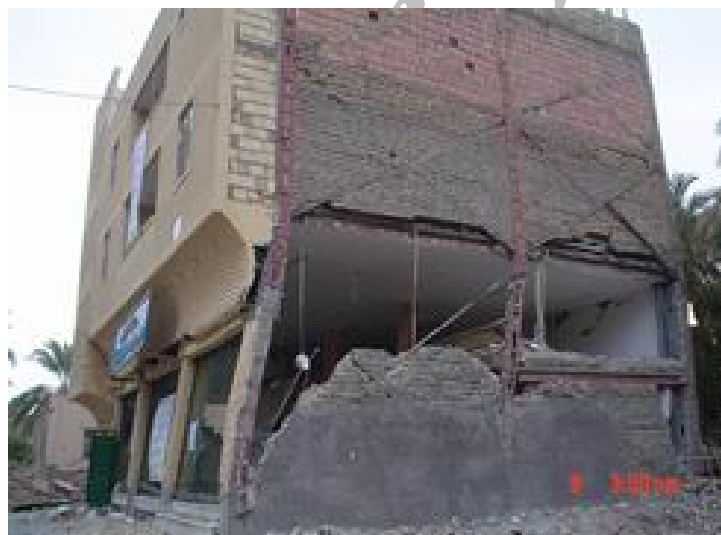
Figure 10. Unacceptable bracing system where the cross-section of bracing member is insufficient

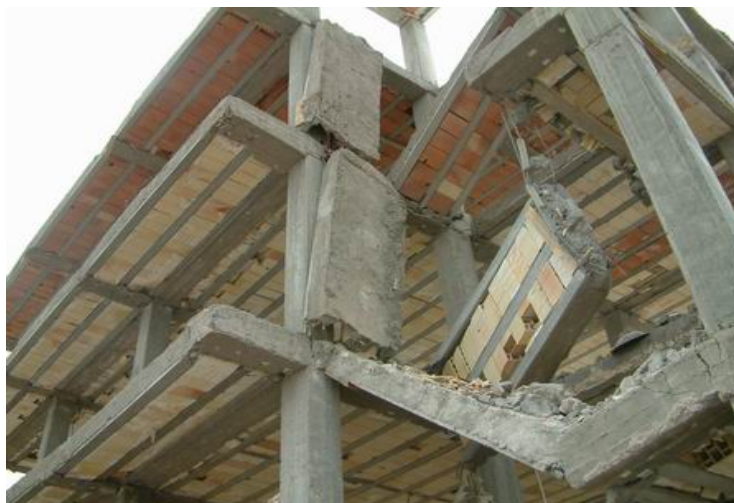
- A. Poor performance of stairs as shown in Figure11.
- B. Poor quality of concrete.

Figure 11. Poor performance of stairs in reinforced concrete structures

As a result, authors believe that most problems of reinforced concrete structures would be removed if they were designed and constructed properly. Even, higher RC buildings might

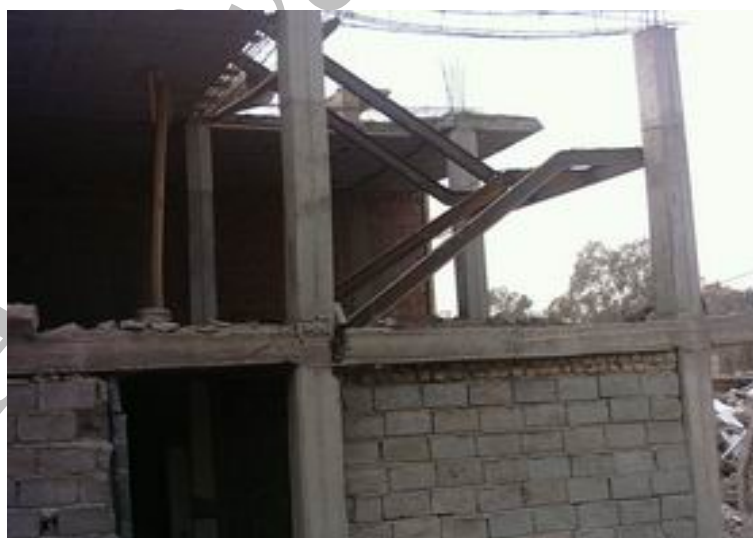
- A. Lack of homogeneity between the structural components. For example in one case in a reinforced concrete structure, steel stair case was used (Figure12).

Figure 12. Use of steel stair in a reinforced concrete structure

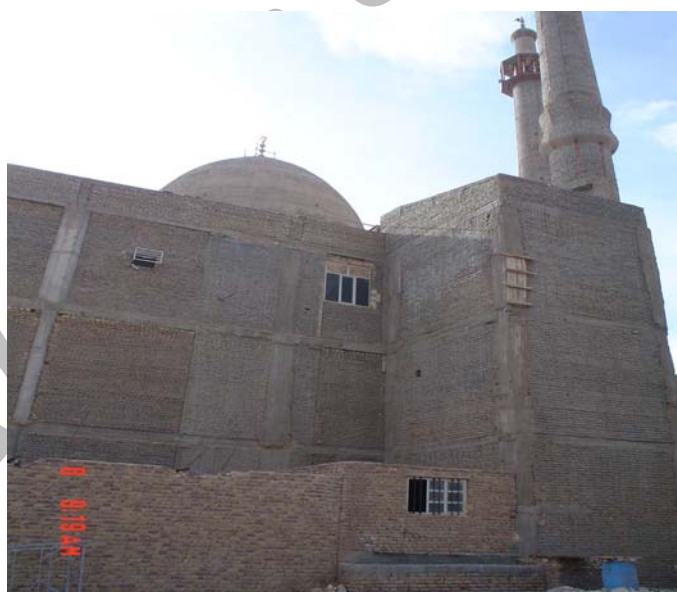
There are some notable structures other than buildings in the area from which the most important are a reinforced concrete mosque; an elevated reinforced concrete water tank tower and multi span Reinforced Concrete Bridge. As a whole, all of them had a satisfactory performance and do not sustain any significant damage. In the case of the mosque, it has a three dimensional dome and it is very difficult to find a crack created from the earthquake and all the walls remained undamaged (Figure13). Some researchers such as Adeli [5] believe that due to the three dimensional behavior of dome, the structure is treated rigidly during the earthquake. Also field investigations showed that the structural elements (beams and columns) had adequate steel bars and cross sections. The concrete and brick infill walls were observed to have good conditions. It is believed that the infill walls greatly increased the stiffness of the structure in both directions.

Figure 13. A reinforced concrete mosque after the earthquake which had a satisfactory performance

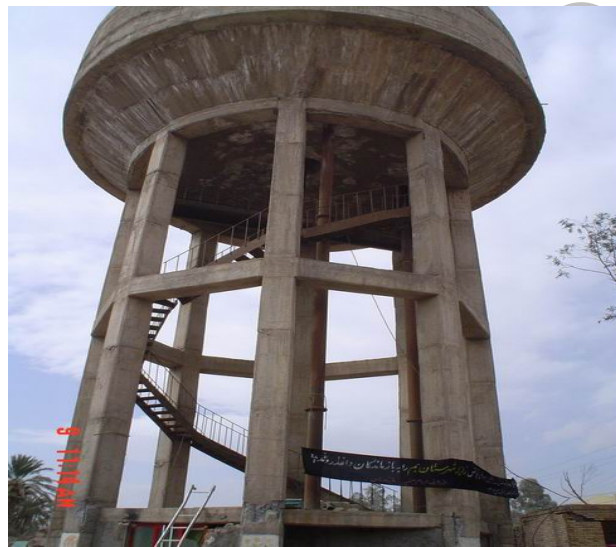
The other important structure is an elevated reinforced concrete water tank tower with approximately 20m in height and 350m³ in capacity which can be seen in Figures 14 and 15.

Figure 14. The elevated reinforced concrete water tank tower, where some cracks in the structural joints can be seen but the general performance is satisfactory.

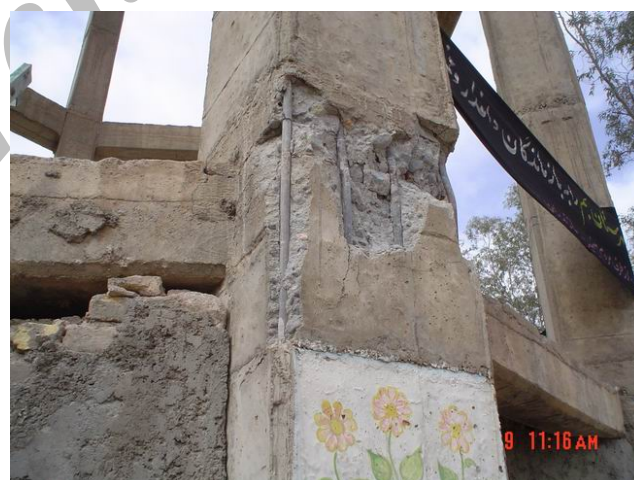
According to Figure15, the general performance of the structure was good but as shown in Figure15, some joints cracked so that the steel bars can be seen. As a matter of fact the only observed defect in this structure was improper reinforcement detailing. Investigations showed that the used steel rebars in the structure were round ones to which the cracks to some extent can be related. In addition, one will be surprised knowing that the columns are not reinforced with ties (at least in the joints). It is believed that the cracks in the joints to a great extent are related to the lack of ties in the joints.

Figure 15. Clos-up view of the cracks in the structural joints of the elevated reinforced concrete water tank tower (note the rebars with no threads).

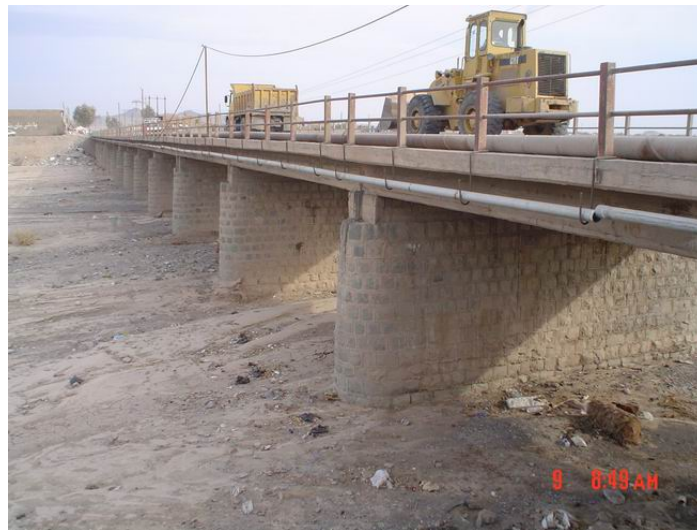
The other important structure in the area is a reinforced concrete bridge having piers lined by stone to resist against the river flow and its probable erosion (Figure 16). Like the mosque and the water tank tower, the mentioned bridge had good conditions being under service after the earthquake. Some parts of abutments cracked slightly, but there was no lateral displacement. Some spans got separated about 3 centimeters from the abutments (Figure17). As a result we can conclude that this bridge withstood the intense earthquake approximately without significant damage.

Figure 16. General view of the multi spans Reinforced Concrete Bridge after the earthquake which is in good condition and of course under service.

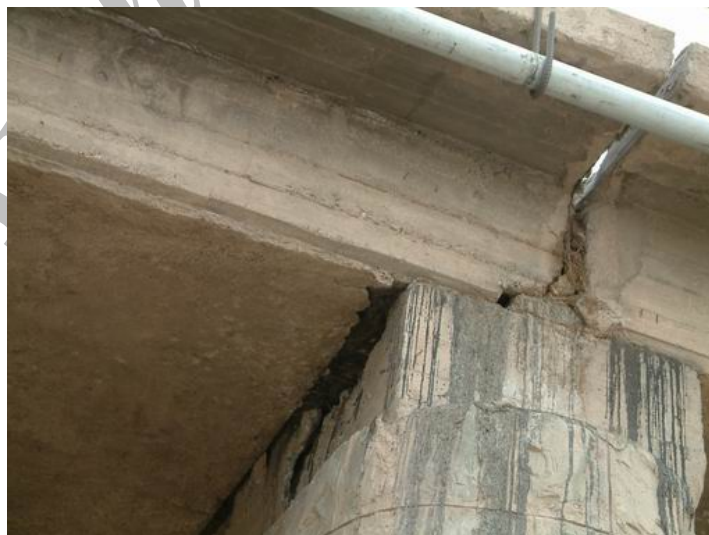
Figure 17. Separation of bridge Spans from the abutment
