“Research Note”

FAILURE ANALYSIS OF HP40-Nb MODIFIED PRIMARY REFORMER TUBE OF AMMONIA PLANT *

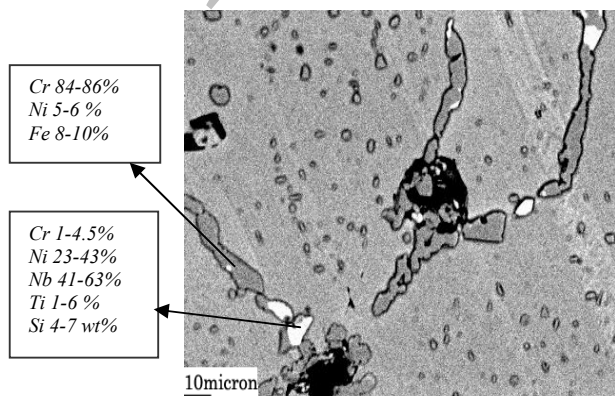
Figure 1 shows the SEM microstructure of the damaged material. The figure shows niobium and chromium rich carbides in the grain boundary in the damaged part of the tube. Grain boundary voids are shown in the optical microstructure. Appearance of the void indicates the occurrence of creep and grain boundary deformation phenomenon in the tube [5]. The various phases were analyzed (Fig. 1).

Fig. 1. Back scatter SEM photo of dominant phases in grain boundary. Dark phase is chromium rich carbides, light phase is niobium rich carbides

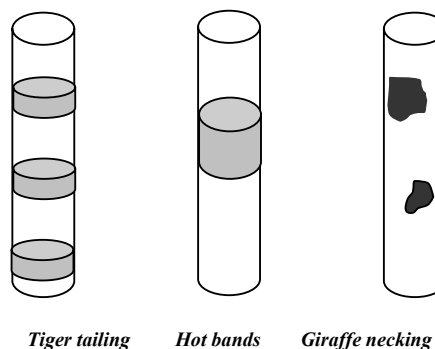
It seems that catalyst plays key role for developing several forms of overheating in the tubes. Several typical forms of overheated tubes are shown in Fig. 2 [6].

Fig. 2. Forms of overheated tubes [6]
