FAILURE ANALYSIS OF GE-F9 GAS TURBINE JOURNAL BEARINGS*

Abstract– This paper presents a failure analysis of journal bearings used in GE-F9 gas turbines. Detailed studies including visual examination, optical microscopy, scanning electron microscopy, XRD and oil analysis were performed to determine the root causes of failure. Based on the results, it was determined that fretting, sulfur attack and fatigue were the main causes of failure.

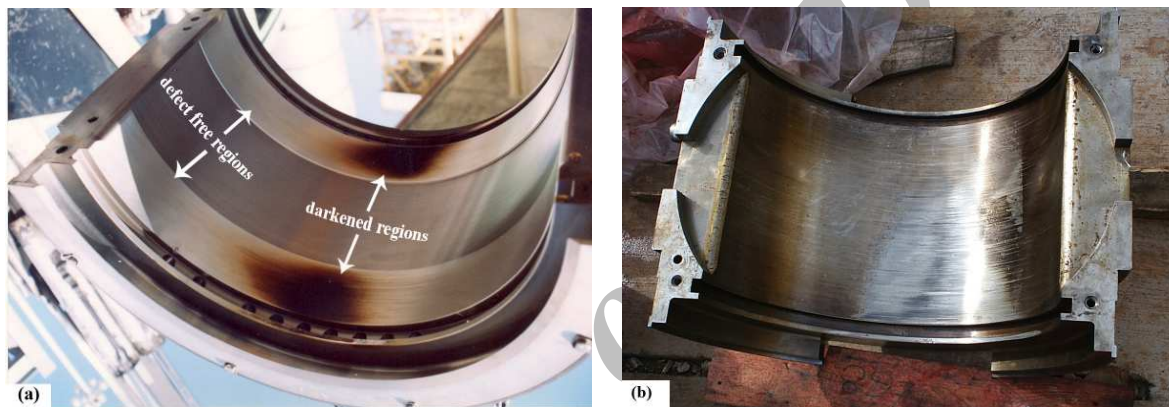
A visual examination of the bearing showed, clearly two black regions in the center of the upper half of the bearing, as shown in Fig. 1. The damage is confined to the upper half, with the bottom half of the bearing showing signs of normal wear.

Fig. 1. a) Upper half of the bearing, b) and bottom half of the bearing

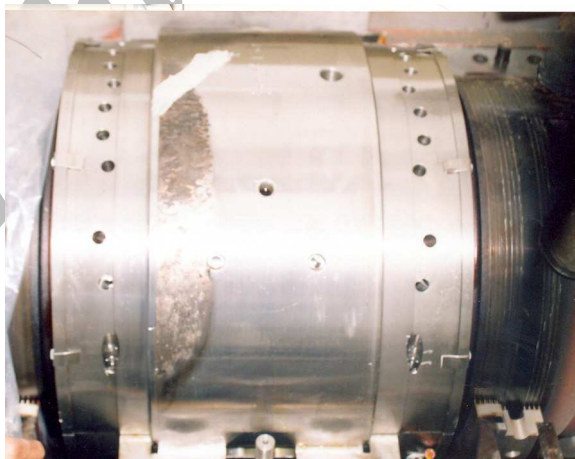
The outside surface of the upper half of the bearing backing was also damaged. It is easy to identify the severe fretting damage from the outer surface of the steel backing of the upper half shown in Fig. 2.

Fig. 2. Outside surface of upper half of bearing backing

Fretting of the outside of the bearing backing occurs as a result of small relative movements between mating surfaces. Movement may occur when there is insufficient press fit between the bearing and the housing. Lack of press fit can result when housing bores are oversized or when bolts are insufficiently tightened. The inner surface of housing also showed evidence of fretting.

1. Relative movement between the bearing backing and the housing has been the main cause of failure. This movement resulted in the fretting of the outer surface of the bearing backing. Probably, the best measure to reduce or totally eliminate this movement is to use anti-rotation pins which keep the bearing and housing firmly together.

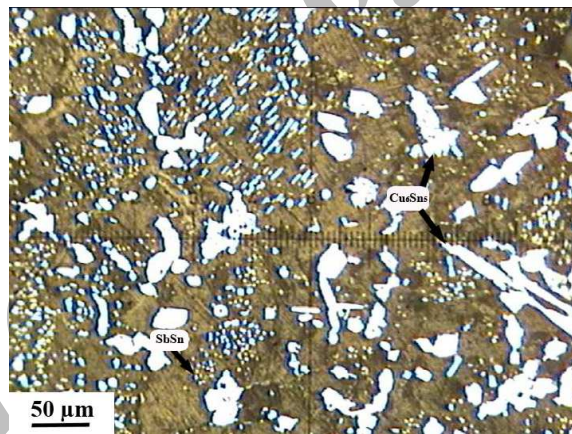
Metallographic analysis of the bearing material has been conducted. The micrograph in Fig. 3 shows a lining microstructure, where hard and small SbSn cuboids and hard Cu_6Sn_5 needles are embedded in the soft solid solution matrix of antimony in tin. There was no difference between the microstructures in the darkened region and the defect free region.

Hardness measurements were also carried out. Microhardness H_v of individual phases is as follows: matrix: 25.2; cuboids: 77.2; needles: 89.3. Metallographic analysis confirmed that lining chemical composition, microhardness and microstructure correspond to tin-based babbitt alloy.

Fig. 3. Microstructure of bearing lining.

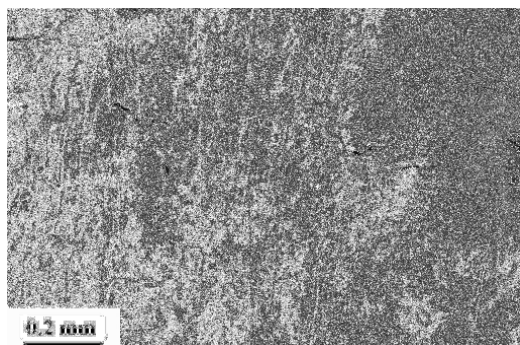
Both darkened and defect free surfaces of a bearing were examined in a scanning electron microscope. Relatively low magnification fractographs in Figs. 4 and 5 show the surfaces of the bearing in darkened and defect free regions, respectively. It can be seen that some fatigue cracks have formed in the darkened regions. This seems to be the initial stages of fatigue damage before any loose pieces can form. Tin-based babbitt alloys have a low strength and readily suffer fatigue damage with rising temperature accompanied by alternating loads. In the present case, alternating loads are a consequence of vibration. Increasing temperature locally at the upper half of the bearing due to relative movement between the bearing and the housing has lowered the fatigue strength of the babbitt layer and caused

Fig. 4. Presence of fatigue cracks on darkened region

4. The cracks that can be seen on the darkened regions are fatigue cracks before joining to each other and making loose pieces. Increasing the temperature of the upper half of the bearing due to relative movement between the bearing and housing has reduced the fatigue strength of the bearing lining and caused fatigue damage.

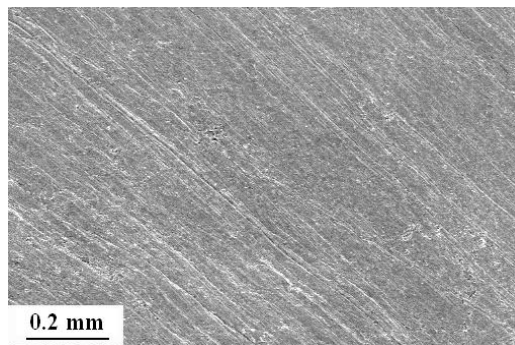
fatigue damage. In other regions of the bearing surface (Fig. 5) there was no sign of fatigue or other damage.

Fig. 5. Surface of defect free region

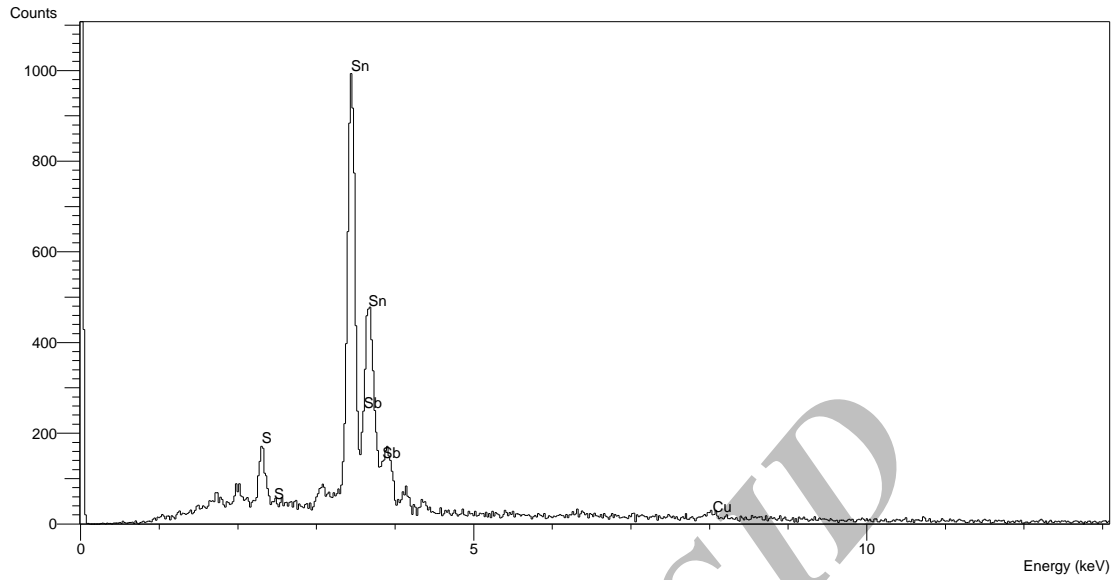
SEM-EDAX analysis was carried out to determine if there is any change in the composition of the bearing lining on the surface. The results for darkened and free defect regions are respectively shown in Fig. 6 and Fig. 7. One notable feature is the presence of sulfur at significant levels in the darkened regions. X-ray diffraction analysis was used for the specific identification of deposits. Some picks which correspond to copper sulfide (Cu_2S) picks are marked in Fig. 8. Since the surface of the bearing lining was not completely smooth, some additional noises are observed in the XRD pattern. The sulfide was formed by the action of sulfur acids in the lubricating oil on the copper in the bearing material. The decomposition of sulfur compounds in the lubricating oil usually occurs when moisture is present in the oil and when the operating temperature is high and exceeds a normal condition. In the present case, the frictional heat due to the oscillation of the bearing in the housing bore has stimulated a sulfur attack.

Fig. 6. EDAX analysis of darkened region

2. The dark corrosion product that covered the bearing surface was identified as copper sulfide (Cu_2S). The reaction of copper sulfide formation is a temperature dependent one; therefore preventing the rise of the operating temperature and changing the oil before sulfur acids accumulate to a harmful level can reduce the corrosive attack on the bearing material. Using sulfur-free oil additives is also a reliable measure which prohibits a sulfur attack.

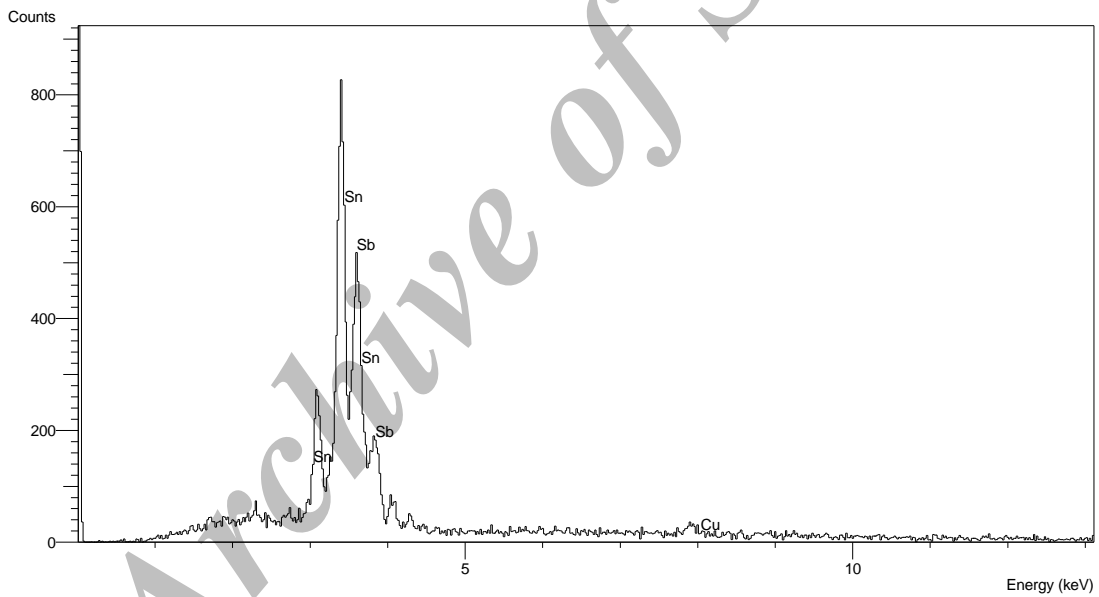
Fig. 7. EDAX analysis of free defect region

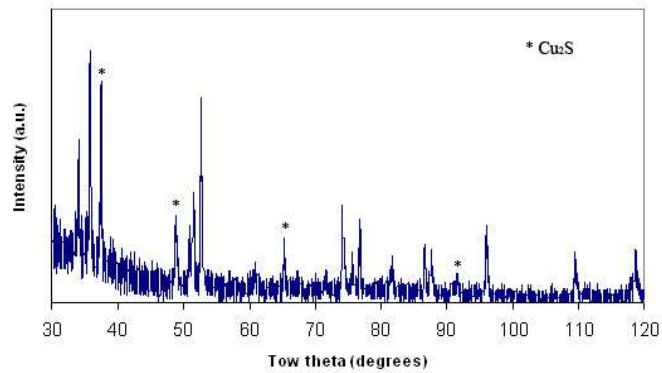
Fig. 8. XRD pattern of the sample taken from the darkened region
