## TECHNICAL NOTE

## CAUSES OF CATASTROPHIC FAILURE OF HIGH MN STEEL UTILIZED AS CRUSHER OVERLAYING SHIELDS

S. R. Allahkaram

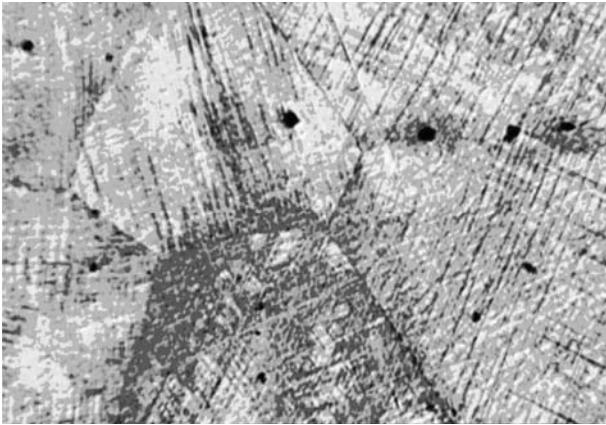
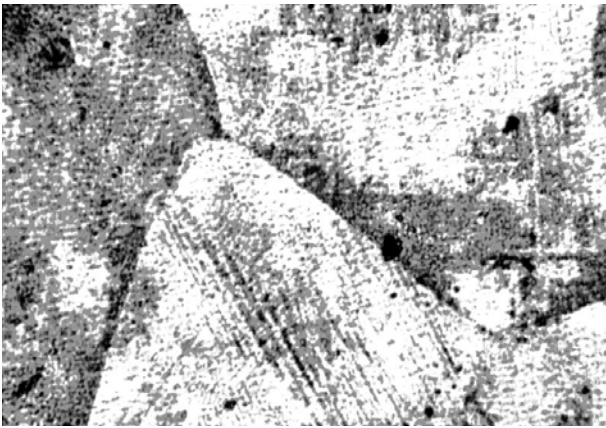
Figures 2a and 2b show the microstructure of the internal surface layer of the shield. The micrographs taken from two different sites of the internal surface indicate inhomogeneity in the sizes of the grains at these regions. As it could be observed, some voids appeared within the grains and grain boundaries with an average diameter of 5µm scattering all over the internal surface of the shield, which were probably due to the removal of the inclusions during grinding.

**Figure 2.** Two micrographs of internal surface structures of cone crusher shield at two different sites, indicating inhomogeneity in grain sizes.

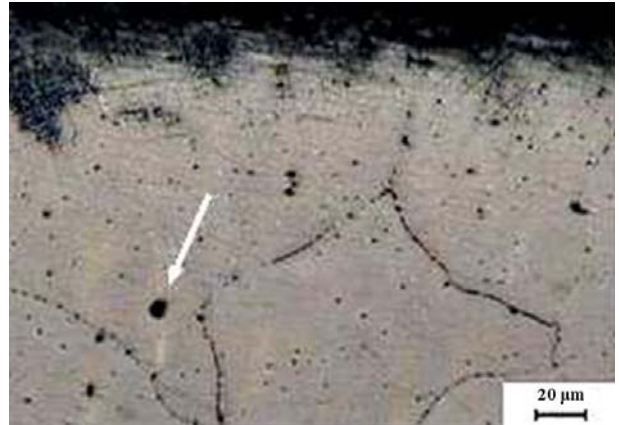
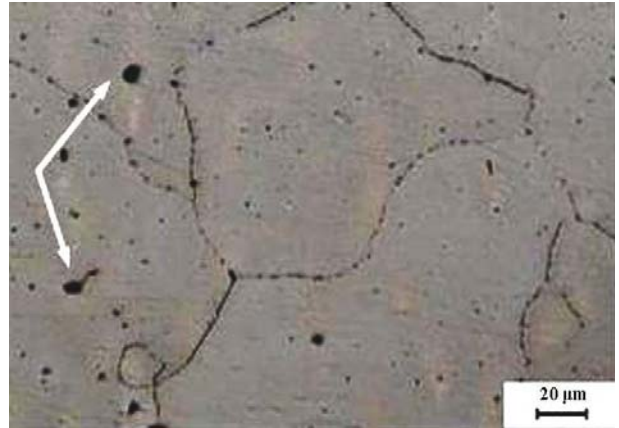
Figures 4a and 4b indicate the microstructures at the inner surface and at 0.5 mm below the inner surface of the shield, respectively. Figures 5a and 6a show the microstructures at 1 mm and 5 mm below the inner surface, respectively.

**Figure 4.** Structural sites near the internal surface of cone crusher shield (x-sectional traverse). (a) Close to the internal surface. (b) At 0.5 mm depth. Note the dark pits indicated by the arrows, probably due to the segregation of precipitated particles.

The average size of the grains at 1 mm depth was about 250  $\mu\text{m}$ , which was almost twice larger than those at 0.5 mm depth (Figures 4b and 6b).

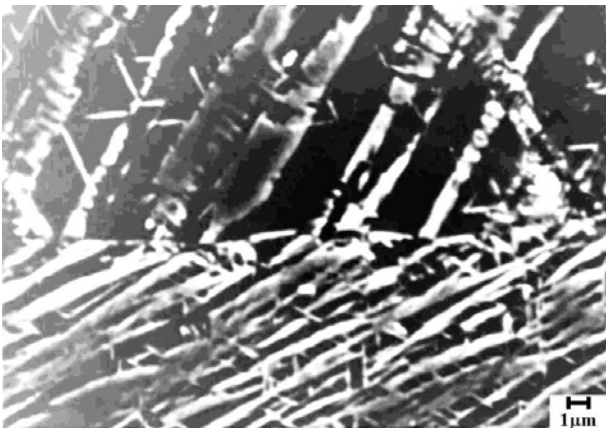
**Figure 3.** Internal surface structure, scanning electron micrograph.

Figure 3 illustrates the twin martensite branches across the boundaries of two neighboring grains of the internal subsurface layer of the shield. According to Tiantu, et al [2], although deformation twins and strain-induced martensite in the subsurface layer of a worn specimen brings about higher work-hardening capacity and hardness, which is beneficial to wear resistance, but at the same time, brittleness of work-hardened layers increases.

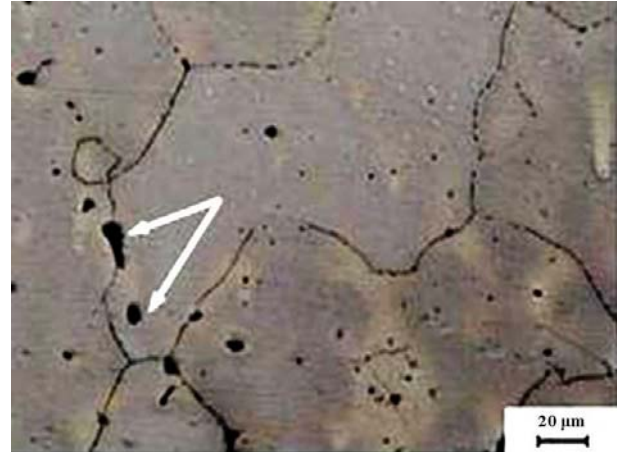
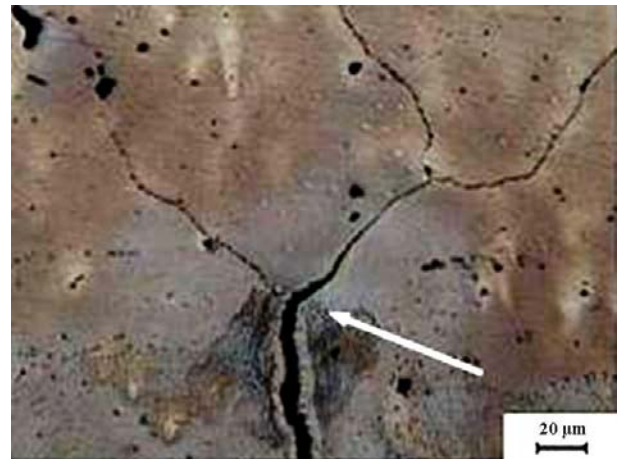
A more detailed examination of the crack direction revealed that the inclusions and/or the voids were preferable sites for crack propagation though the boundaries. These are illustrated in Figures 5b, 6a and 6b.

**Figure 5.** A grain boundary crack at (a) 1 mm depth below the internal surface and (b) 1 mm depth below the surface.

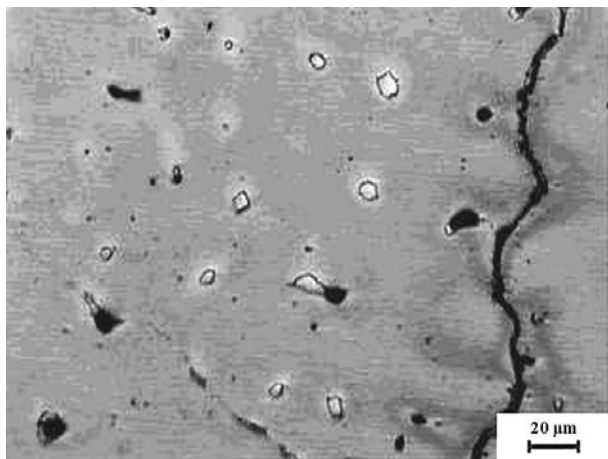
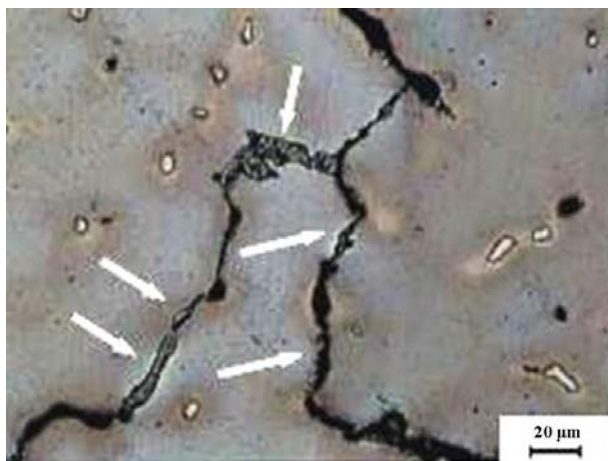
**Figure 6.** Microstructure at (a) 5 mm depth below the internal surface of the shield indicating internal grain boundary crack propagation and (b) precipitated particles within grain boundary cracks shown by arrows.

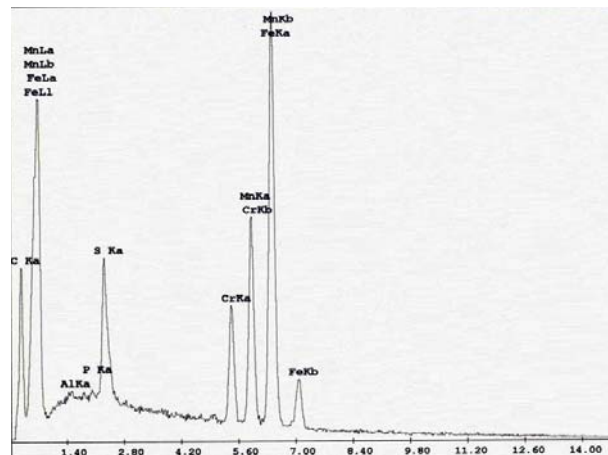
Figures 7 and 8 show the EDX spectroscopy of a precipitated particle within a grain boundary crack and in the austenitic base of the shield, respectively. By comparing these two analyses, it can be clearly observed that the presence of higher carbon content in an isolated particle within a growing crack, compared to the base metal can confirm carbide precipitation in the grain boundary. This indicates the occurrence of

**Figure 7.** EDS analysis of a precipitated particle within a grain boundary crack.

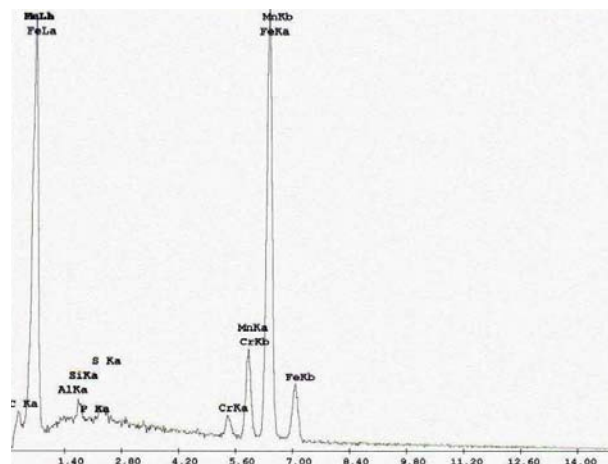
**Figure 8.** EDS analysis from austenitic base.

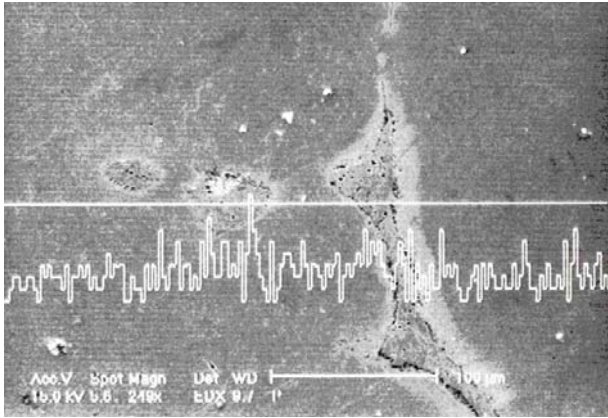
For investigating elemental distributions and variations of their concentration within the material, line-scan was employed. Figures 9 and 10 illustrate the line-scan results for phosphorous taken across a grain and a grain boundary, respectively. It can be deduced from these semi-quantitative analytical results that the concentration of phosphorous within the grain boundary is almost twice as much as the concentration in the grain. Baring in mind that the phosphorous concentration in the alloy was found

**Figure 9.** Phosphorous line-scan taken across a particle within a grain.

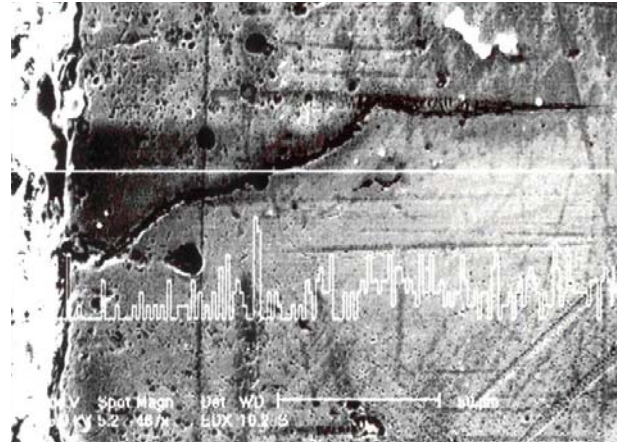
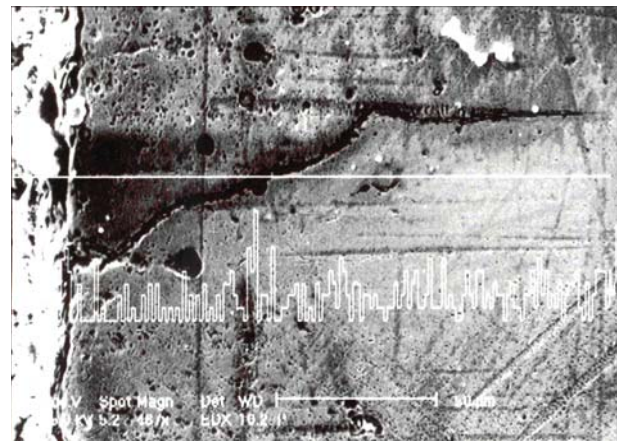
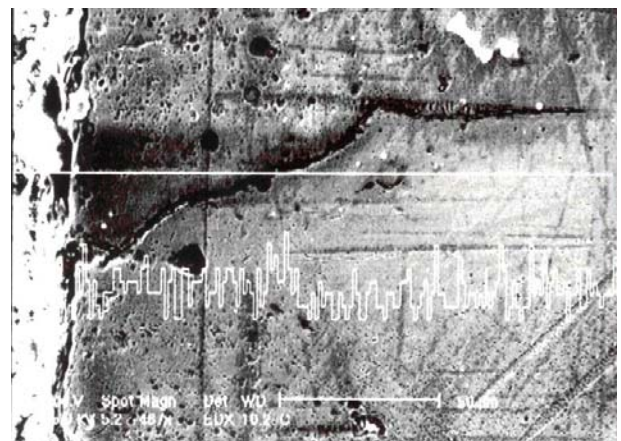
Figures 12a, b and c illustrate the results of line-scans for variations of (a) sulfur, (b) and (c) carbon concentrations through the base metal across a crack, starting from the inner surface of the shield. The scan results indicate that phosphorous and sulfur contents within the crack are higher than those of the base metal. Figure 12c also illustrates that the variation of carbon within the crack was slightly higher than that of the base metal. These results confirm that sulfide and carbide inclusions within the grain boundaries provide available sites for a growing crack.

**Figure 12.** Variations of concentrations of (a) sulfur, (b) phosphorous and (c) carbon in a known crack path adjacent to the internal surface obtained by line-scan. Arrows show the internal surface of the shield.

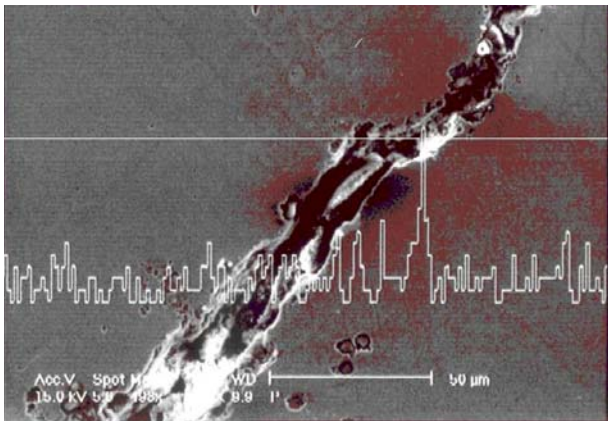
to be 0.05 % (Table 1), hence a build up of its concentration within the grain boundaries can be in excess of 0.1 %. It has been reported that phosphorous concentration over 0.05 % in Hadfield steels promote hot cracking phenomenon during fabrication process [4].

**Figure 10.** Phosphorous line-scan taken across a grain boundary.

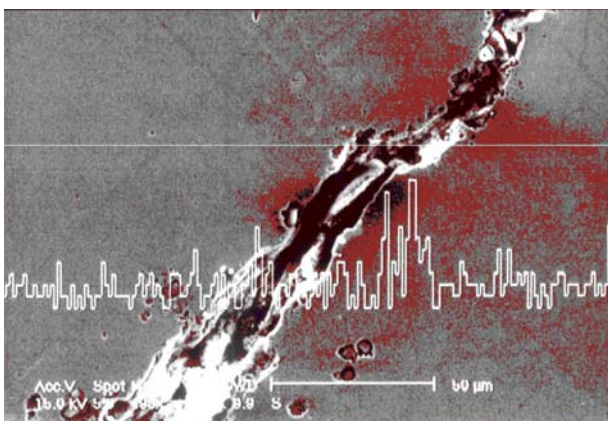
This can be further influenced due to higher concentration of interstitial sulfur diffused toward the grain boundaries. According to Figure 11, the amount of sulfur in a particle within the grain boundary is almost twice as much as the base metal.

**Figure 11.** Sulfur line-scan taken across a particle within a grain boundary.

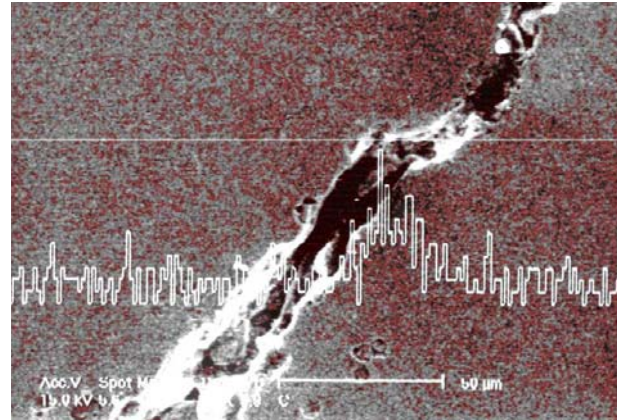
Figure 13 indicates the line-scan result for carbon variations within a grain boundary at a further distance away from the internal surface of the shield. This micrograph also illustrates that the carbon content within the grain boundary is almost twice that of the base metal as well as in the vicinities adjacent to the grain boundary. Figure 14 shows the eutectoid substructure and its associated line-scan for the carbon in a selected path.

**Figure 13.** Carbon line-scan taken across a particle within a grain.

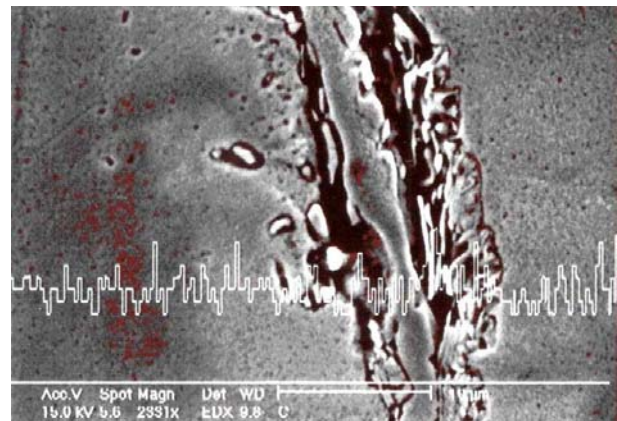
**Figure 14.** Carbon line-scan taken across a lamellar structure (possibly eutectoid).

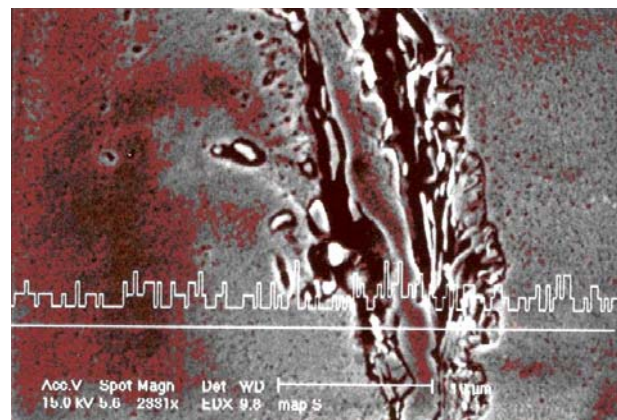
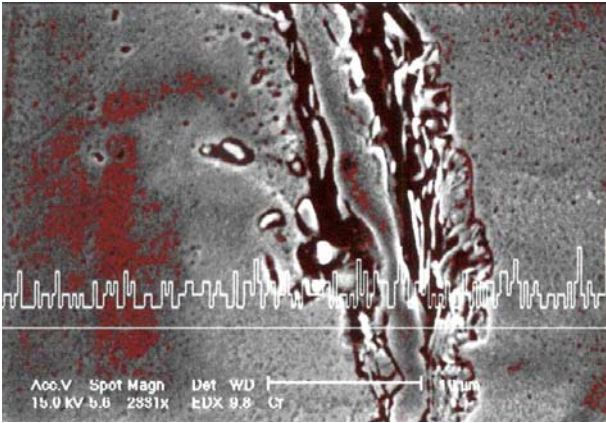
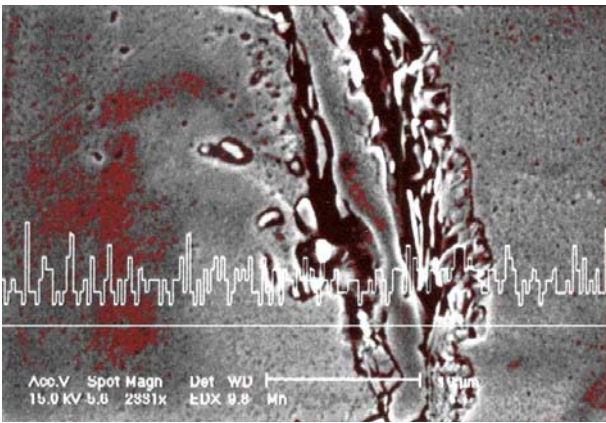
Figures 15-17 also show similar topographical analyses for sulfur, chromium and manganese concentrations, respectively. The line-scans across the eutectoid substructure for various elements indicate lower elemental contents in the eutectoid lamellar substructure than elsewhere. This finding confirms the eutectoid nature of the lamellar substructure. The depletion of alloying elements from the grains and other phases such as eutectoids and their diffusion toward the boundaries to form various inclusions within the grain boundaries result in the formation of an ideal path through which a crack can grow across the wall thickness of the shield.

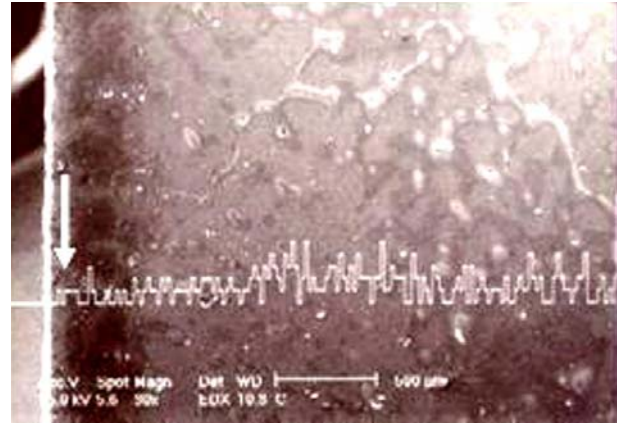
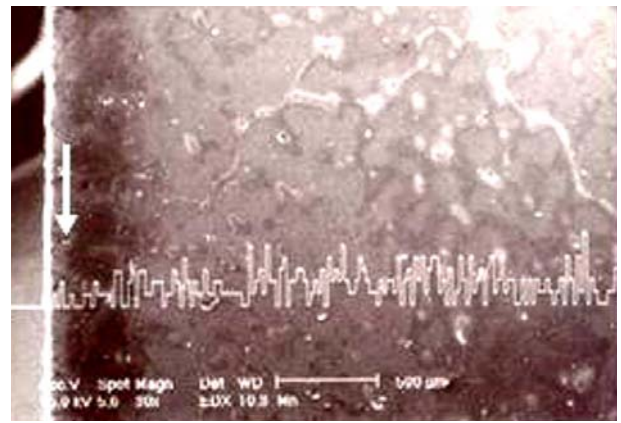
For further investigation of possible decarburization and demagnetizations of the inner surface of the shield, line-scans were employed again for carbon and manganese variations from the internal surface up to 500  $\mu\text{m}$  depth below the surface of the shield. Figures 18 and 19 show the results of these analyses for carbon and manganese, respectively. The distributions of these two elements can be seen to be lower near the inner surface and gradually increase through the core up to a level, after which they remain almost constant.

By comparing these figures, it can be deduced that the Mn variations from the surface through the metal is more pronounced than that of C variations along the same line.

Therefore, it is true to say that demagnetizations is a prevailing structural defect as compared to the decarburization phenomenon in these shields. This is in keeping with other investigator's findings, i.e. the ratio of  $\text{Mn}/\text{C} < 10$  results in demagnetizations and hence failure of Hadfield steel cone crushers [8]. Hence, the propagating crack initiated from the internal surface (Figure 12), can be primarily related to the demagnetizations phenomenon.
