Post-Earthquake Quick Inspection of Damaged Buildings in Bam Earthquake of 26 December 2003

A.S. Moghadam and A. Eskandari

Structural Engineering Research Center, International Institute of Earthquake Engineering and Seismology (IIEES), Tehran, Iran, e-mail: moghadam@iiees.ac.ir

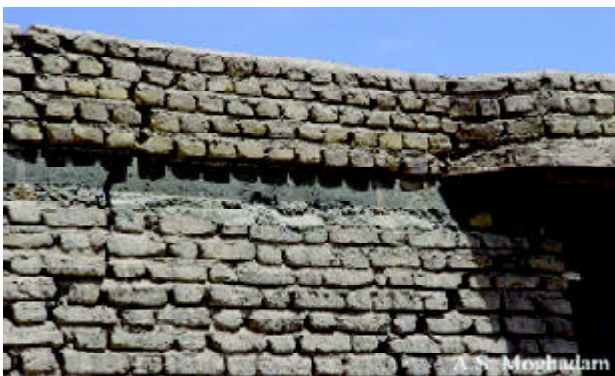
The masonry structures that have been evaluated are categorized in two groups: Bearing wall without vertical and horizontal tie beams, bearing wall with vertical and horizontal tie beams (lintels). In the masonry structures without tie beams, the bearing walls and even partitions had been activated during earthquake and resisted the applied load and had experienced significant damages. Most of the damages are limited to shear cracks (diagonal, 45 degree cracks). In some cases all the wall were damaged and collapsed. According to “Iranian Code of Practice for Seismic Resistant Design of Buildings” [5], these buildings are not acceptable, due to lack of tie beams. If concrete condition and reinforcement detailing in vertical and horizontal tie beams of the masonry structures be proper, then the tie beams act as effective elements and resist earthquake load. Because of their short height and short period, their strength rather than ductility is important. To mobilize their full strength the tie beams should be able to keep the integrity of the walls. In many masonry buildings, because of the inappropriate details and concrete condition, some damages had occurred in tie beams, see Figure (10), and in the connections, see Figure (11). Also the bars had buckled and the concrete cover of tie beams had cracked. Some horizontal tie beams were not at the same level, which is not acceptable according to the code.

Figure 10. Crack in tie beam due to lack of reinforcement.

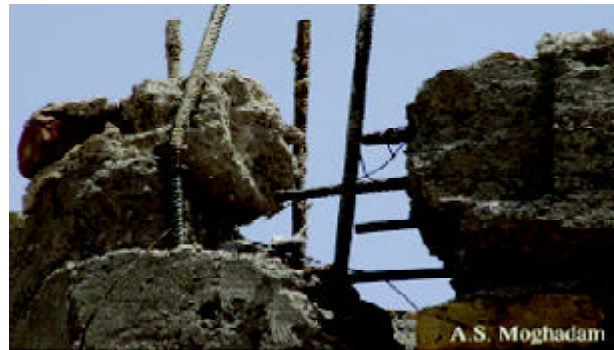
Figure 11. Improper connection of vertical and horizontal tie bars.

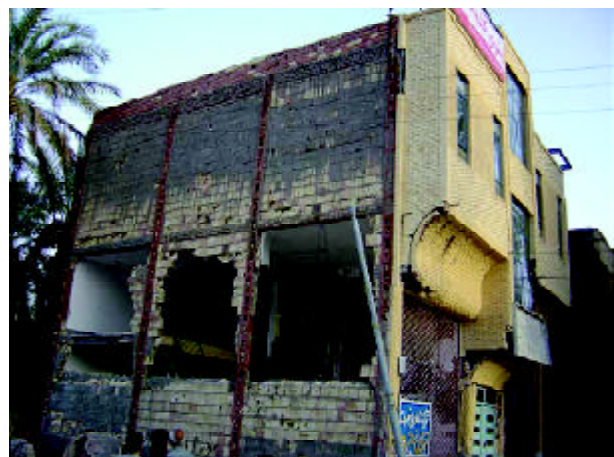
Structural system of the most existing steel structures in Bam city is continuous side connection (satchel connection) simple frame in one direction and simple frame in the other direction, see Figure (12). In some

cases, there is not any frame in the other direction. In braced steel structures, the bracings and their connections were often suffering from different construction deficiencies. Most of the bracings had experienced buckling and damaged in the connection region, see Figure (13). In some steel structures without bracing, the stairs were performed as bracing

Figure 12. Simple steel frame without bracing.

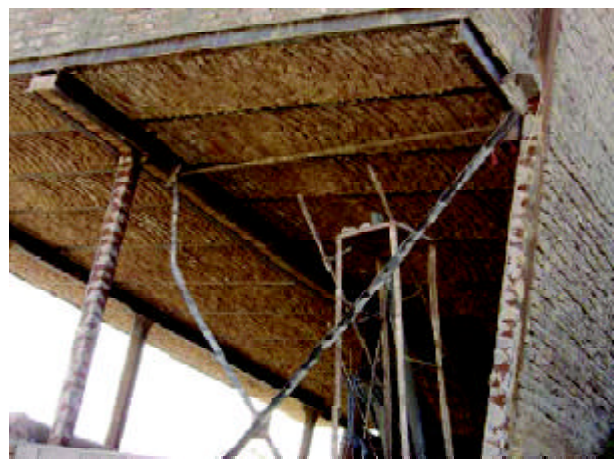
Figure 13. Buckling of bracing and connection damage.

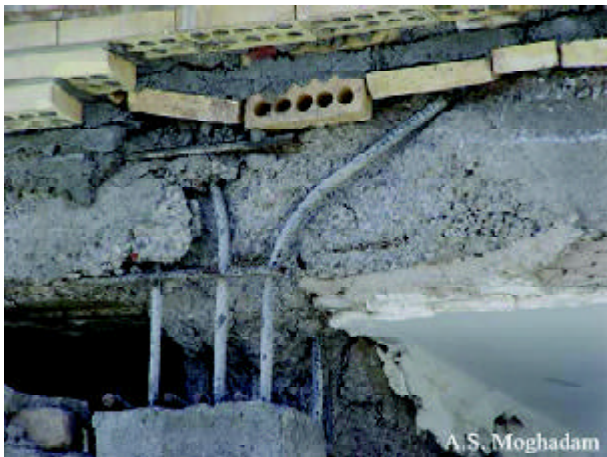
The number of reinforced concrete buildings in Bam was far less than number of masonry or steel buildings. Poor quality of concrete, improper forming, and incorrect reinforcement detailing was widespread. In many reinforced concrete buildings, due to existence of many stiff and strong infills, the beam and columns of frames had performed as tie (lintel) beams for the frames. Therefore, in many reinforced concrete frame buildings, the infills suffer significant damages, but the beams and columns with poor quality remain intact, as they had only acted as tie beams. A sample of poor detailing in connections is shown in Figure (14). A common practice of damaging columns for installing staircase is shown in Figure (15).

Figure 14. Poor detailing in connection.

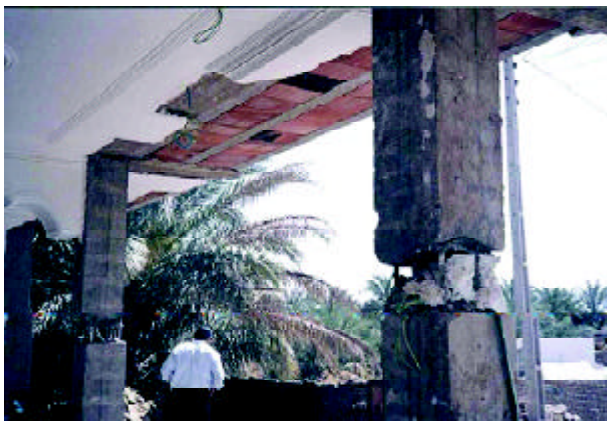
Figure 15. Removing concrete to install stair case.
