Reconnaissance Report on Building Damage Due to Bam Earthquake of 26 December 2003

Yasushi Sanada¹, Masaki Maeda², Ali Niousha³, and M. Reza Ghayamghamian⁴

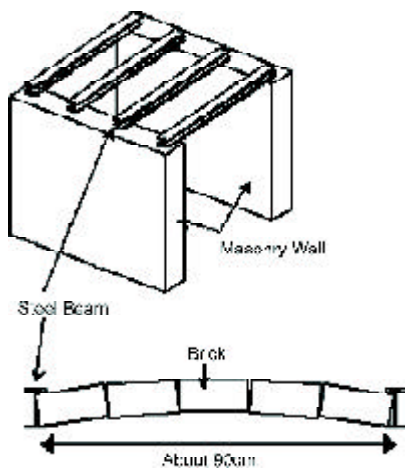
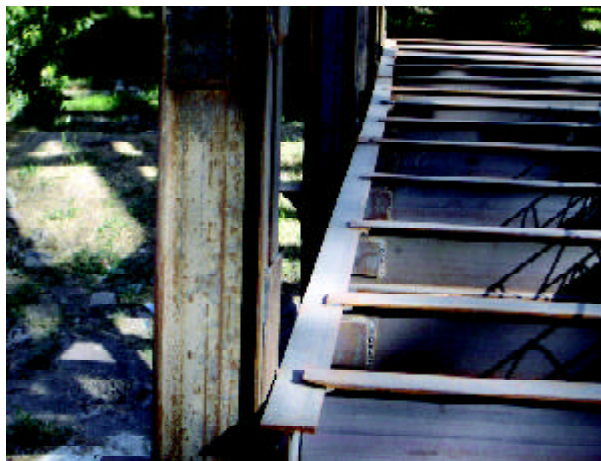
The common slab in the buildings was the brick jack arch type, see Figure (1). The system consists of parallel I-shape steel beams at about 90cm distance. These beams support the brick arches, which are covered and leveled off by gypsum plaster in the bottom and mortar and tiling at the top.

These slabs are heavy and behave as a flexible diaphragm unless detailing is considered. The slabs constructed in this way are usually not tied together and to the supporting walls or girders. Therefore these kinds of slabs have caused heavy building failures and an unusually high death toll in many recent earthquakes in Iran.

Figure 1. Commonly used jack arch slab (left: wall supporting, right: order supporting).

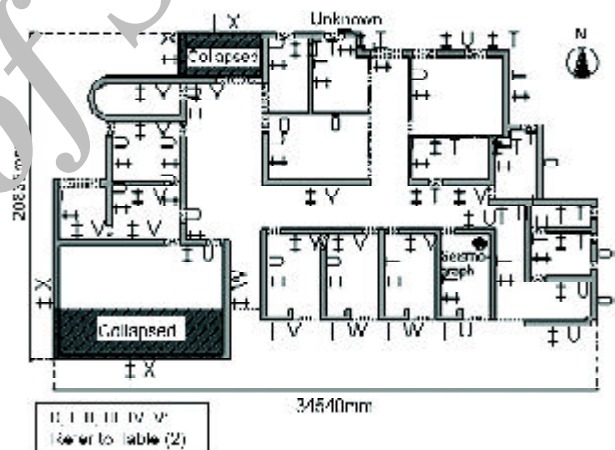
Governor’s Building is a two-story *SM* building with reinforced concrete horizontal ties, as shown in Photo (1). This building has an irregular plan. The wall arrangement is illustrated in Figure (9). The damage level, classified by *EMS-98*, was Grade 4 due to the partially collapses of *NW*- and *SW*-sections as shown in Photo (2). The location of the seismograph is also illustrated in Figure (9), which shows that the seismograph was placed far from both collapsed areas. The wall ratios (= the sum of the first floor wall sectional area / the first floor area) were 6.4% to 6.8% in the *NS* direction and 5.8% to 6.7% in the *EW* direction considering the unknown collapsed area.

Moreover, the damage levels and the maximum crack widths of all masonry walls in the first story were measured in Governor’s Building according to the criteria shown in Table (2). The damage levels of walls are also shown in Figure (9) and the

Figure 9. First floor plan and damage levels of masonry walls of Governor’s building.

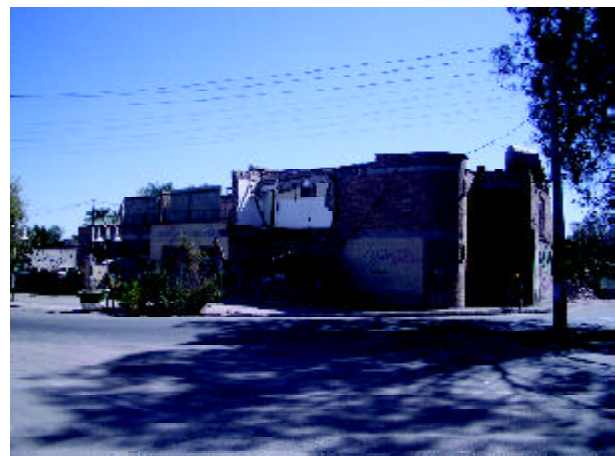
Photo 1. North view of Governor’s building.

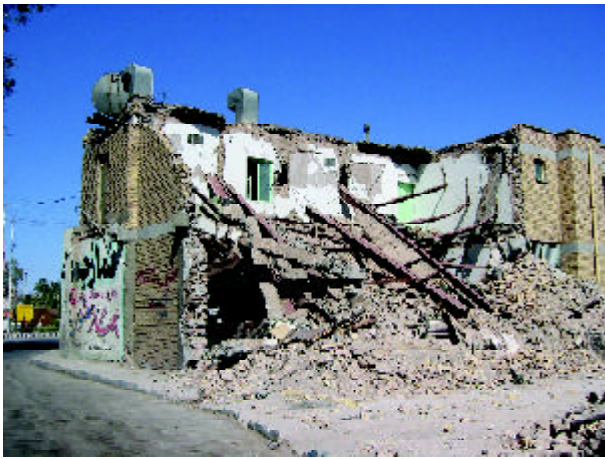
Photo 2. Collapse at the south west section.

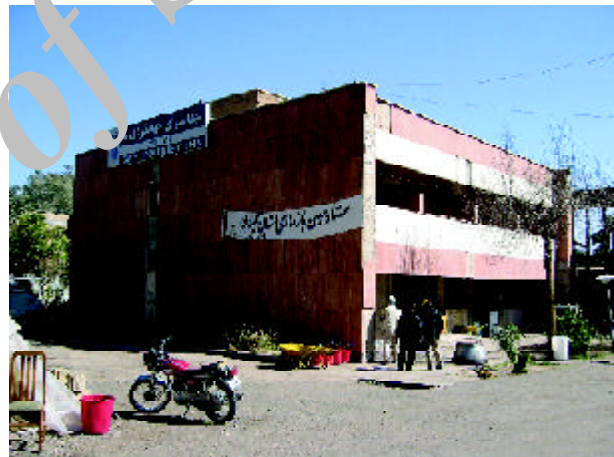
Bam Tourist Inn, used as hotel and restaurant, is a two-story SM building as shown in Photo (3). The plan of this building is relatively regular, see Figure (11). The damage level, classified by *EMS-98*, was as low as Grade 2 as estimated from Photo (3),

Photo 3. South west view of Bam Tourist Inn.

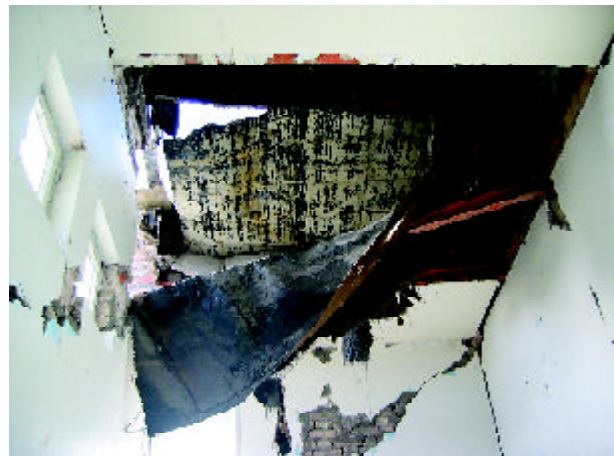
however, the roof of the penthouse fell down as shown in Photo (4). The wall ratio in the *NS* direction was 9.4%, which was much larger than those of Governor's Building, and that in the *EW* direction was 5.5%. The damage levels of the walls, which were evaluated based on the definition in Table (2), were illustrated in Figure (11). Figure (12) shows the distribution of the wall damage level in each direction. The averaged damage level of walls in the *NS* direction of 1.3 was a little smaller than that in the *EW* direction of 2.3, which roughly corresponds to the damage level of Governor's Building except the collapsed area.

Photo 4. Falling down of the roof of penthouse.

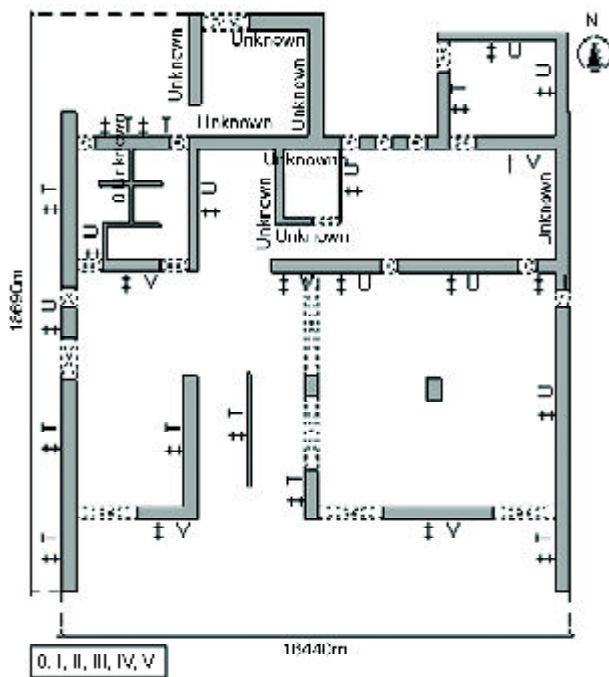
Figure 11. First floor plan and damage levels of masonry walls of Bam Tourist Inn.

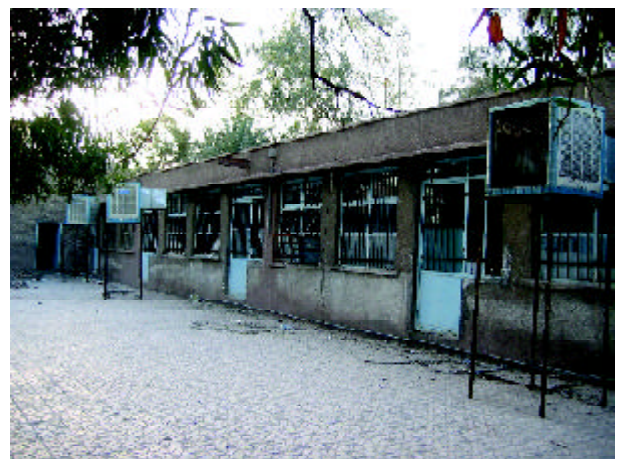
17 Shariwar High-School is located a few hundreds meter west of Governor's Building and consists of three SM buildings. The two single-story buildings escaped severe damage, as shown in Photo (5), although minor cracks were found on brick walls. On the other hand, the two-story building was partially collapsed, see Photo (6). This building consists of intermediate steel frame and exterior brick walls. The floor slab system is a jack arch type, mentioned earlier. The floor plan of the collapsed part is shown

Photo 5. Single-story school building (slight damage).

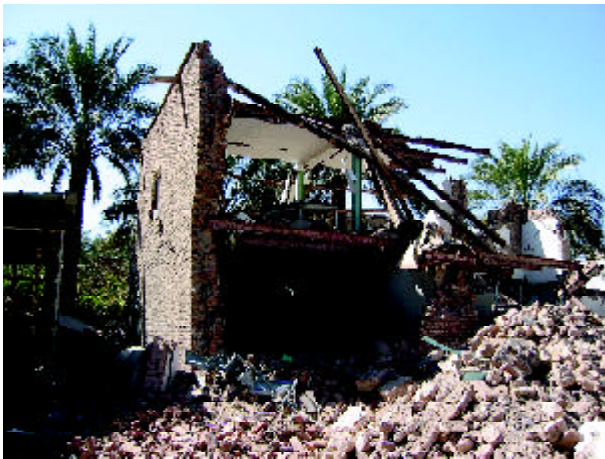
Photo 6. Collapsed two-story school building.

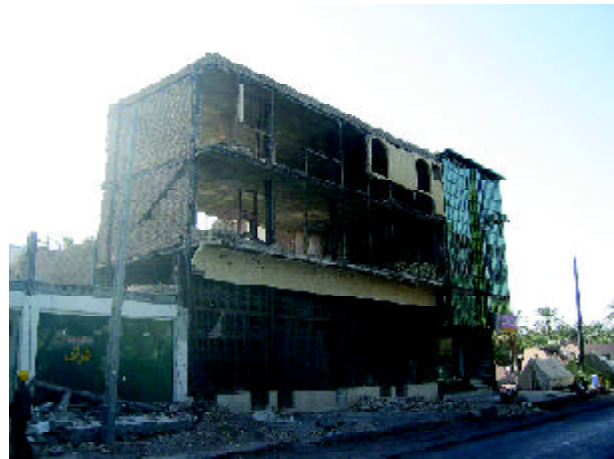
Photo 7. Residence and store building under construction.

The under construction building, see Photo (7) is located a few hundreds meter south of Governor's Building. The structural system of this building is quite typical of the buildings along the main streets in the downtown. The three-story steel structure consists of 4 bays in *NS* direction along the street and one bay in transverse direction (*EW*) as shown in

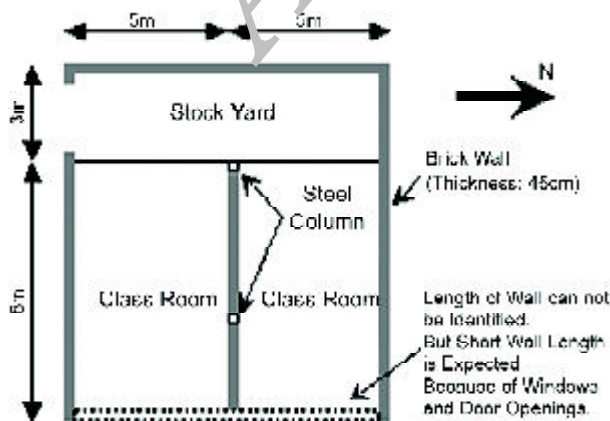
in Figure (14). The roof and floor slab fell off due to the collapse of an east exterior brick wall.

The wall area ratio in the first story is obtained as 4.1% in *NS* direction and 11.0% in *EW* direction. Note that the value in *NS* was calculated assuming that the area of collapsed east exterior wall is 0, not only because thickness and length of the collapsed wall could not be identified but also very short wall length may be expected due to existence of the windows and doors. The wall area ratio in *NS* direction of 4.1%, in which severer damage occurred, is less than values of the two buildings mentioned before.

Figure 14. Floor plan of collapsed part of two-story school building.

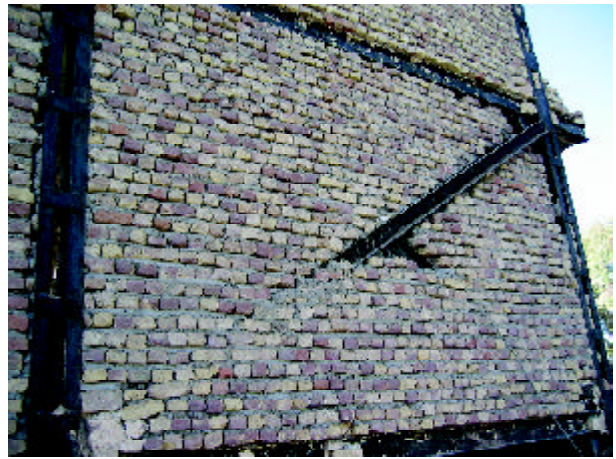
In the first story, fractures of welding joint and buckling of steel brace were observed, see Photos (8) and (9), and as a result, the brick walls were collapsed. Damage to the brick wall in the second story, see Photo (10) was also observed. No remarkable structural damage to the steel columns in *NS* direction was found, although bricks fell off the facade of the building.

Photo 10: Buckling of steel brace and damage to brick wall.

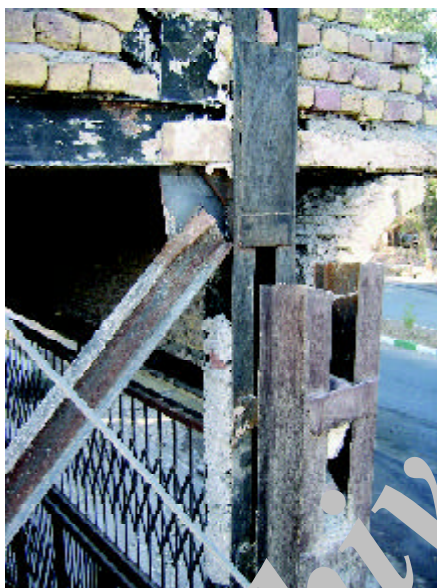
Photo 8. Fracture of welded joint of a steel brace.

and (4) floor area is $3.7m \times 16m = 91.2m^2$. These assumptions give a base shear coefficient, *C*, of 0.33. This base shear coefficient is relatively lower than the approximated values for both Governor's Building and Bam Tourist Inn. This may be one reason why this building suffered severe damage. Other reasons may be poor quality of welding, see Figures (8) and (9), and unconfined brick walls.

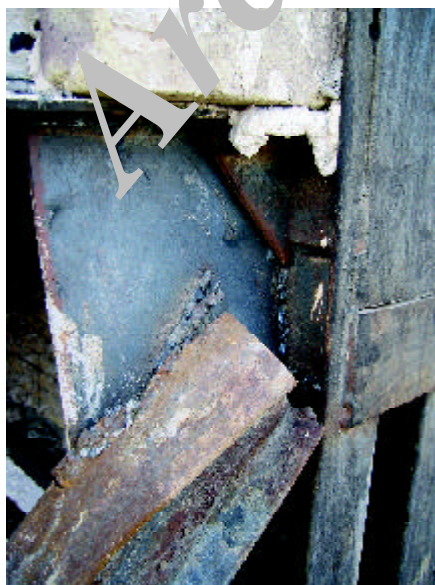
Photo 9. Close-up of Figure (8).
