Performance of Batten Columns in Steel Buildings During the Bam Earthquake of 26 December 2003

B. Hosseini Hashemi and M. Jafari S.

Structural Engineering Research Center, International Institute of Earthquake Engineering and Seismology (IIEES), Tehran, Iran, email: behrokh@iiees.ac.ir

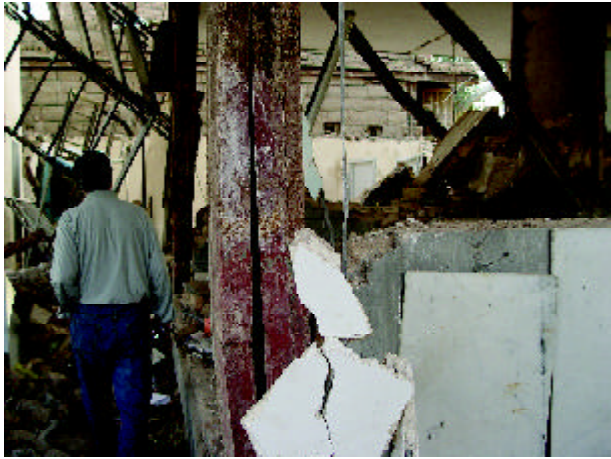
Different failure modes in steel buildings, including overall collapse and damage to or failure of structural components such as columns, braces and connections, were observed in Bam after the earthquake. The most common type of column used was the batten column. In some buildings, box columns were used and, with this type of column, failure modes such as rupture in the longitudinal joint, see Figure (1) and local buckling, see Figure (2) were observed.

Figure 1. Rupture of longitudinal joint in box column.

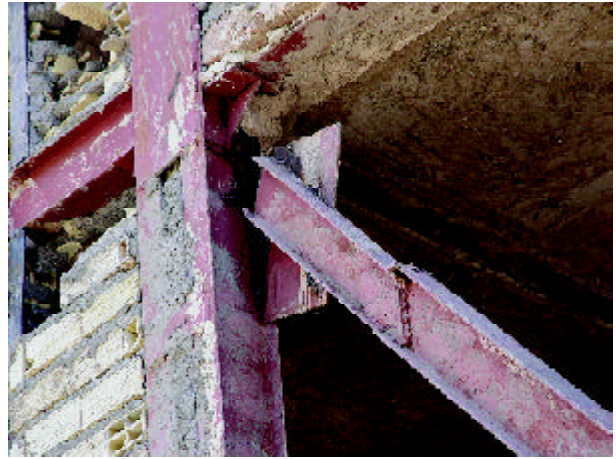
Figure 2. Local buckling of box column.

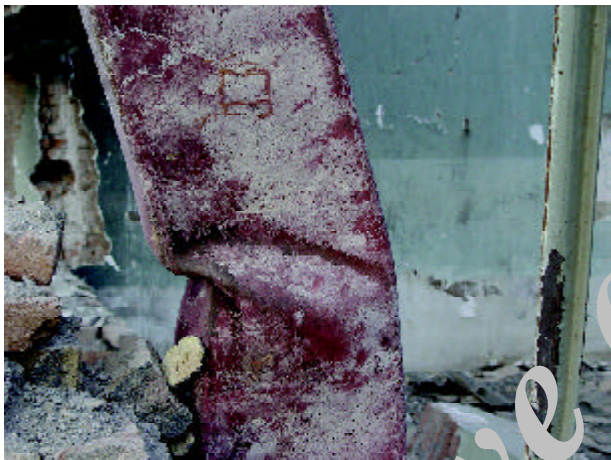
Figure 3. Rupture of connections in concentrically X bracing.

common type of bracing in steel braced frames in Bam. The observed failure modes in these braces were out of plane buckling and rupture of connections. The major reasons for these failures were construction defects and incomplete welding of connections. Some examples of bracing failures are shown in Figures (3) and (4).

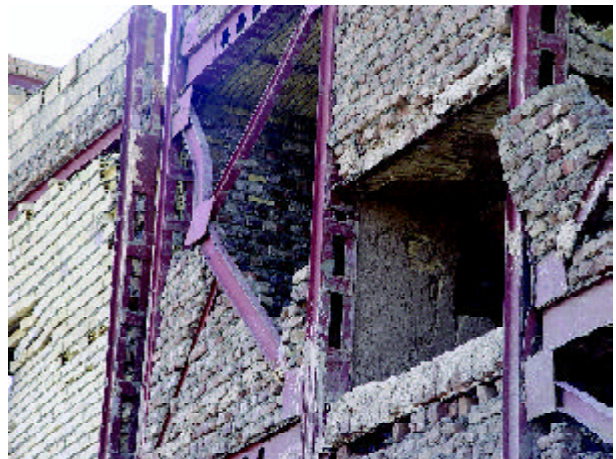
Figure 4. Out of plane buckling of concentrically X bracing.

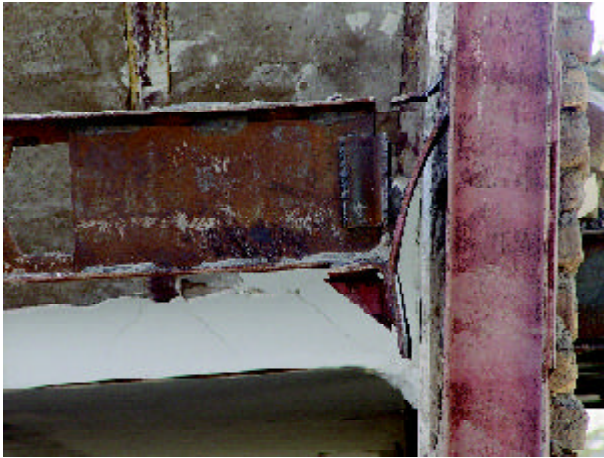
Beam to column connections in most steel buildings in Bam are khorjini and simple connections with top and bottom angles. Weld fractures, rupture of connection devices and rupture of connection plates from batten columns were failure modes observed in these connections. Some examples of these failures are shown in Figures (5) to (7). Because of the wide range of failures in connections, one can concluded that the collapse of structures was mostly initiated by connection failures. Failure modes in steel structures such as were seen in Bam have been reported in most earthquakes [1-8].

Figure 5. Weld rupture of web and top angle of connection and separation of column plate.

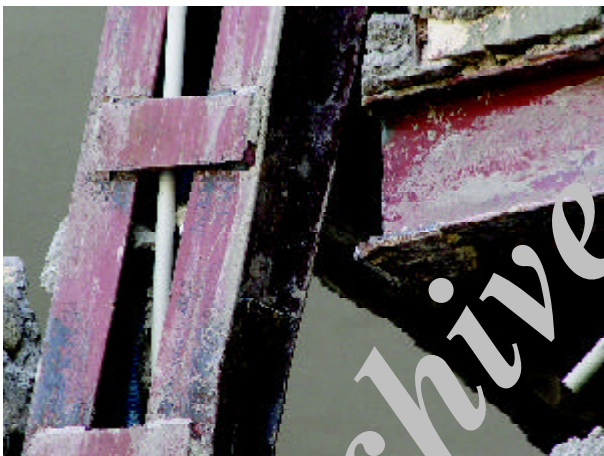
Figure 6. Rupture of seat angle of simple connection.

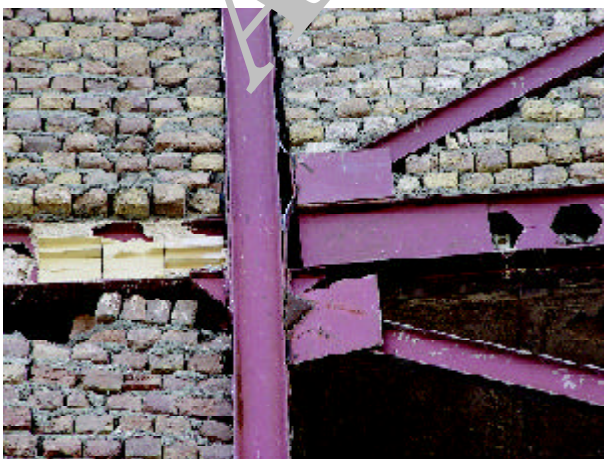
Figure 7. Separation of connection plate of batten column.

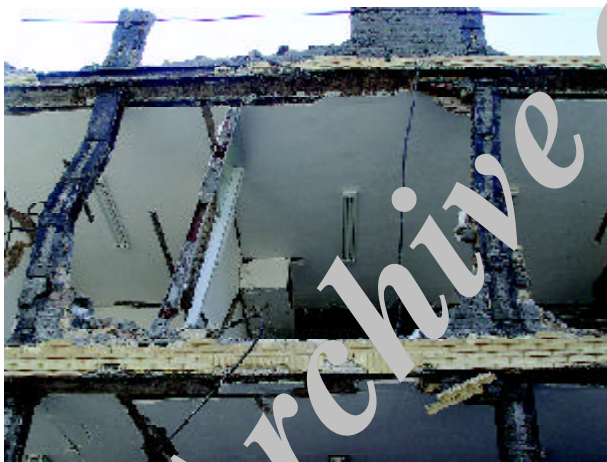
The overall buckling of batten columns was observed in some steel buildings in Bam. An example of overall buckling in the columns of a pharmacy is shown in Figure (8). It is significant that the buckling has occurred about the hollow axis. As mentioned earlier, according to the code, this type of buckling

Figure 8. Overall buckling of batten columns about hollow axis in a pharmacy.

is undesirable. The other important point revealed in Figure (8) is the occurrence of buckling in the top story of the building, in which columns have low gravity loads. This may be due to the increased column axial force through the effect of the high vertical component of the earthquake. Reyas-Salazar et al [13] studied the effect of vertical acceleration on the seismic response of steel frames with flexible connections. Another example of overall buckling of the batten column about the hollow is shown in Figure (9).

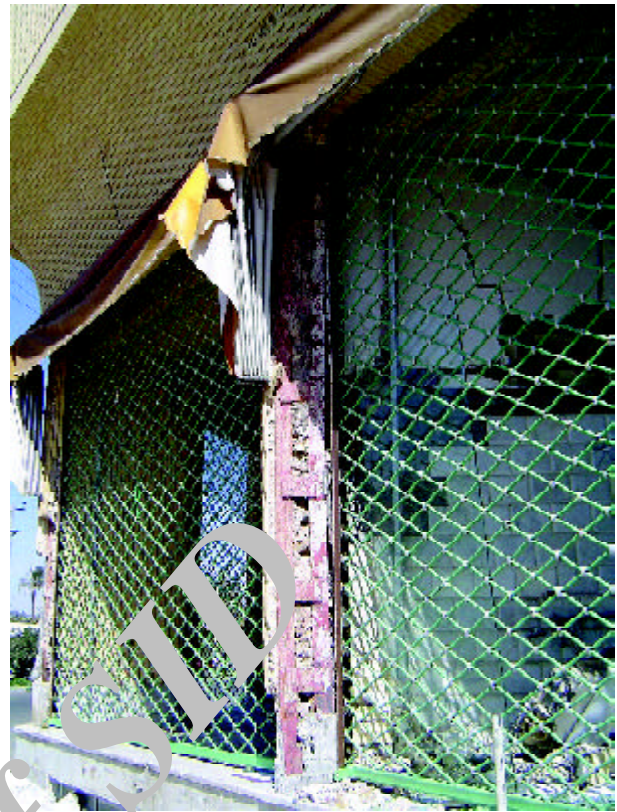
Figure 9. Overall buckling of batten columns about hollow axis in a store.

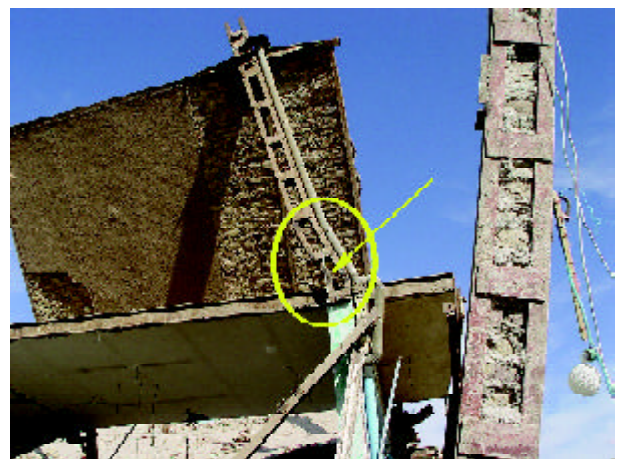
An example of local buckling in one of the chords of a batten column is shown in Figure (10). Because of the relative direction of batten columns and khorjini connections, in spite of code recommendations, a bending moment about the hollow axis could be applied to batten columns. This bending moment, as mentioned before, may lead to the occurrence of local buckling in batten columns, as shown in Figure (10).

Figure 10. Local buckling of one chord of batten column.

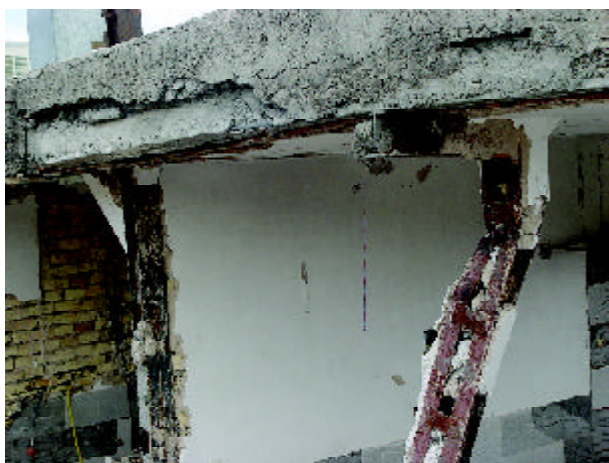
Lateral-torsional buckling is a probable mode of failure in batten columns. Nevertheless, there is no special provision regarding lateral-torsional buckling of batten columns in the part 10 of the *INBC*. In some cases, lateral-torsional buckling was observed in batten columns in Bam. An example of this mode of failure is shown in Figure (11).

Figure 11. Lateral-torsional buckling of batten column in a store building.

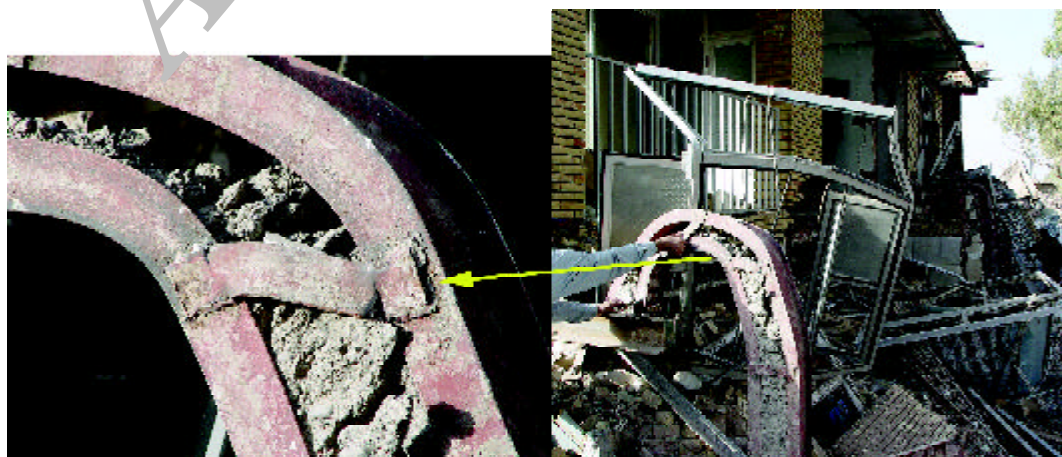
Some examples of rupture in battens are shown in Figures (12) to (14). In Figure (12), the dimension of battens are smaller than those that are common in steel buildings. The rupture of these battens could occur due to improper design and construction, or usage of improper materials.

Figure 12. Rupture of battens in a two story residential building.

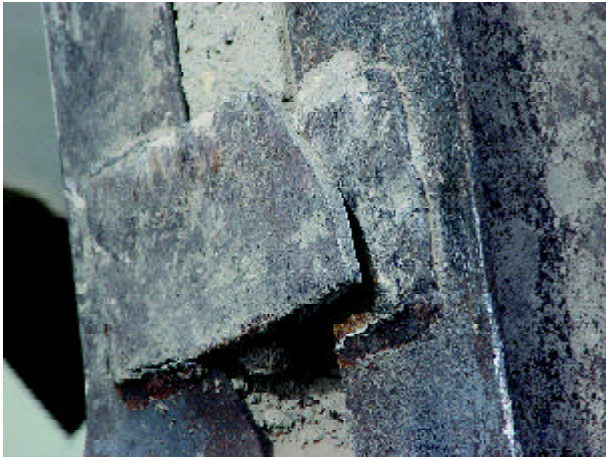
In Figures (13) and (14), battens having proper dimensions are observed. The rupture of these battens may be due to the increase of applied forces on battens relative to design forces in the codes. As mentioned, an increase of applied forces may result in the application of bending moment about the hollow axis or the occurrence of large deformations in columns. Such failures in battens are undesirable and must be prevented. It is evident that further study into the design forces of battens is required.

Figure13. Rupture of battens in a pharmacy.

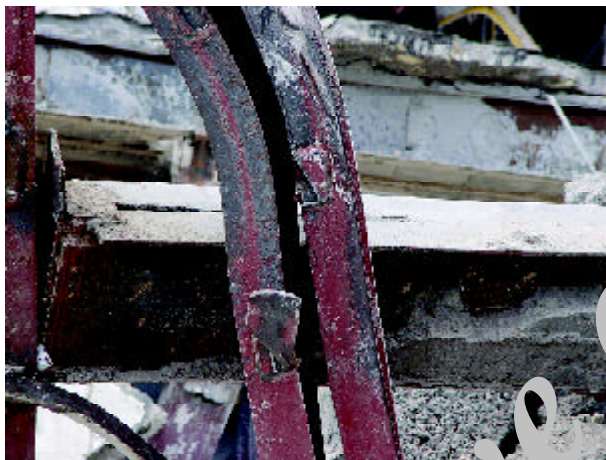
Figure 14. Rupture of battens in a shopping center.

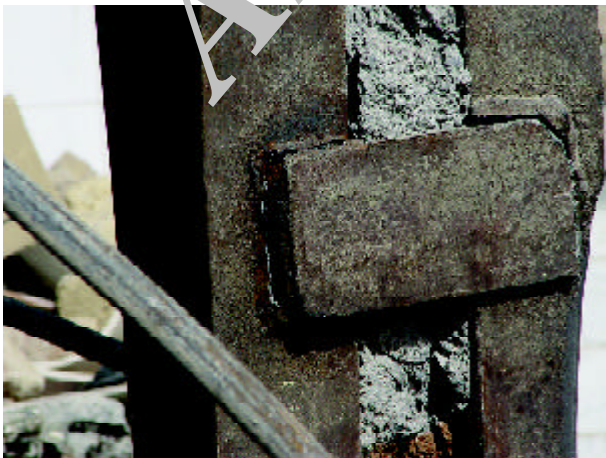
In many cases, the failure of battens in batten columns occurs in the weld of the battens to chords. Some examples of weld ruptures are shown in Figures (15) to (17). Because of the absence of quality

control for welding in Iran, the occurrence of weld failures in different components of steel buildings during earthquakes is expected. However, batten rupture may also lead to the rupture of batten welds. In the

Figure15. Weld rupture in battens of batten column in a pharmacy.

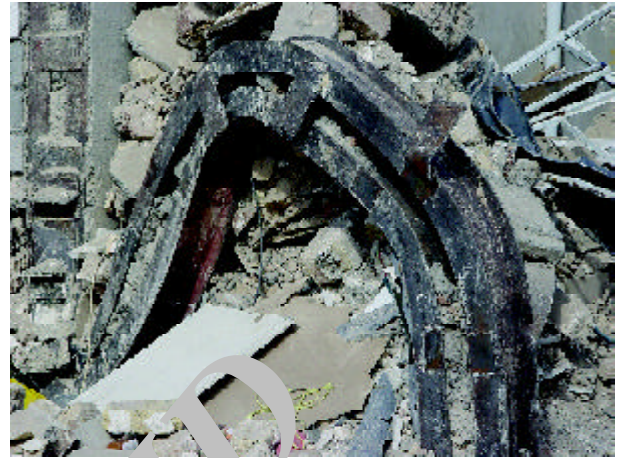
column shown in Figure (16), all of the battens failed at the welds. This failure may have led to separation of the chords and the collapse of the batten column.

Figure 16. Weld rupture in all battens of batten column in a pharmacy.

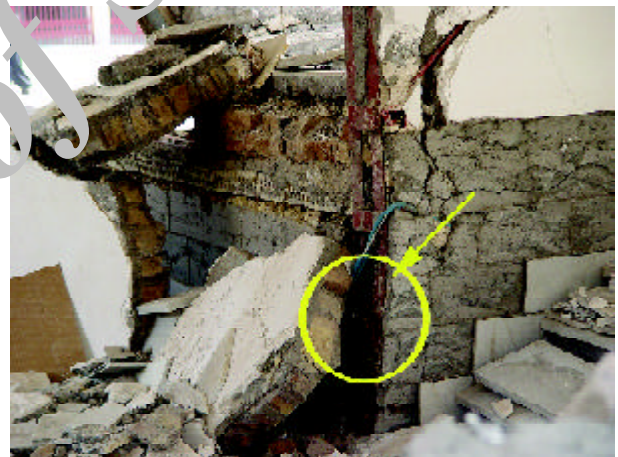
Figure17. Weld rupture in battens of batten column in an insurance building

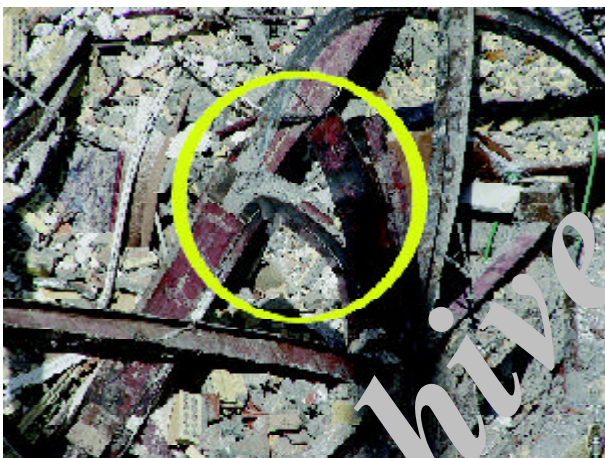
splices in columns must be scrupulous. An example of splice failure of a batten column is shown in Figure (19).

Figure19. Failure of batten column at splice location in kimia building.
