Lessons Learned from Steel Braced Buildings Damaged by the Bam Earthquake of 26 December 2003

N.A. Hosseinzadeh

Structural Engineering Research Center, International Institute of Earthquake Engineering and Seismology (IIEES), Tehran, Iran, email: hosseinz@iiees.ac.ir

Keywords: Bam earthquake; Steel buildings; Welded bracing connections; Brittle failure

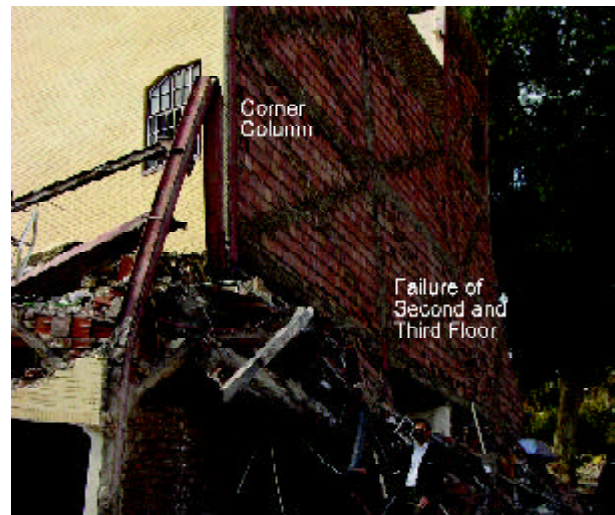
Figure 3. Northern view of Kimia building.

building was diagonal bracing in the East-West direction and a simple frame in the North-South direction. As shown in these Figures, the bracings in the second and third stories fractured and a lateral movement of about 400 cm, occurred in these stories. The remaining fourth and fifth stories collapsed in aftershocks. Failure of the slender rod braces ($\varnothing 18$) with very weak connections shown in Figures (5) and (6) led to a dramatic reduction in the lateral strength and stiffness of the building in second and third stories.

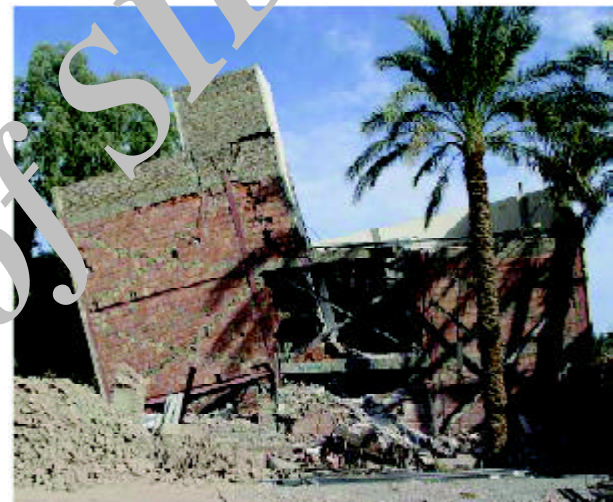
Figure 4. Southern view of Kimia building

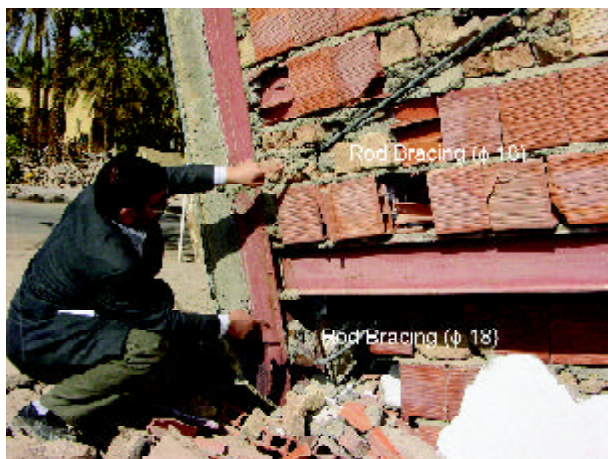
Figure 5. Rod bracings in stories.

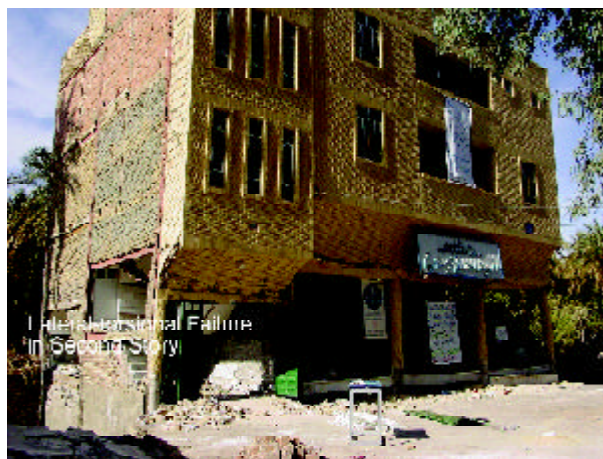
Figure 7. Eastern view of the insurance building.

the second story was not considered. This resulted in horizontal and vertical irregularities. Weak cross bracings and very poor welded braced connections caused a sudden change in stiffness and strength of this story. Therefore, excessive lateral-torsional deformations of about 70cm occurred in the corner column of the second story. It should be mentioned that the height of this story was greater than for the other stories. This is a common problem occurrence in buildings with shops in the ground floor. No damage occurred in the basement, surrounded by brick masonry infill walls.

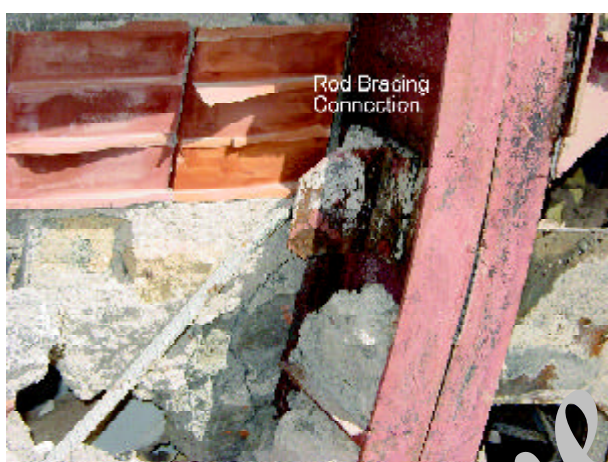
Figure 6. Rod bracing connections.

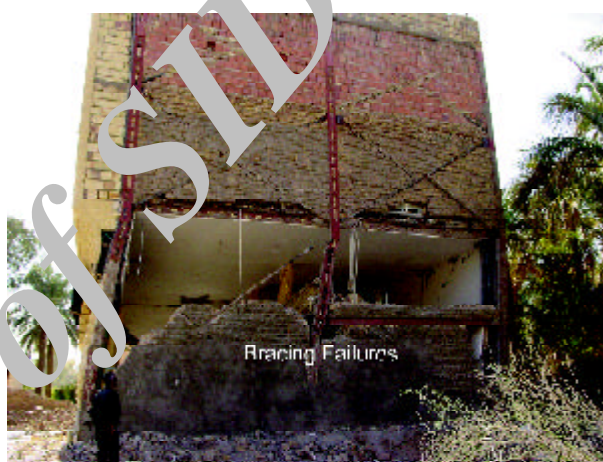
Figure 8. Northern view of the insurance building.

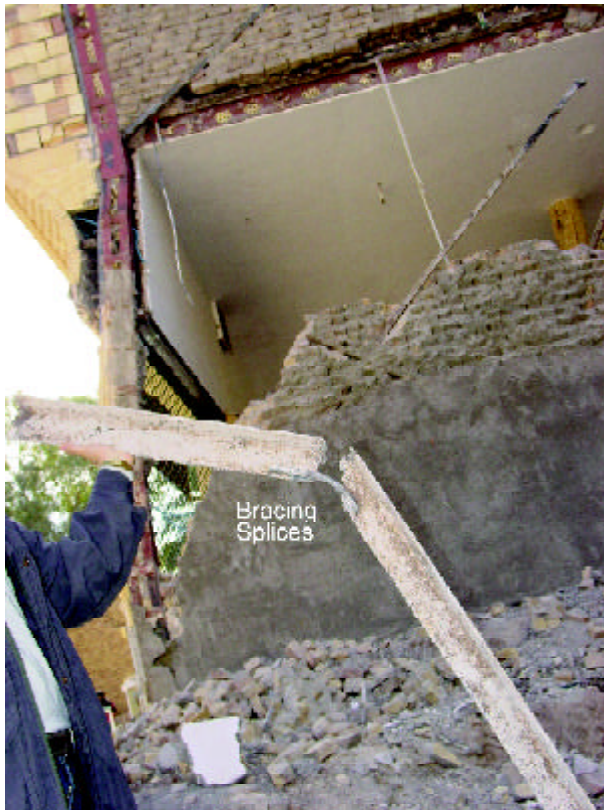
A typical cross bracing member of this building (L80x80x8) spliced with a rod (Ø16) is shown in Figure (9). However, the failure occurred in bracing connection, not in the spliced section. In other words this kind of weak splice was stronger than the bracing connections. The masonry infill brick walls of the first story prevented the total collapse of this building. Because of excessive deformation and damage that

Figure 9. Brace spliced with a rod.

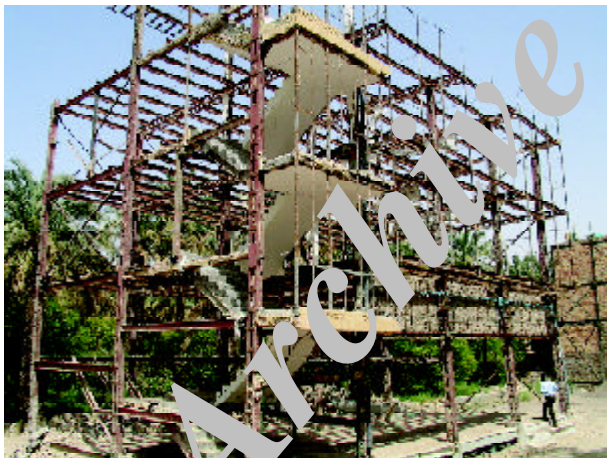
occurred in the second story, the owner decided to demolish and reconstruct this building (Figure (10)).

Figure 10. Demolition of the insurance building.

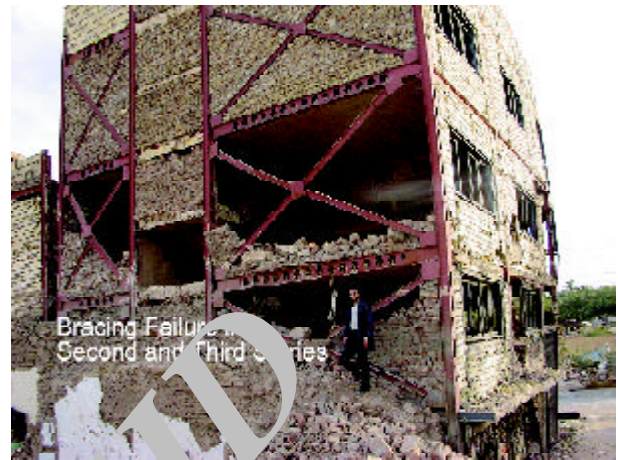
The Northern view of this four story braced building is shown in Figure (11). Cross bracings in the second and third stories of this building failed during the earthquake. Lateral deformations of about 40cm occurred in the second and third stories. Fracture of tension brace member connections and buckling of compression members were the main modes of failure as shown in Figures (12) and (13). Fracture of connection plates between columns and gusset plates was another type of failure (Figure (14)).

Figure 11. North view of the residential building.

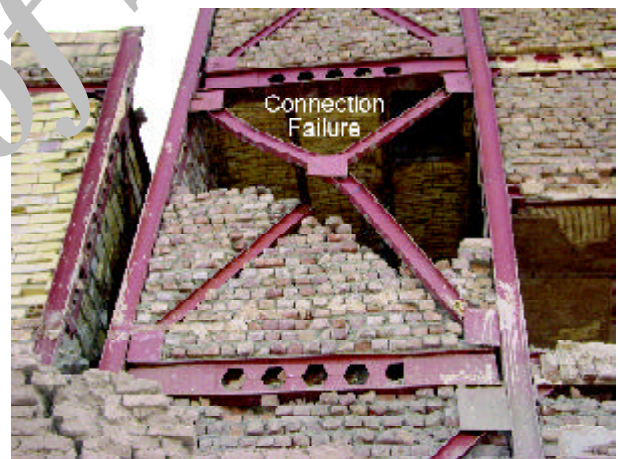
Figure 12. Fracture of bracing connections.

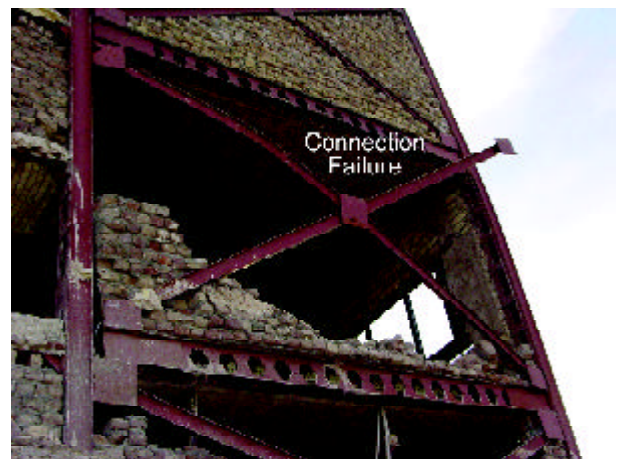
Figure 13. Fracture of bracing connections.

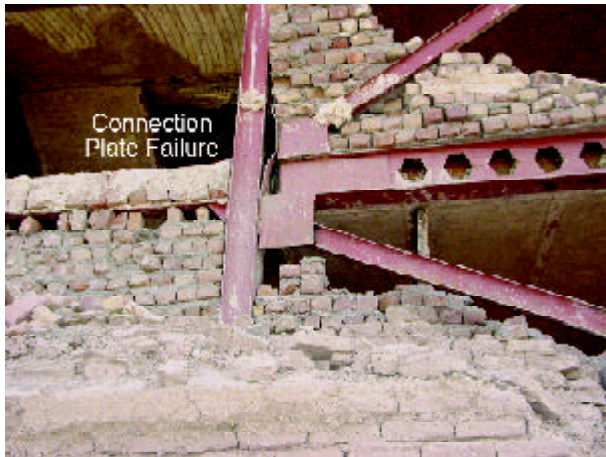
Figure 14. Fracture of bracing-to-frame connections.

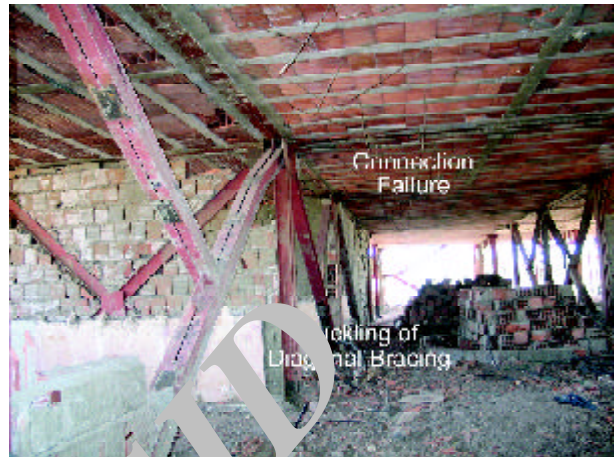
Failure of cross bracing connections in the first story is shown in Figure (16). Excessive damage of bracing members is caused by the impact of compression bracing after connection failure. A compression buckling of diagonal bracings of the first story is shown in Figure (17). Built up cross sections similar to columns were used as diagonal

Figure 17. Buckling of diagonal bracings.

4. Flexural strength: *AISC* requirements stipulate that the design flexural strength of the connections shall be equal to or greater than the expected nominal flexural strength $1.1 R_y M_p$ of the brace about the critical buckling axes. This requirement is not included in the Iranian code. An example of connection failure due to bracing buckling has been observed in sample buildings as shown in Figure (17).

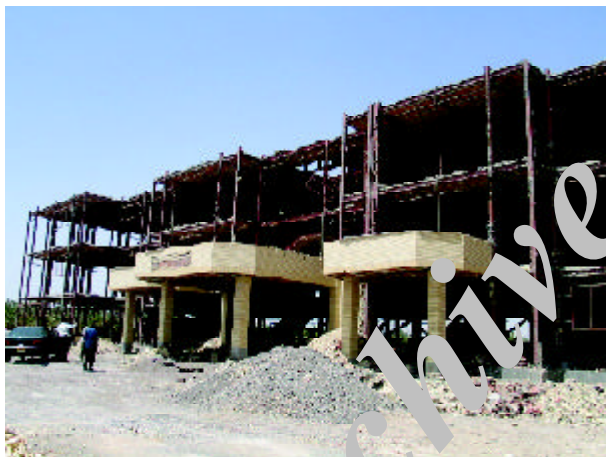
The Southern view of this three-story governmental building (a housing organization) is shown in Figure (15). This building was under construction during

Figure 15. Southern view of nursery building.

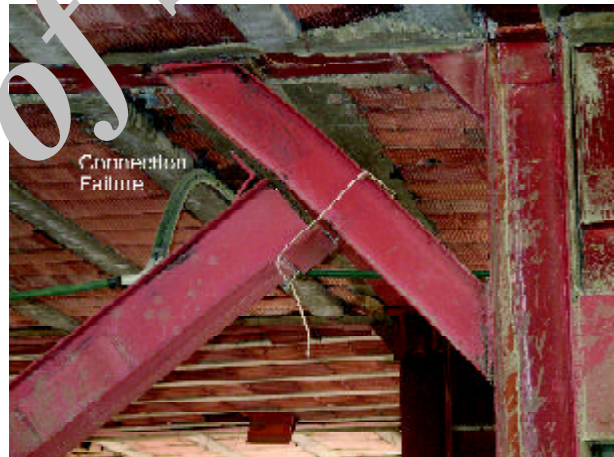
bracings. Another type of failure in the cross bracing connections to the frame system is shown in Figure (18). This kind of connection was considered in some cross bracings that lacked sufficient length.

Figure 18. Failure of bracing connections to frame.

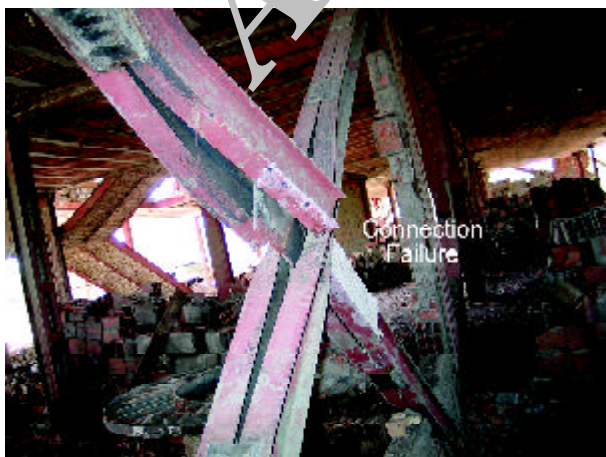
Figure 16. Failure of cross bracing connections.

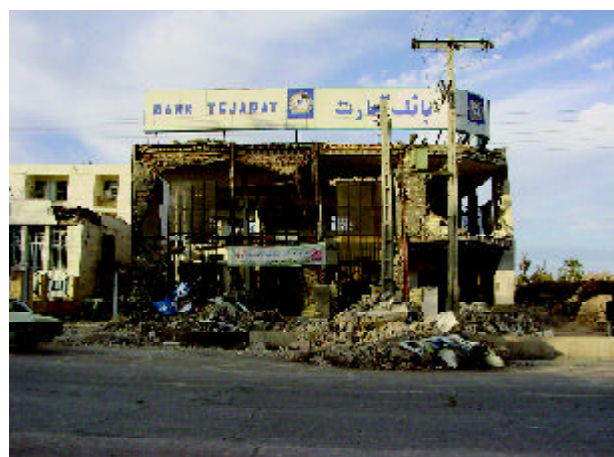
The Southern view of this two-story braced building is shown in Figure (19). Very poor braced connections and braced member splices caused heavy damage.

Figure 19. Southern view of bank Tejarat.

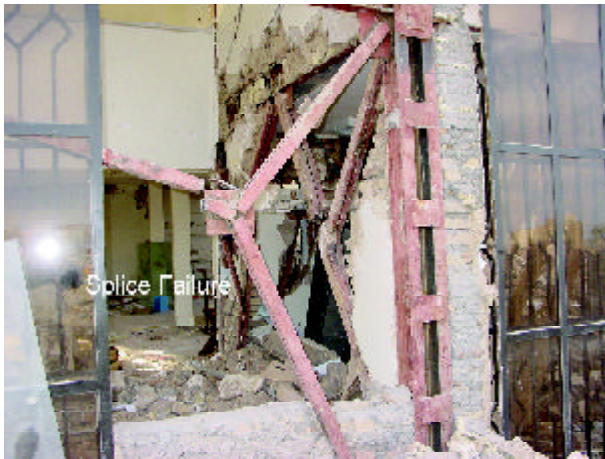
An example of bracing member fracture in a poor spliced section is shown in Figure (20). The small dimensions of the gusset plate, and poor quality and insufficient welding are clear in Figures (21) and (22).

Figure 20. Fracture of spliced bracing members.

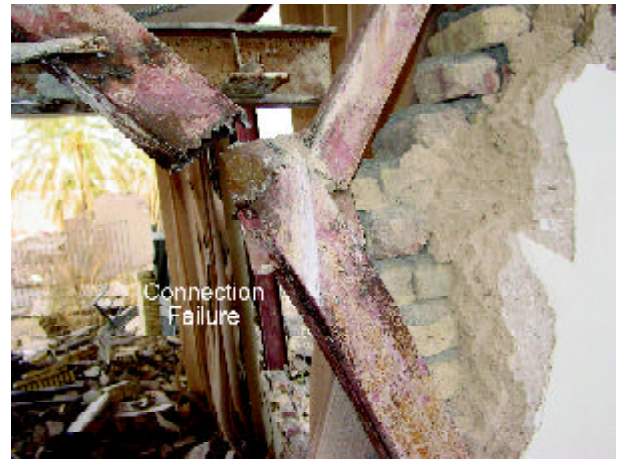
Figure 22. Fracture of bracing connections.

As shown, extremely bad detailing has been used in the bracing connections of this building. It should be mentioned that all bank buildings were heavily damaged during the earthquake.

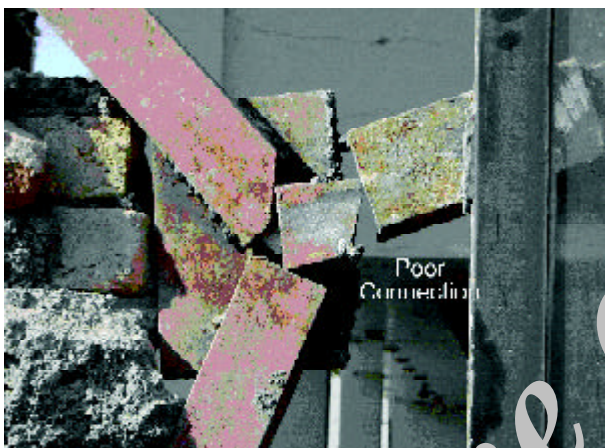
Figure 21. Very poor bracing connections.

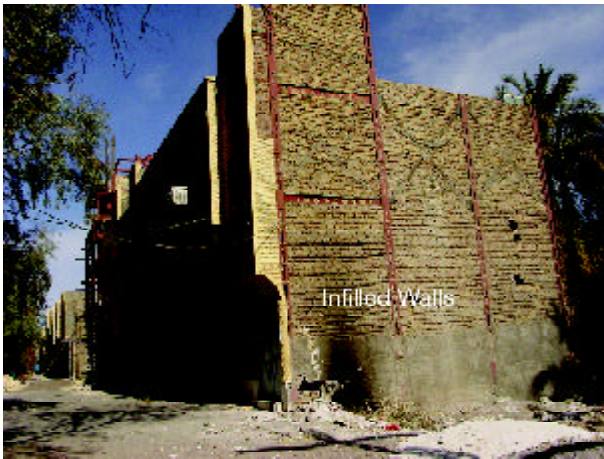
Figure 25. Masonry infill building.

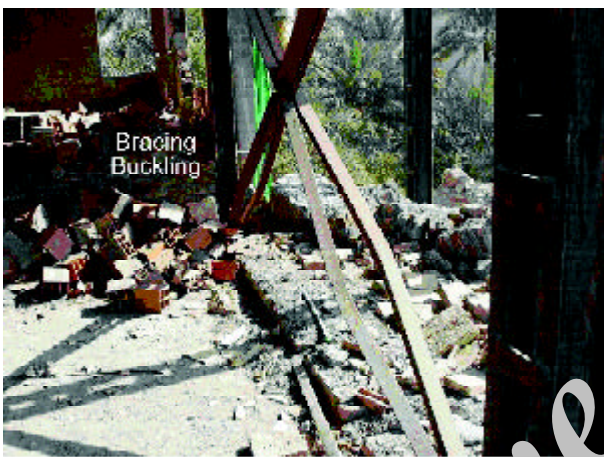
It should be noted that for out-of-plane buckling in bracing members, failure of infill walls is inevitable. An example of this type of buckling in built-up braced members and failure of the infill walls is shown in Figure (26). As can be seen, no stitches have been used in the bracing members and out of plane buckling occurred in individual elements.

Figure 26. Out of plane buckling of built up brace.

3. Built-up members: Based on the Iranian code requirements, the spacing of stitches shall be such that the slenderness ratio (l/r) of individual elements between the stitches does not exceed 0.7 times the governing slenderness ratio of the built-up members. Generally, this requirement was not observed in built-up bracing members. An example of this kind of bulking is shown in Figure (26).
