Lessons Learned from Steel Braced Buildings Damaged by the Bam Earthquake of 26 December 2003

N.A. Hosseinzadeh

Structural Engineering Research Center, International Institute of Earthquake
Engineering and Seismology (IIEES), Tehran, Iran, email: hosseinz@iiees.ac.ir

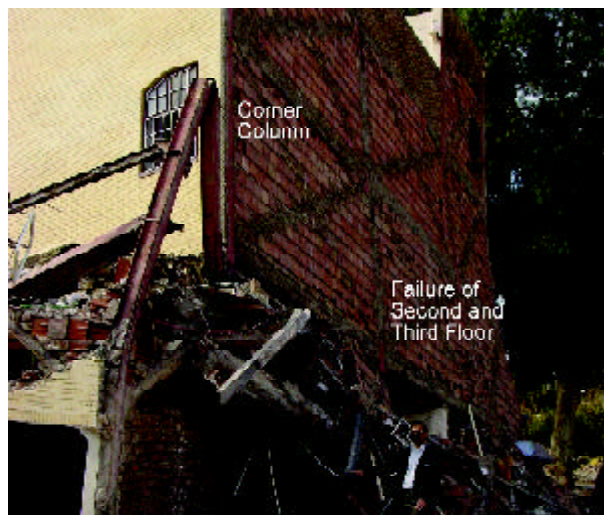
Figure 3. Northern view of Kimia building.

building was diagonal bracing in the East-West direction and a simple frame in the North-South direction. As shown in these Figures, the bracings in the second and third stories fractured and a lateral movement of about 400 cm, occurred in these stories. The remaining fourth and fifth stories collapsed in aftershocks. Failure of the slender rod braces ($\varnothing 18$) with very weak connections shown in Figures (5) and (6) led to a dramatic reduction in the lateral strength and stiffness of the building in second and third stories.

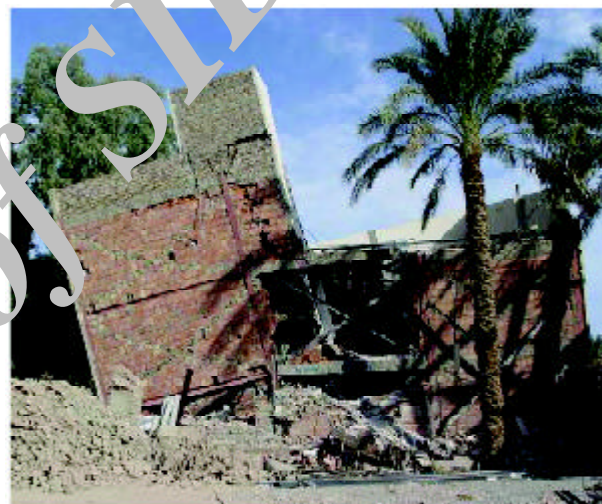
Figure 4. Southern view of Kimia building

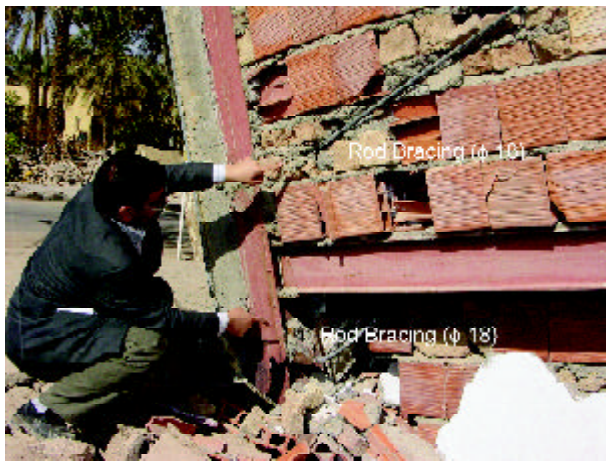
Figure 5. Rod bracings in stories.

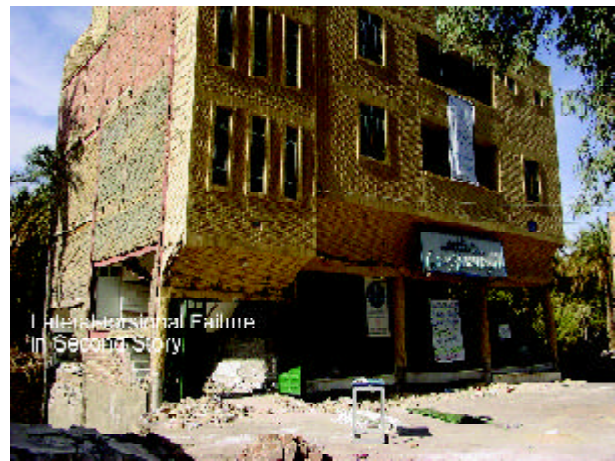
Figure 7. Eastern view of the insurance building.

the second story was not considered. This resulted in horizontal and vertical irregularities. Weak cross bracings and very poor welded braced connections caused a sudden change in stiffness and strength of this story. Therefore, excessive lateral-torsional deformations of about 70cm occurred in the corner column of the second story. It should be mentioned that the height of this story was greater than for the other stories. This is a common problem occurrence in buildings with shops in the ground floor. No damage occurred in the basement, surrounded by brick masonry infill walls.

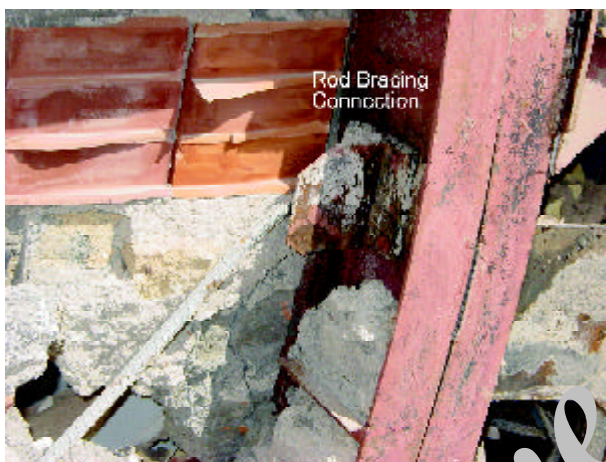
Figure 6. Rod bracing connections.

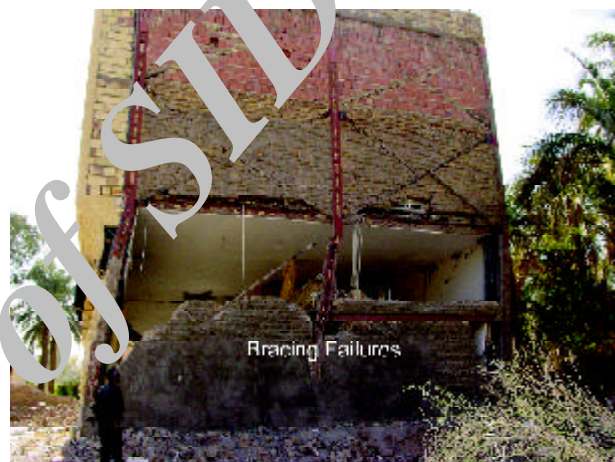
Figure 8. Northern view of the insurance building.

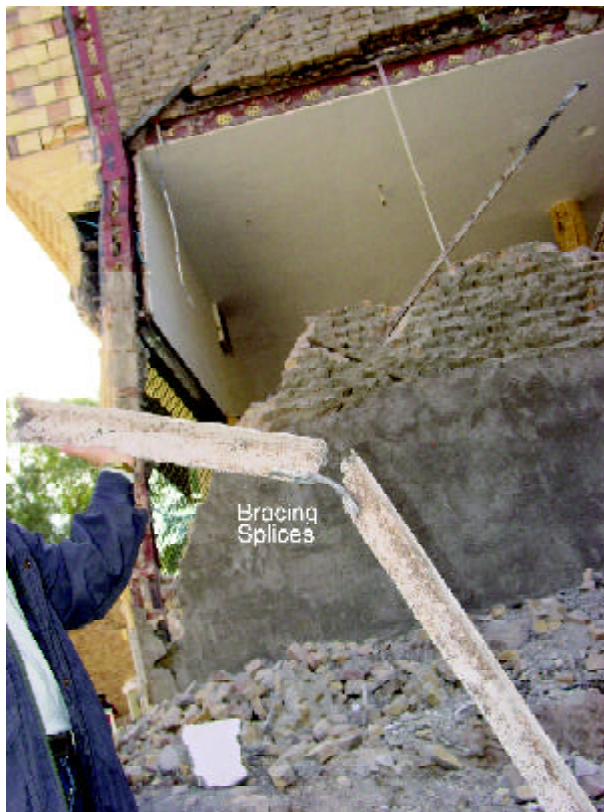
A typical cross bracing member of this building (L80x80x8) spliced with a rod (Ø16) is shown in Figure (9). However, the failure occurred in bracing connection, not in the spliced section. In other words this kind of weak splice was stronger than the bracing connections. The masonry infill brick walls of the first story prevented the total collapse of this building. Because of excessive deformation and damage that

Figure 9. Brace spliced with a rod.

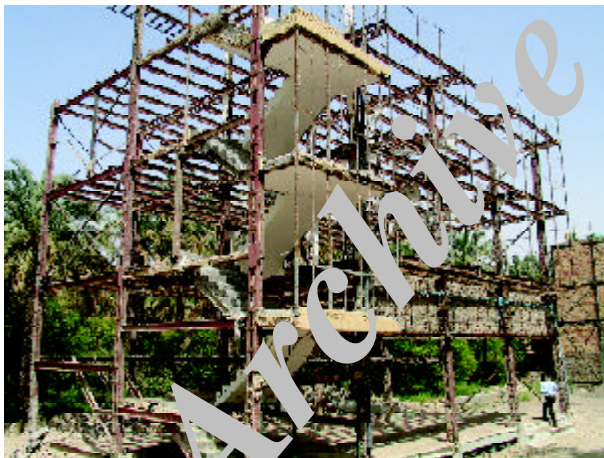
occurred in the second story, the owner decided to demolish and reconstruct this building (Figure (10)).

Figure 10. Demolition of the insurance building.

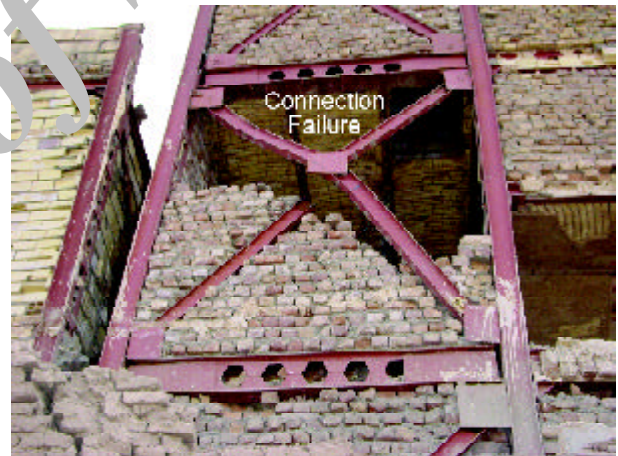
The Northern view of this four story braced building is shown in Figure (11). Cross bracings in the second and third stories of this building failed during the earthquake. Lateral deformations of about 40cm occurred in the second and third stories. Fracture of tension brace member connections and buckling of compression members were the main modes of failure as shown in Figures (12) and (13). Fracture of connection plates between columns and gusset plates was another type of failure (Figure (14)).

Figure 12. Fracture of bracing connections.

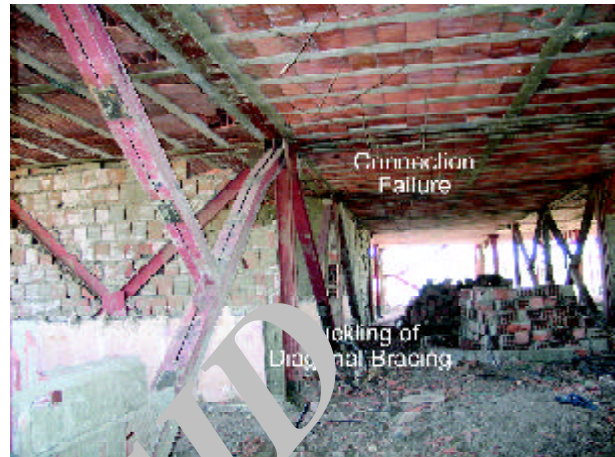
Failure of cross bracing connections in the first story is shown in Figure (16). Excessive damage of bracing members is caused by the impact of compression bracing after connection failure. A compression buckling of diagonal bracings of the first story is shown in Figure (17). Built up cross sections similar to columns were used as diagonal

Figure 17. Buckling of diagonal bracings.

4. Flexural strength: *AISC* requirements stipulate that the design flexural strength of the connections shall be equal to or greater than the expected nominal flexural strength $1.1 R_y M_p$ of the brace about the critical buckling axes. This requirement is not included in the Iranian code. An example of connection failure due to bracing buckling has been observed in sample buildings as shown in Figure (17).

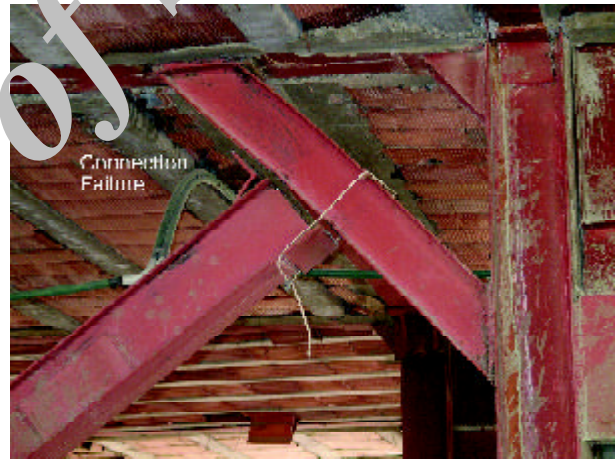
bracings. Another type of failure in the cross bracing connections to the frame system is shown in Figure (18). This kind of connection was considered in some cross bracings that lacked sufficient length.

Figure 18. Failure of bracing connections to frame.

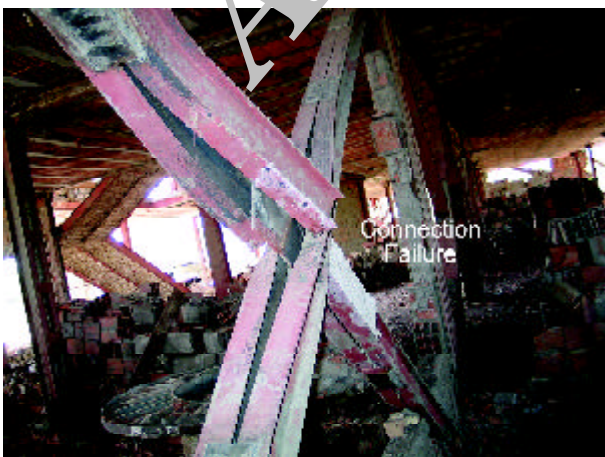
Figure 16. Failure of cross bracing connections.

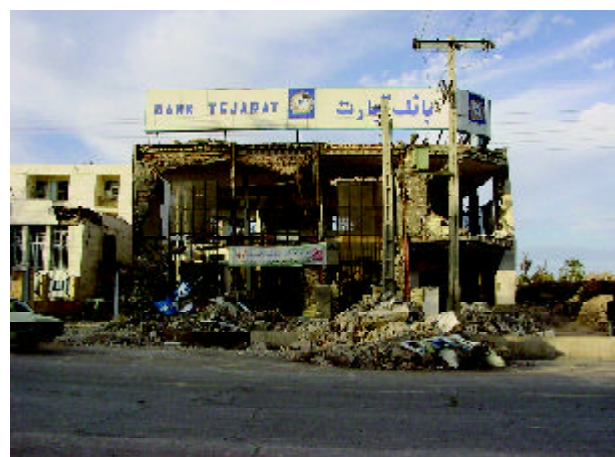
The Southern view of this two-story braced building is shown in Figure (19). Very poor braced connections and braced member splices caused heavy damage.

Figure 19. Southern view of bank Tejarat.

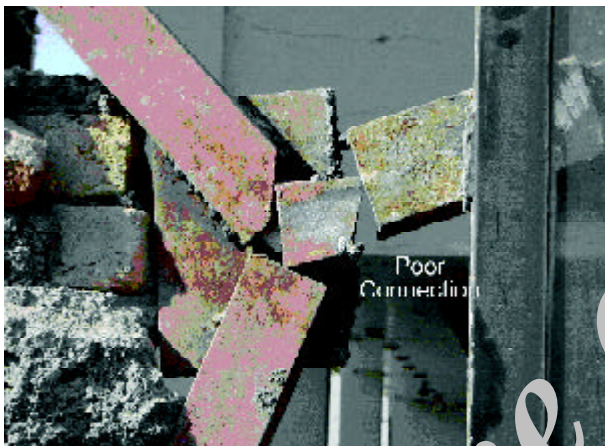
An example of bracing member fracture in a poor spliced section is shown in Figure (20). The small dimensions of the gusset plate, and poor quality and insufficient welding are clear in Figures (21) and (22).

Figure 21. Very poor bracing connections.

As shown, extremely bad detailing has been used in the bracing connections of this building. It should be mentioned that all bank buildings were heavily damaged during the earthquake.

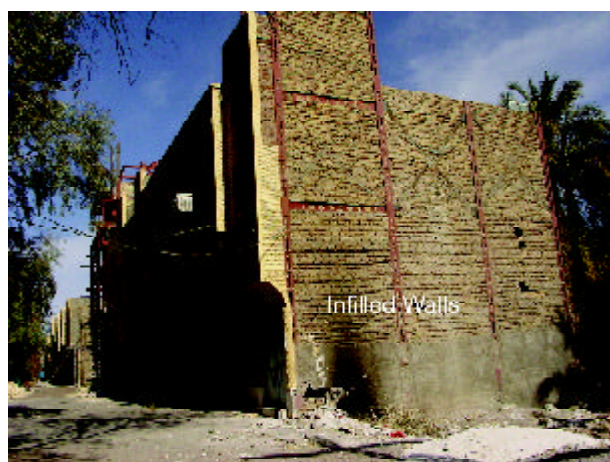
Figure 25. Masonry infill building.

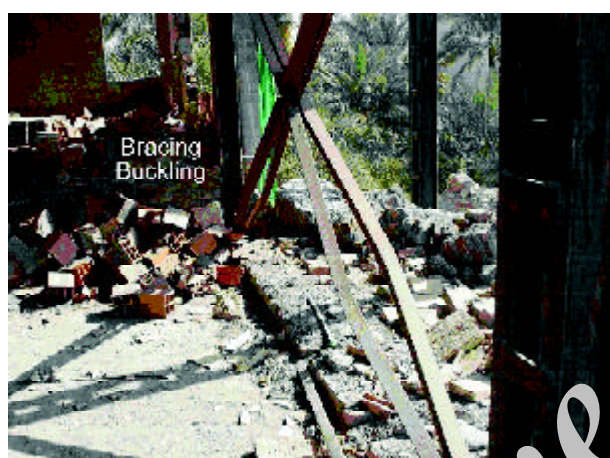
It should be noted that for out-of-plane buckling in bracing members, failure of infill walls is inevitable. An example of this type of buckling in built-up braced members and failure of the infill walls is shown in Figure (26). As can be seen, no stitches have been used in the bracing members and out of plane buckling occurred in individual elements.

Figure 26. Out of plane buckling of built up brace.

3. Built-up members: Based on the Iranian code requirements, the spacing of stitches shall be such that the slenderness ratio (l/r) of individual elements between the stitches does not exceed 0.7 times the governing slenderness ratio of the built-up members. Generally, this requirement was not observed in built-up bracing members. An example of this kind of bulking is shown in Figure (26).
