# Performance of Lifeline Systems in Bam Earthquake of 26 December 2003

Masoud Moghtaderi-Zadeh<sup>1</sup>, Farrokh Nadim<sup>2</sup>, and Mohammad Javad Bolourchi<sup>3</sup>

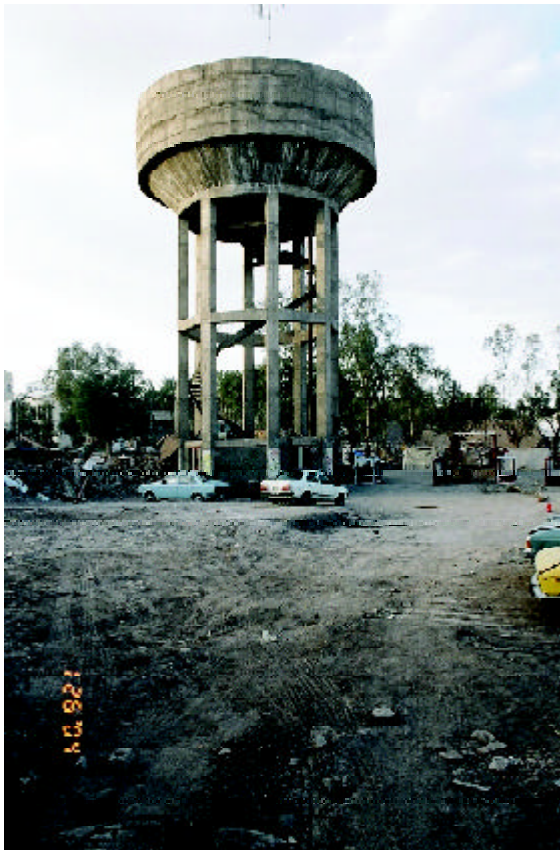
There was report of damage to a number deep wells and also several pipeline breaks throughout the city. Due to collapse of the buildings and breakage of connecting pipes, at users ends, water had to be brought by tanker trucks to the tents and shelters and other users after the earthquake. Overall the storage tanks performed well. Figures (1) shows an elevated concrete water tank, located near the old section of the city close to the earthquake rupture where the damage was high. The tank experienced severe stress and deformation at the column-beam connections.

**Figure 1.** Elevated concrete water tank located in near the old section of the city where the damage was high. The tank experienced severe stress and deformation at the column-beam connections.

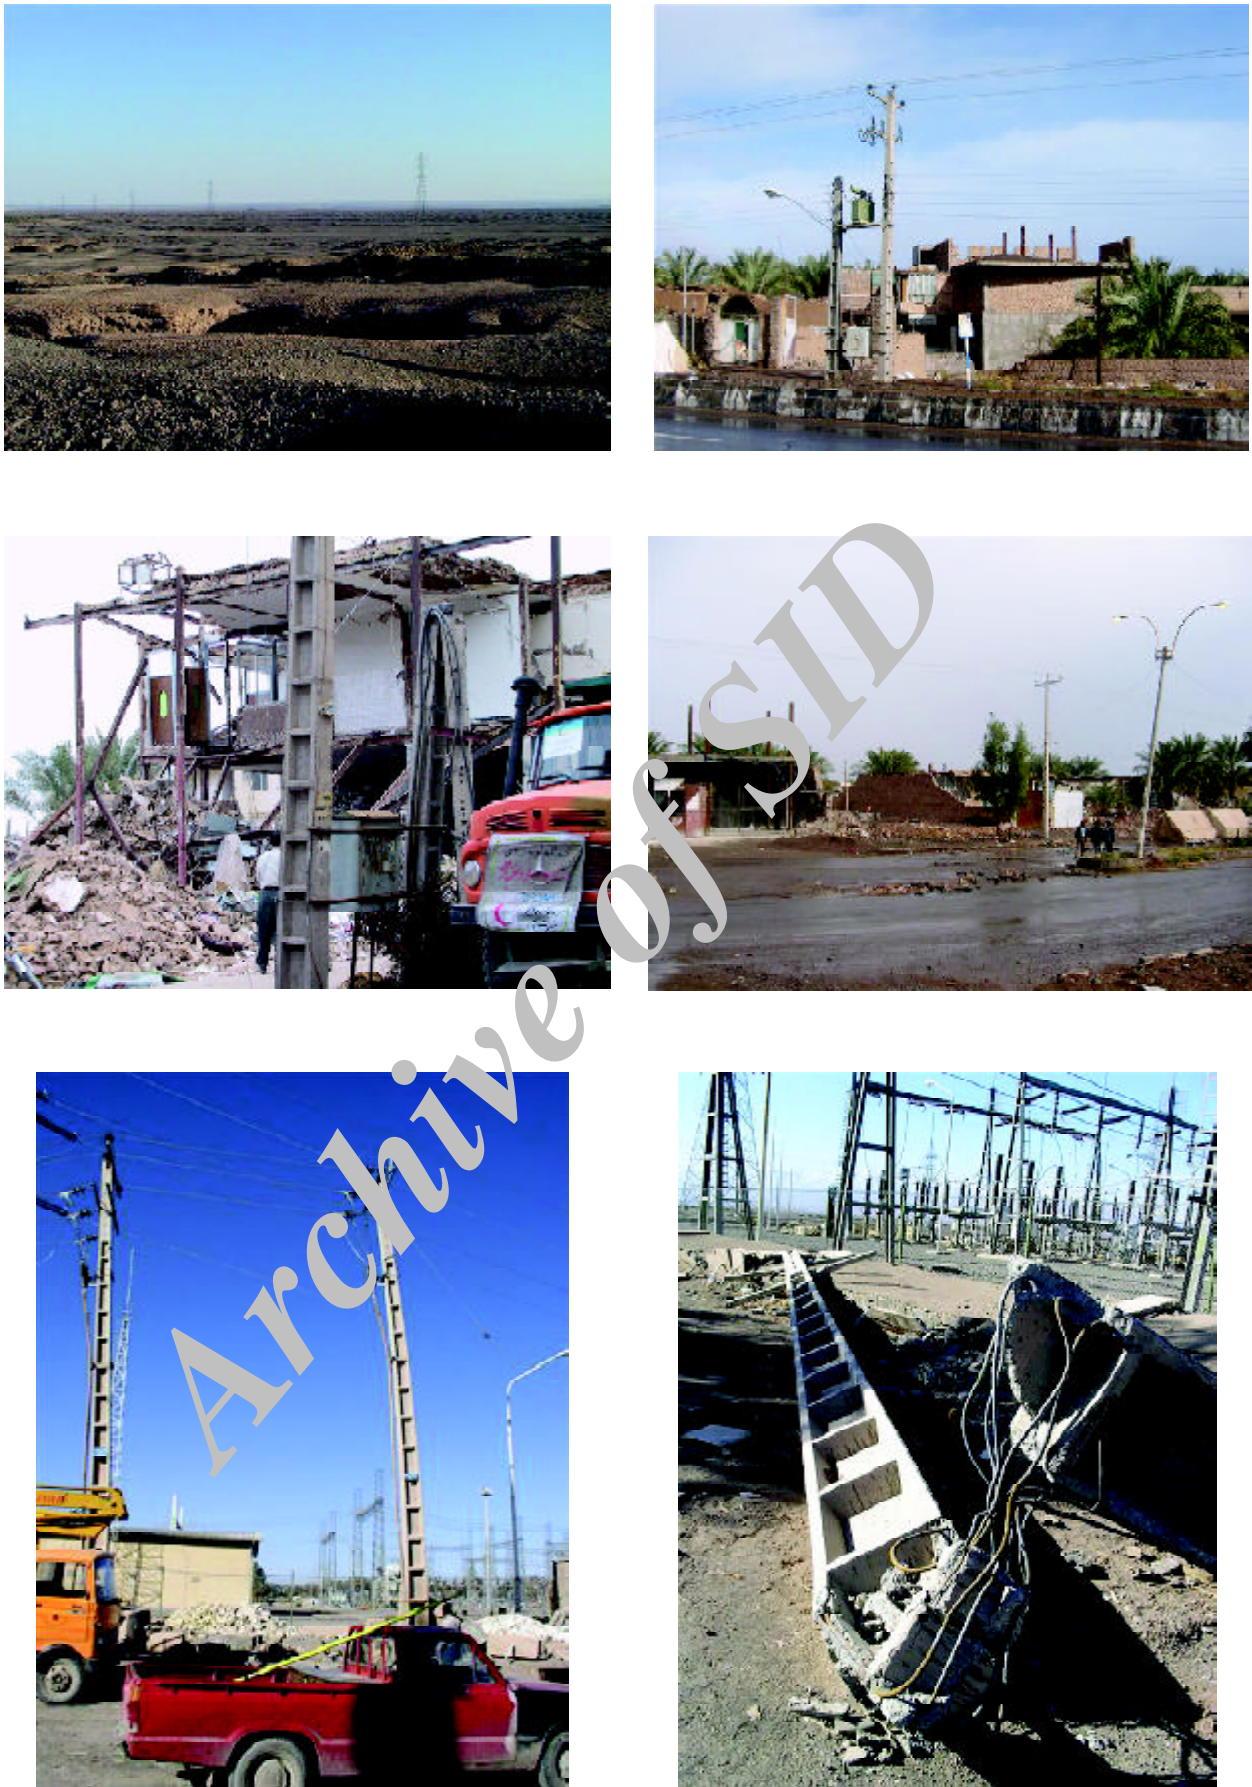
There was no damage to main 230kV transmission lines. There was however damage to concrete poles in the distribution system and streetlights. Part of the damage to the concrete poles was due to collapse of adjacent walls and buildings. We observed series of poles to be out of plumb. Damage to transformers on distribution poles was reported [8], see Figure (8).

**Figure 7.** Damage to transmission line towers was not observed. Concrete and wooden poles are used to bring electricity from substations to users. Pole top transformers convert the electricity to 220V. Many distribution poles were damaged. A large number of distribution poles and street light poles were out of plumb after the earthquake.

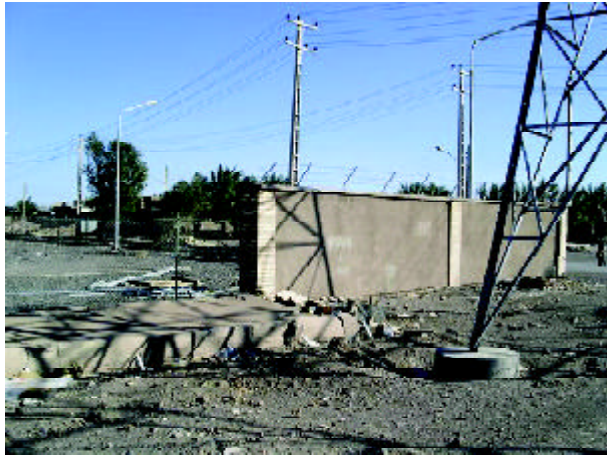
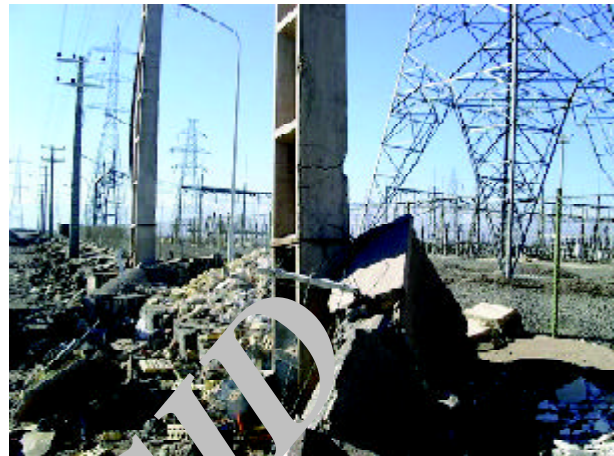
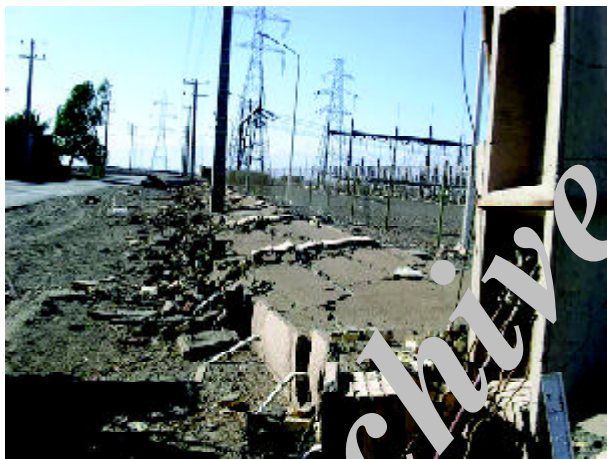
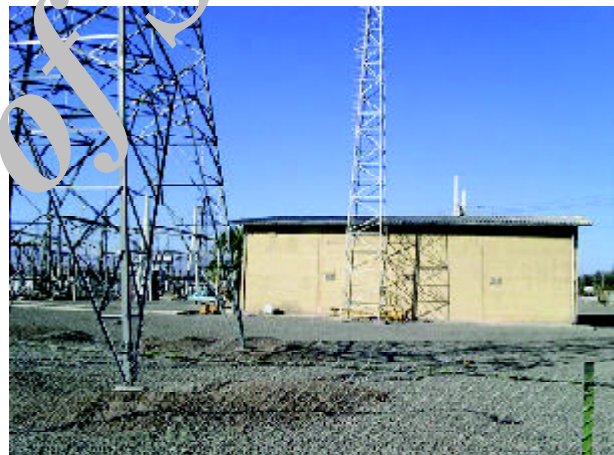
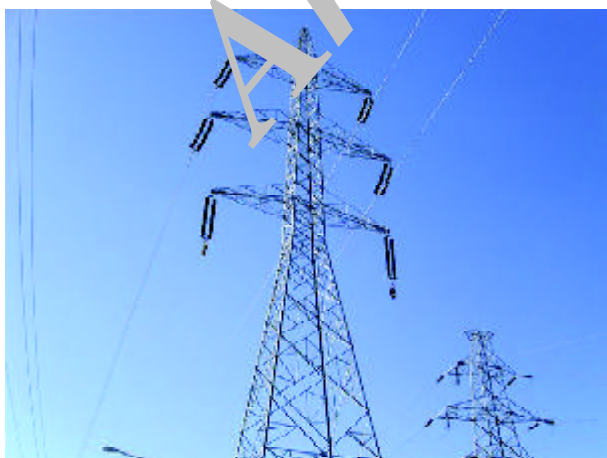
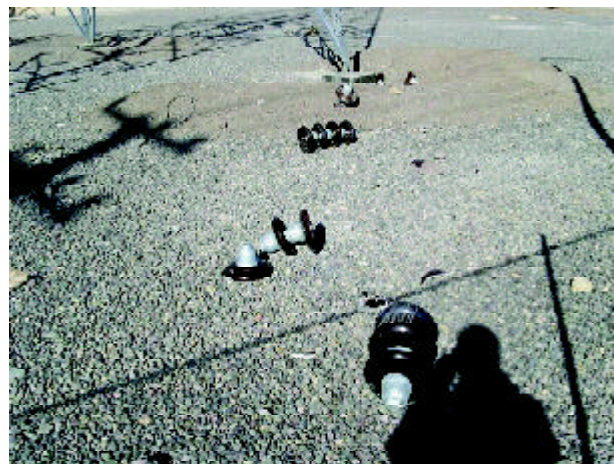
The 230kV substation in Bam experienced some damage. There was some damage to porcelain insulators and bushings at this substation. The wall around the substation collapsed. The office/control building in the substation structurally performed well, see Figures (8) and (9). This substation was about 5km distance from epicenter. At the time of our visit (one month after the earthquake), electricity had been restored throughout the city, even in the area where there was severe to complete building destruction.

**Figure 8.** The 230kV substation experienced minor damage. The wall surrounding the facility collapsed. In the process it hit the concrete poles and caused their failure. A number of porcelain isolators were broken. The office/control room did not seem to have been damaged structurally.

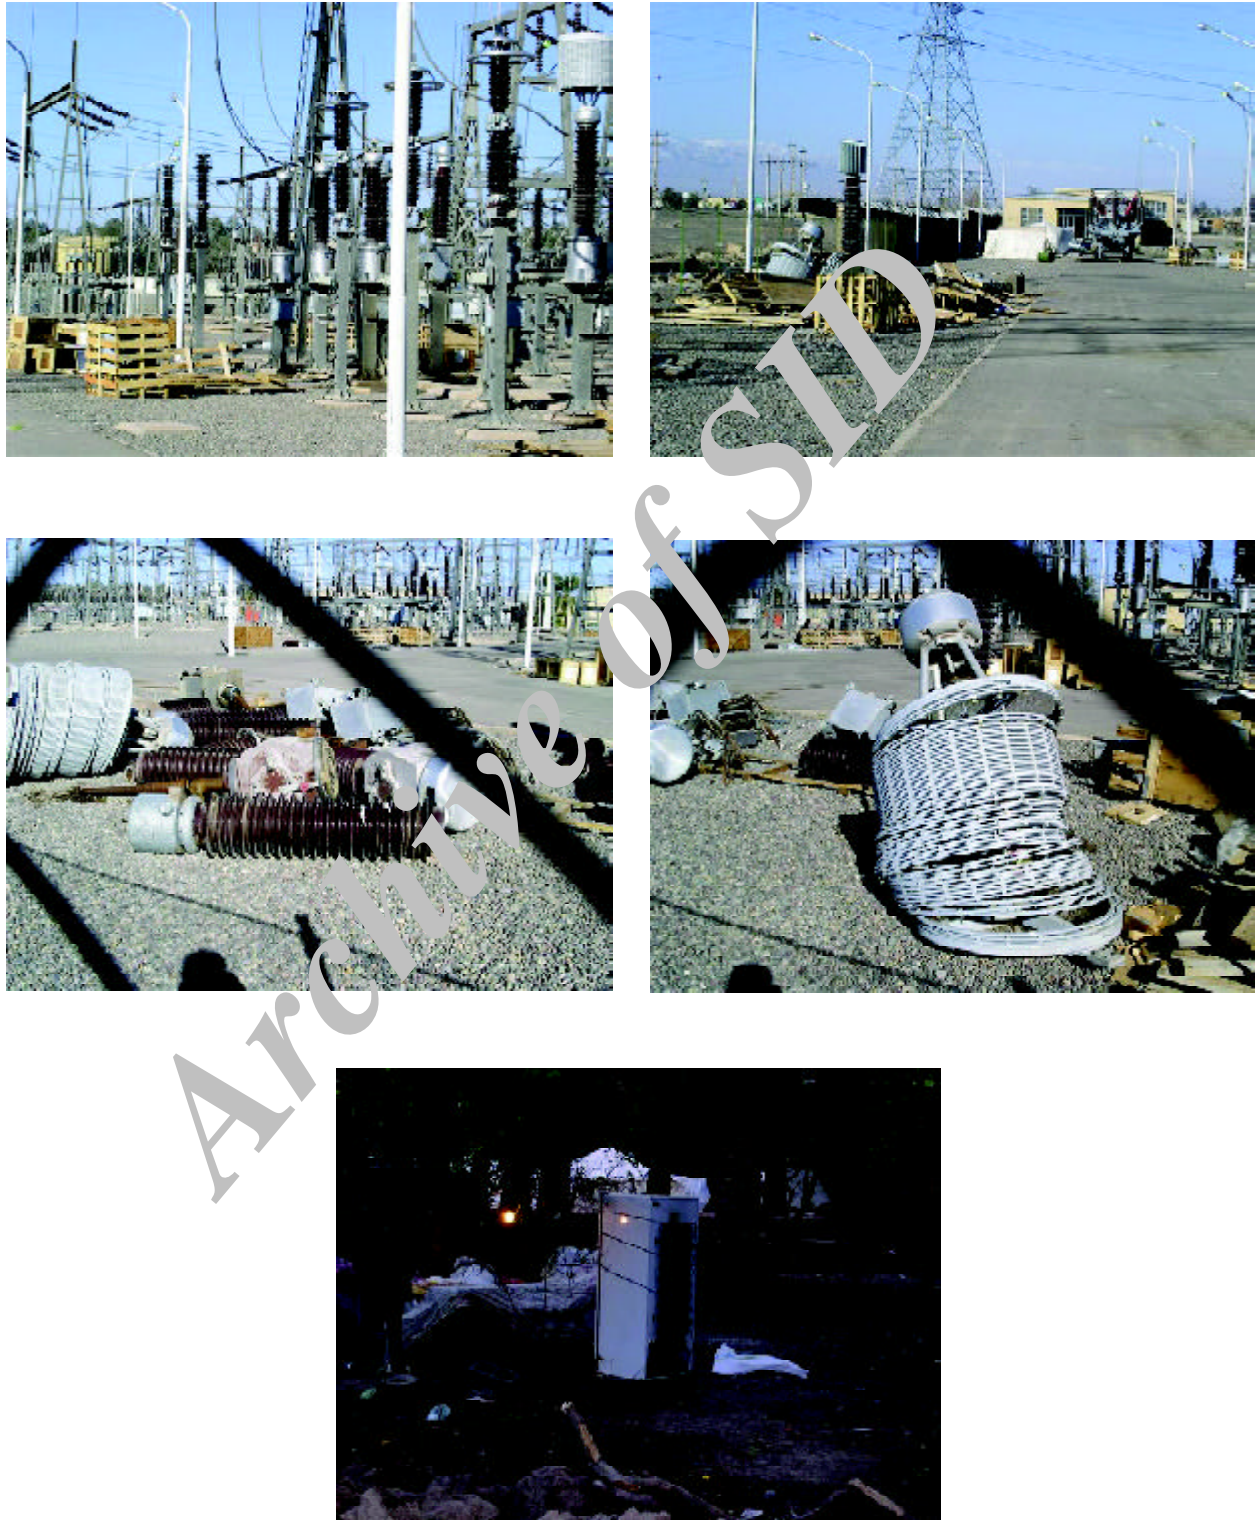
**Figure 9.** Damage to various electric equipments in the 230kV substation is observed in the above pictures. At the time of our visit (one month after earthquake) the electricity was available throughout the city, even though most of the users' buildings had been severely damaged to use the electricity.

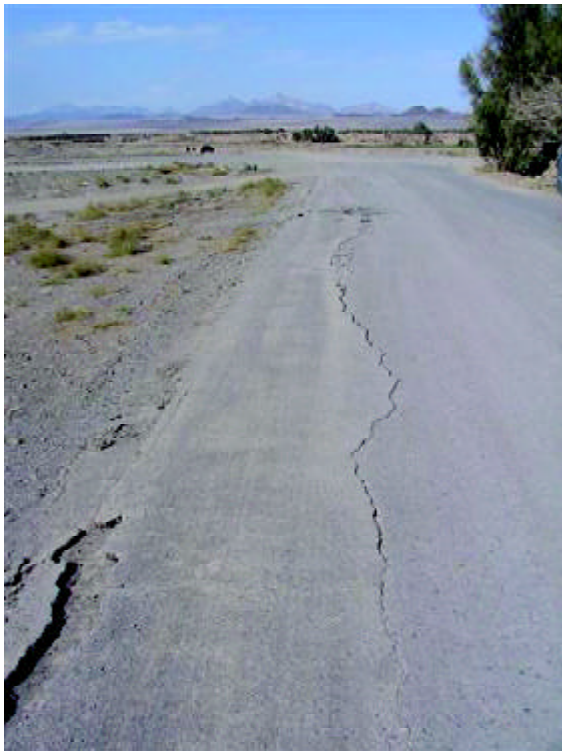
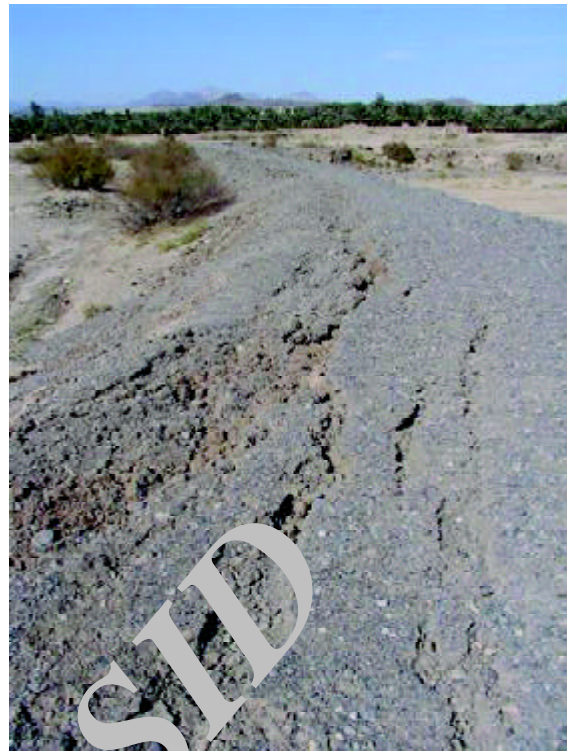
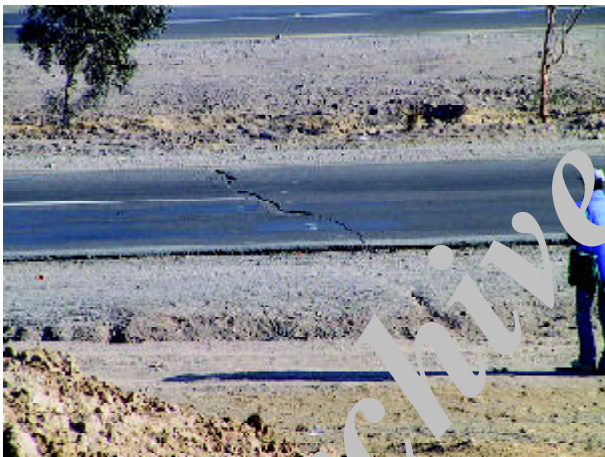
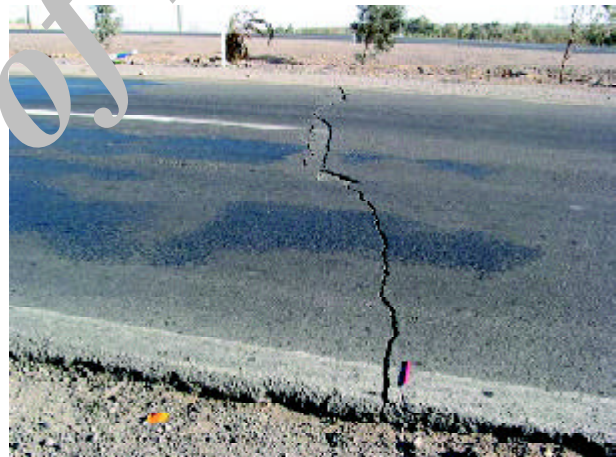
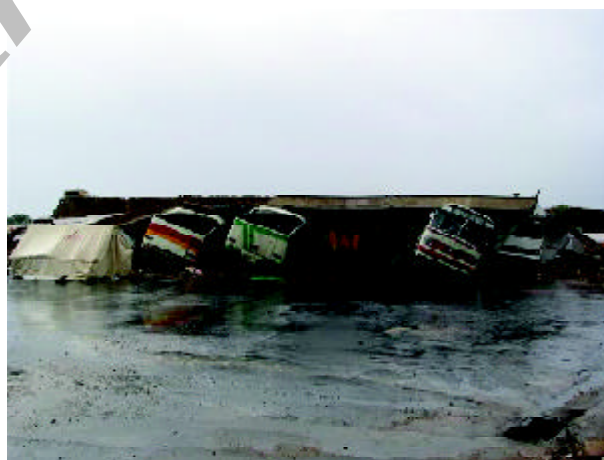
There is a main two-way highway-connecting city of Bam to Kerman on the northwest and Zahedan and Iranshahr on east and southeast of Bam. This road crosses the Bam fault scarp. Very minor damage to road embankments and surface cracks in the main highway close to Bam fault scarp were observed. For the most part, roads and streets were usable immediately after the earthquake, see Figure (10).

Cross-country bus lines are the main mode of transportation for masses in Iran especially outside the major cities. The last picture of Figure (10) shows the roof of a bus terminal building collapsed onto several busses.

**Figure 10.** There were minor damage to roads and highways. There were some damage to road embankment and surface cracks cracks in the main highway close to Bam fault scarp. For the most part roads and streets were usable immediately after the quake. The roof of bus terminal building collapsed onto several busses.

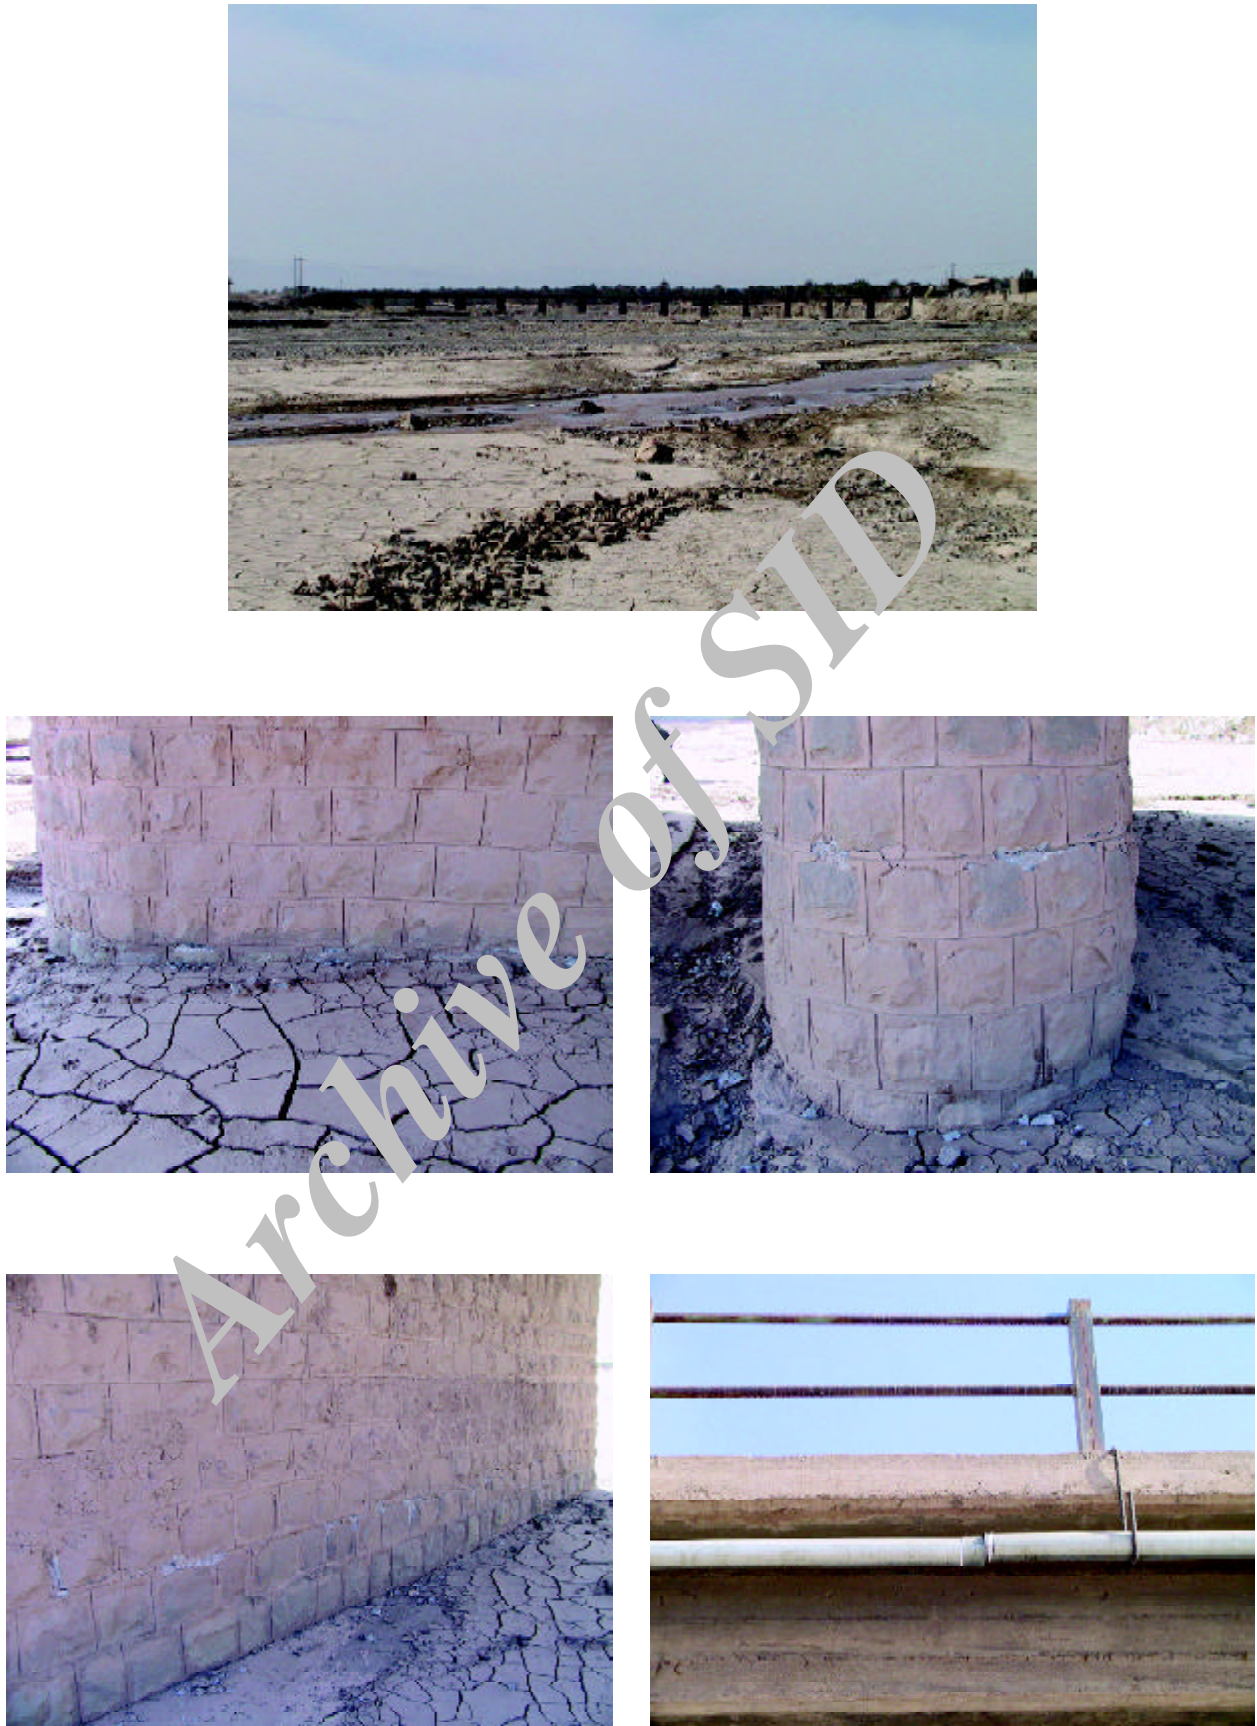
The bridges over a Bam river, called Posht-e-rud, performed relatively well. Figure (11) shows one of the main bridges over the river. There are signs of vertical movement in the base of the support walls/columns. Damage to the pipeline on the side of the bridge is observed. All of the three main bridges were

**Figure 11.** A bridge over the Posht-e-rud performed relatively well. There are signs of vertical movement in the base of the support walls/columns. Damage to pipelines is observed.

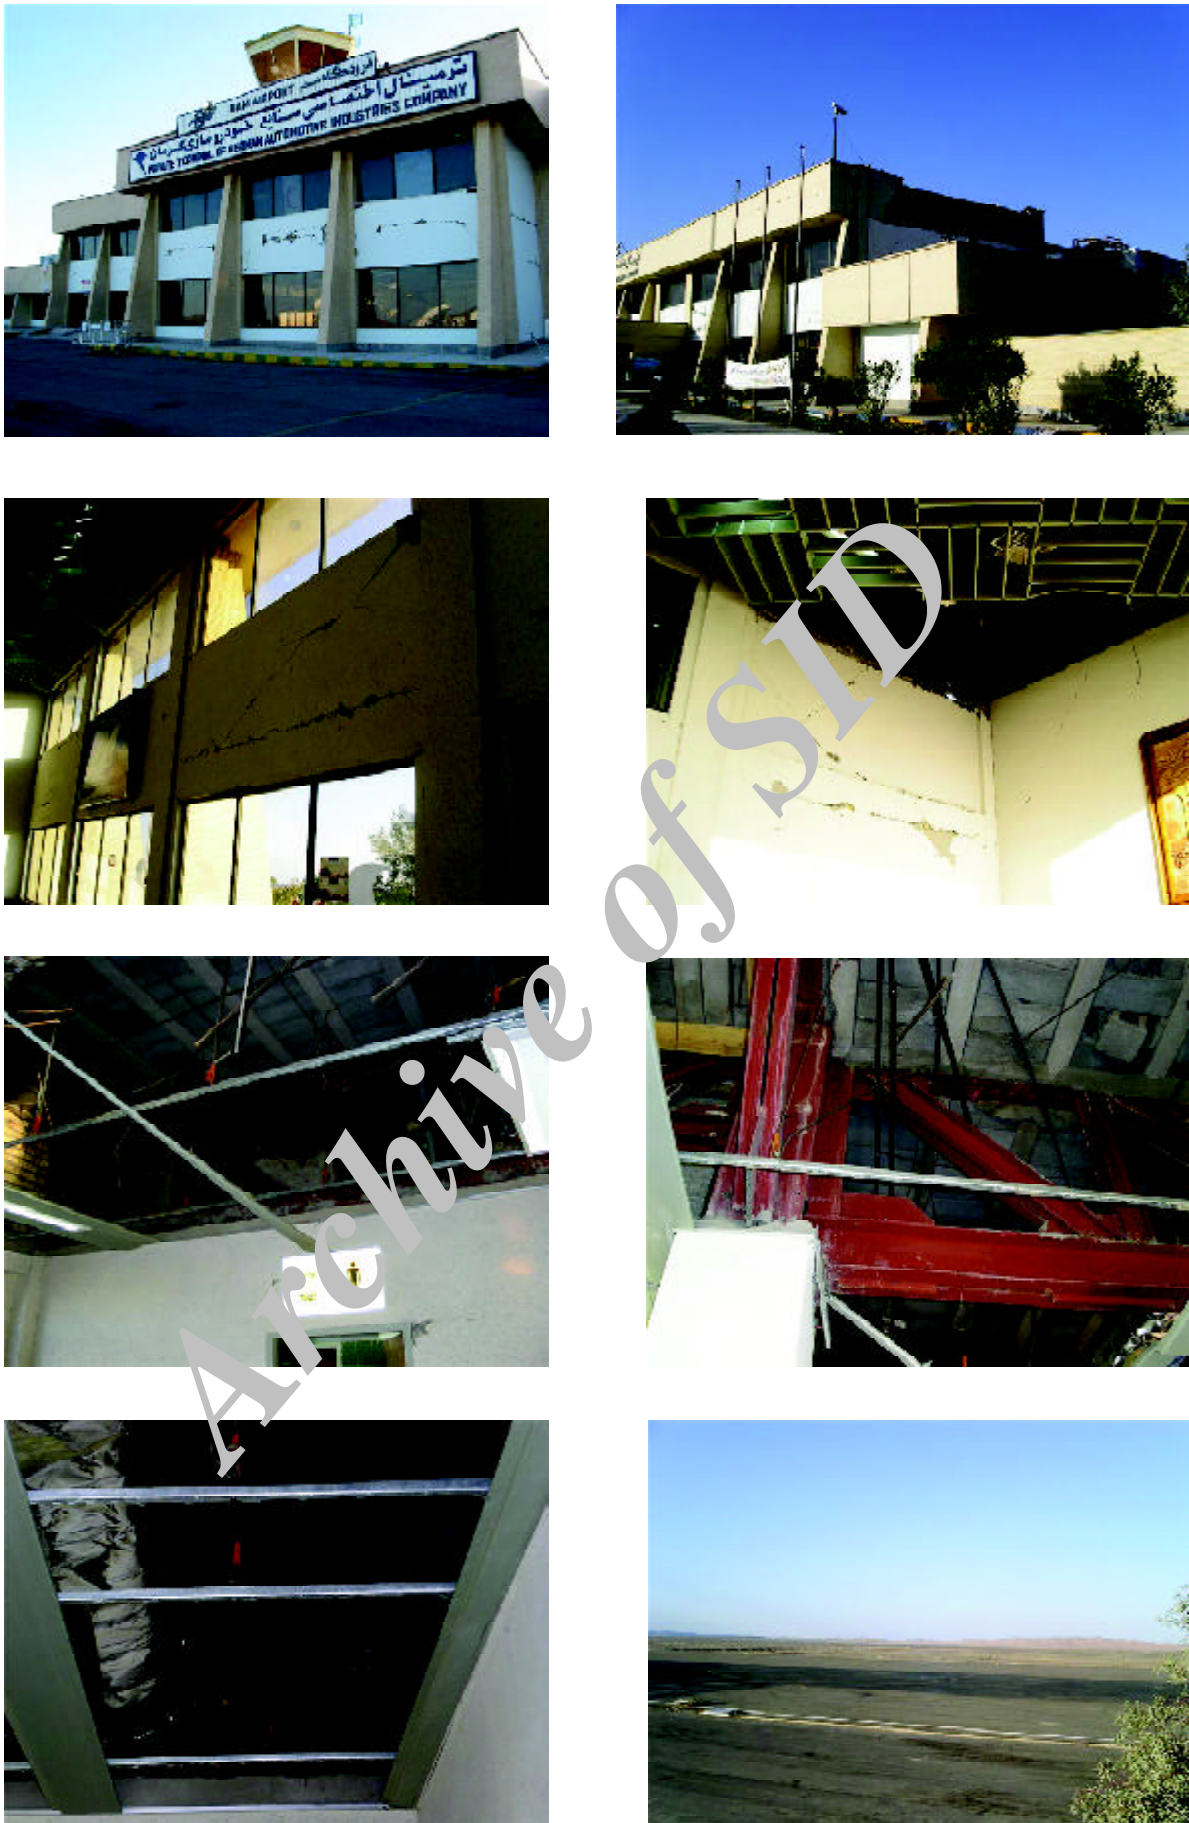
The main terminal building at the Bam airport had moderate damage, but the runway was operational immediately after the earthquake, see Figures (12). The steel frame terminal building was moderately damaged, but it withstood the quake. The masonry infill walls were damaged. The false ceilings were severely damaged. There was moderate damage to stairway to the second floor. There was nonstructural damage to airport control tower (broken windows). The airport runway had little damage and came to be extremely useful for emergency response and recovery effort. Hundreds of flights from inside of Iran and around the world landed in this airport immediately after the earthquake to bring search and rescue teams and equipment as well as much needed medical, food, blankets, tents and other supplies.

**Figure 12.** The engineered steel frame terminal building at Bam airport was moderately damaged. The masonry infill walls were damaged. The false ceilings were severely damaged. The airport runway had little damage.

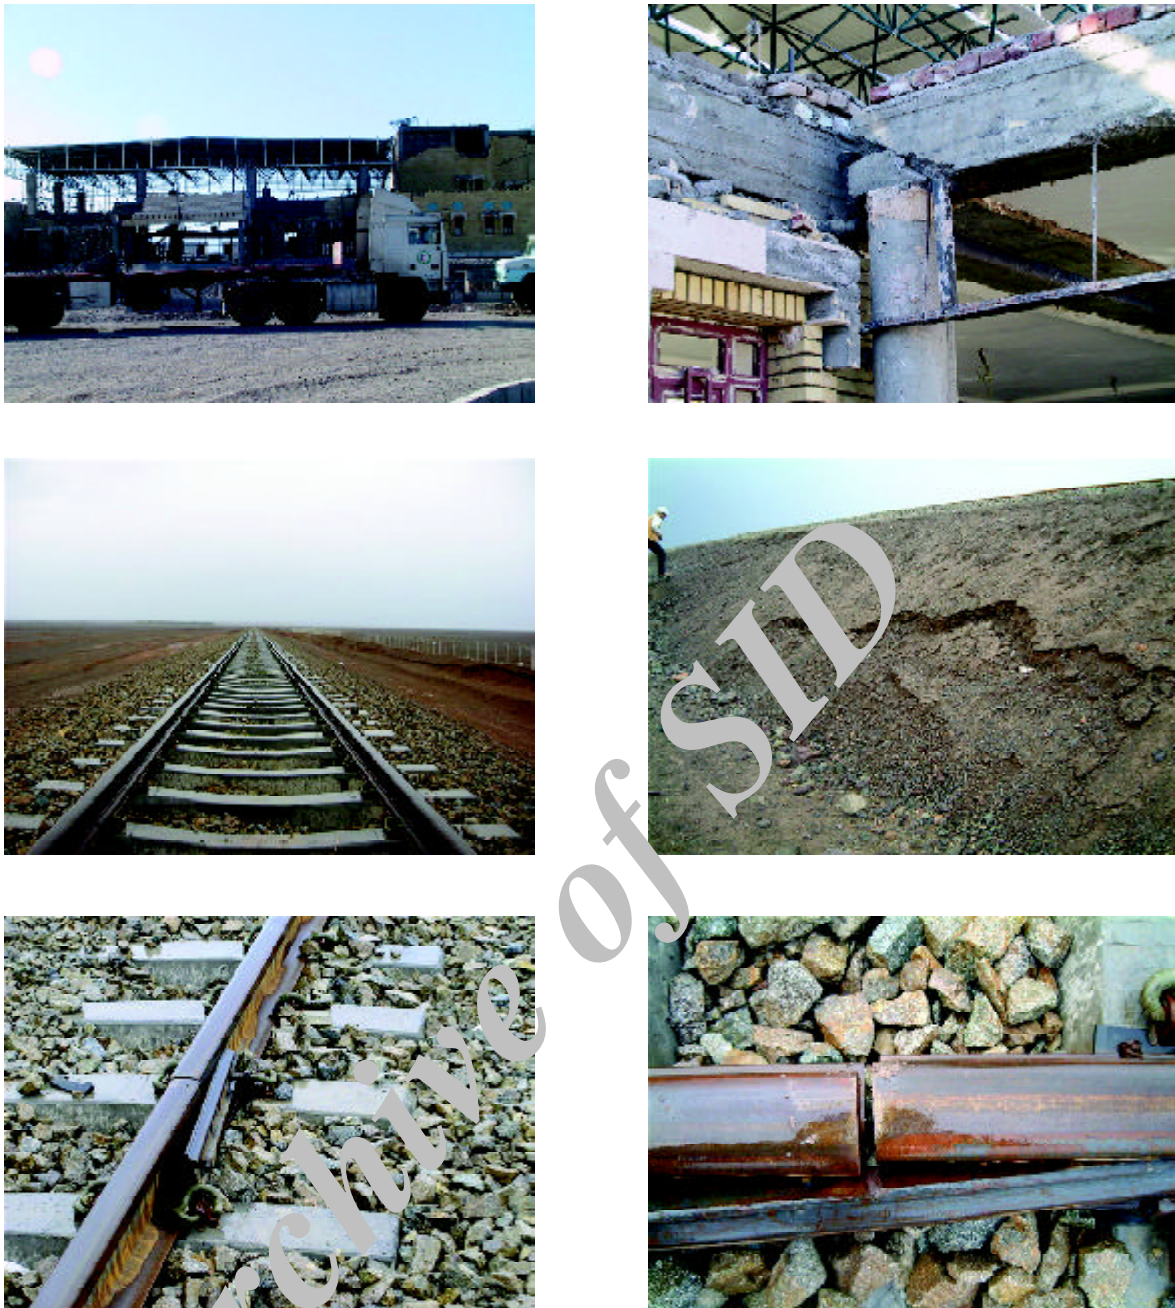
The construction of railroad to Bam had just been completed but the railroad had not been used prior to the quake. The passenger terminal located some 25km south of the city was under construction and had some damage. There was no damage to the rail tracks. There was light damage to embankment. The railroad was extremely useful for bringing supplies and help to Bam immediately after the earthquake, see Figure (13).

**Figure 13.** The passenger terminal was under construction and had minor damage. There was no damage to rail tracks. There was light damage to embankment.
