# Performance of Lifeline Systems in Bam Earthquake of 26 December 2003

Masoud Moghtaderi-Zadeh<sup>1</sup>, Farrokh Nadim<sup>2</sup>, and Mohammad Javad Bolourchi<sup>3</sup>

1. Risk and Reliability Engineering, San Jose, California, USA
2. International Centre for Geohazards, c/o NGI, Oslo, Norway, email: Farrokh.Nadim@ngi.no
3. Engineering Geology Department, Geological Survey of Iran, Tehran, Iran

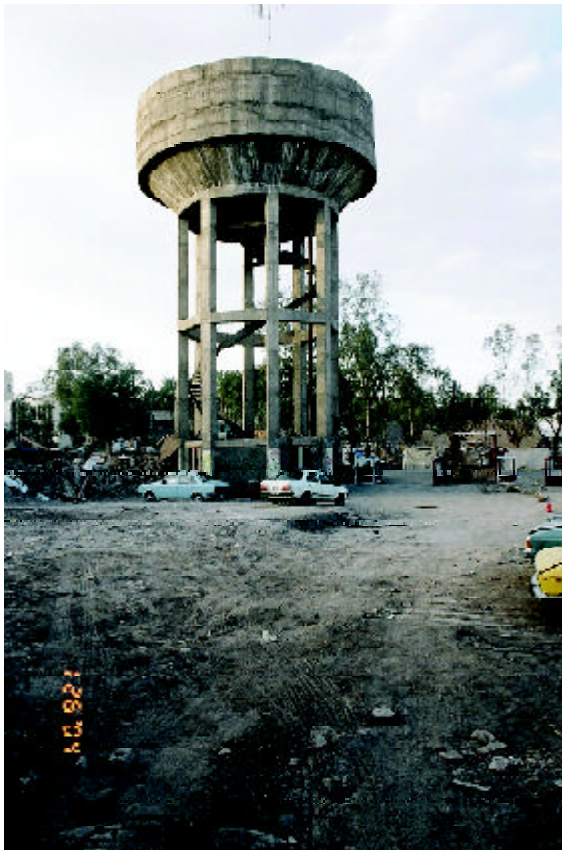
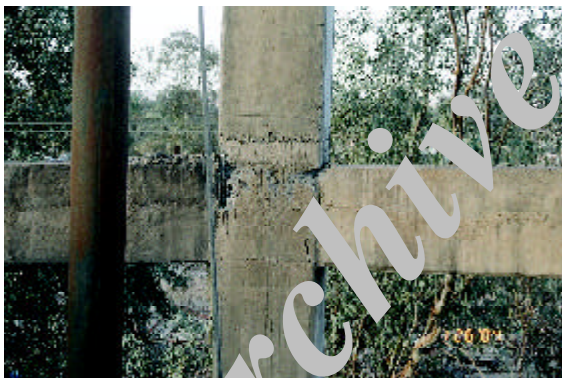
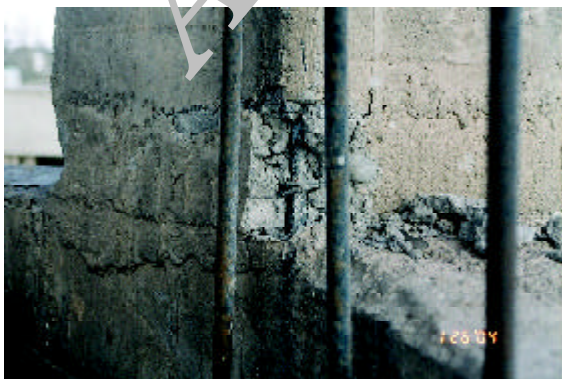
There was report of damage to a number deep wells and also several pipeline breaks throughout the city. Due to collapse of the buildings and breakage of connecting pipes, at users ends, water had to be brought by tanker trucks to the tents and shelters and other users after the earthquake. Overall the storage tanks performed well. Figure (1) shows an elevated concrete water tank, located near the old section of the city close to the earthquake rupture where the damage was high. The tank experienced severe stress and deformation at the column-beam connections.

**Figure 1.** Elevated concrete water tank located in near the old section of the city where the damage was high. The tank experienced severe stress and deformation at the column-beam connections.

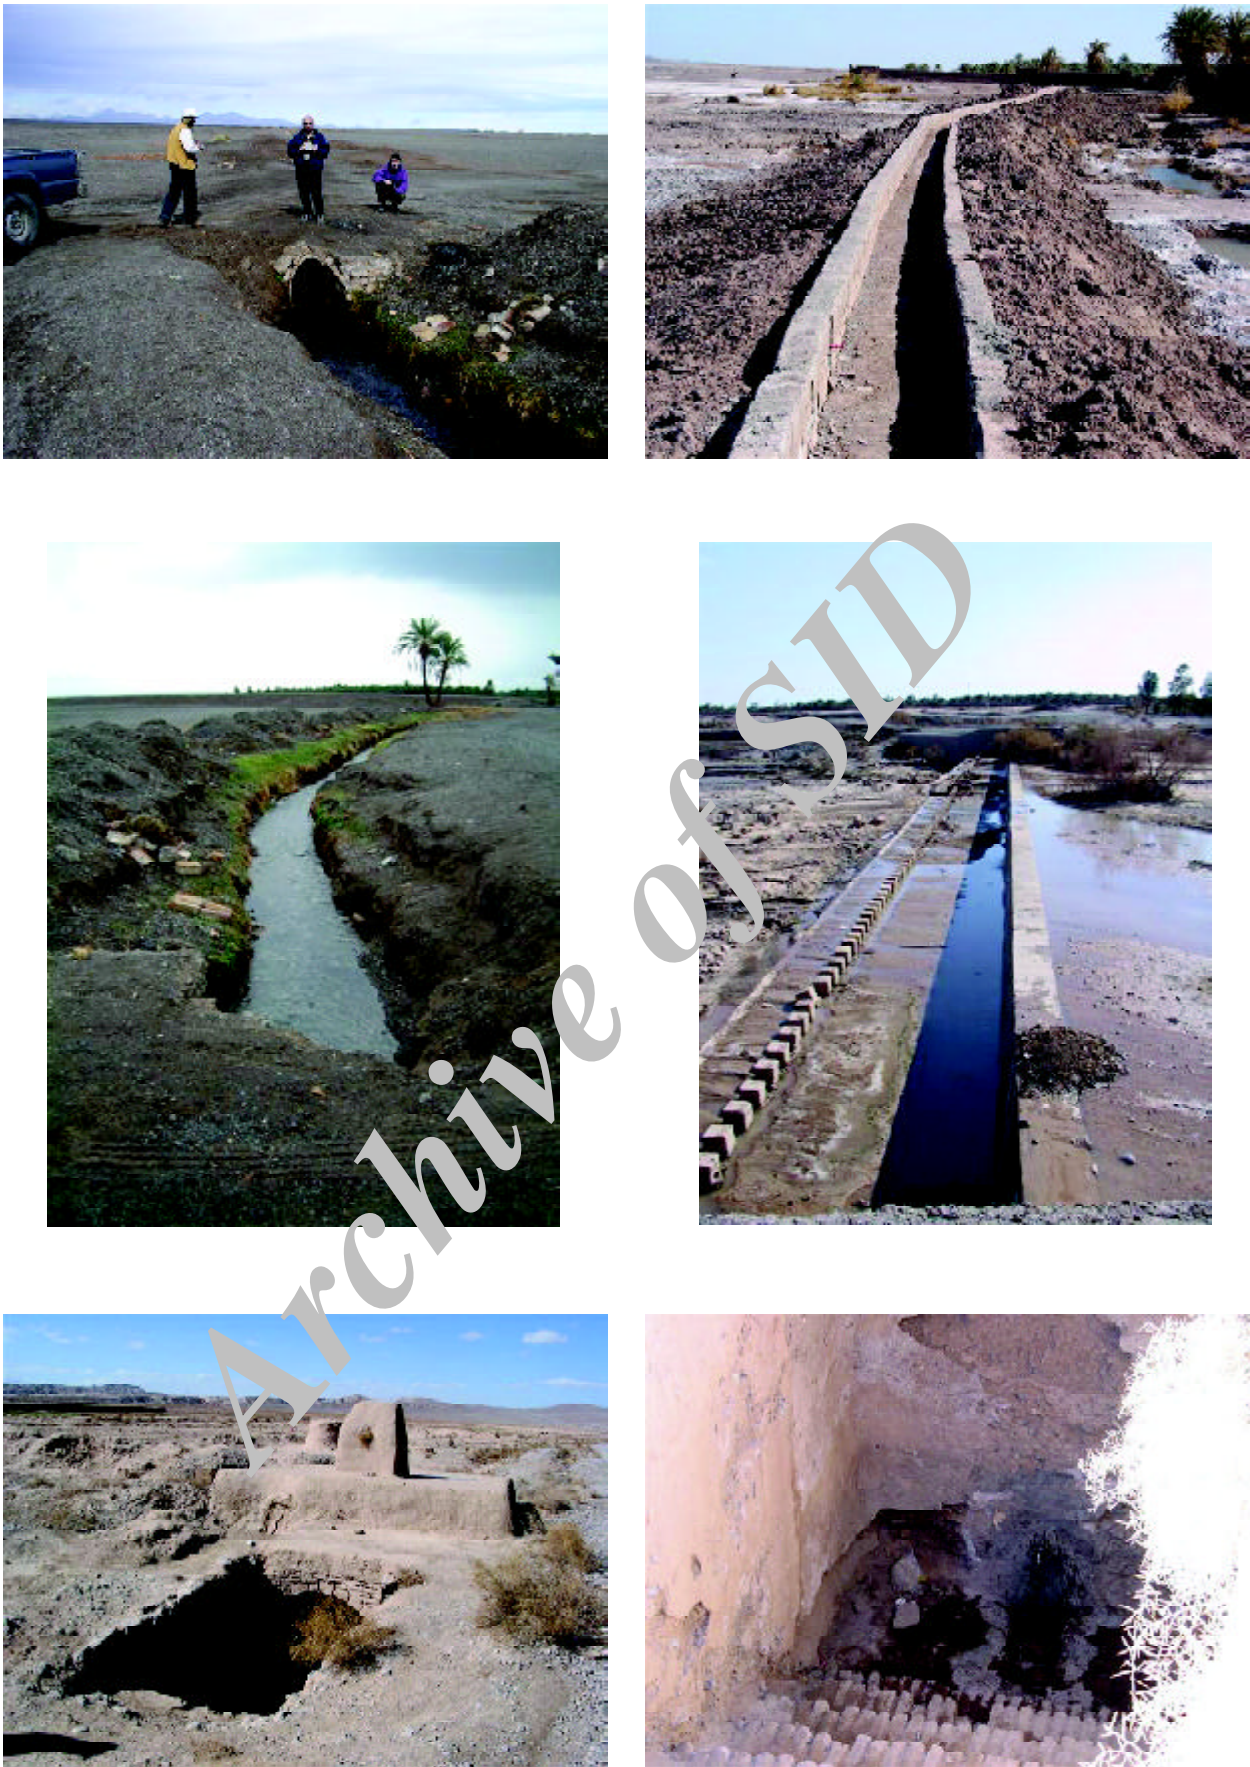
More than 55 chains of qanats had various levels of damage mostly to their wells and underground tunnels closer to the city and the quake epicenter. The damage was in the form of failure of the underground tunnel walls and wells, blocking the water to reach the ground

**Figure 5.** Once the qanat chain arrives at its destination, the underground tunnel reaches the ground surface (top and middle left pictures). From there the water is distributed via man-made channels and brought to farms and date palm gardens. Damage to the channels is noted in the middle and lower right pictures. The qanat water sometime is stored in traditional underground reservoirs (bottom two pictures).

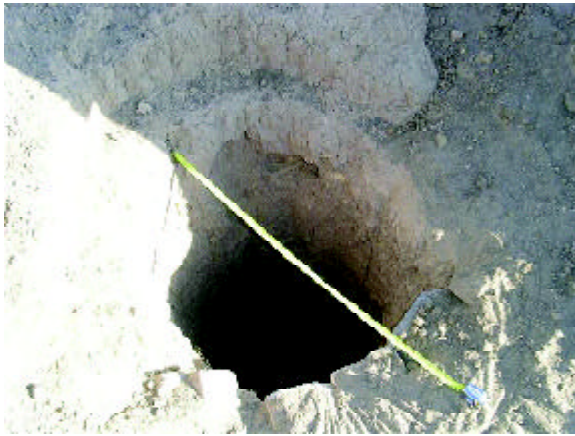
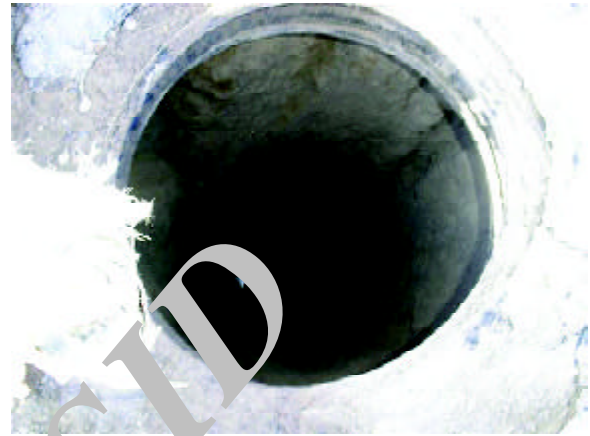
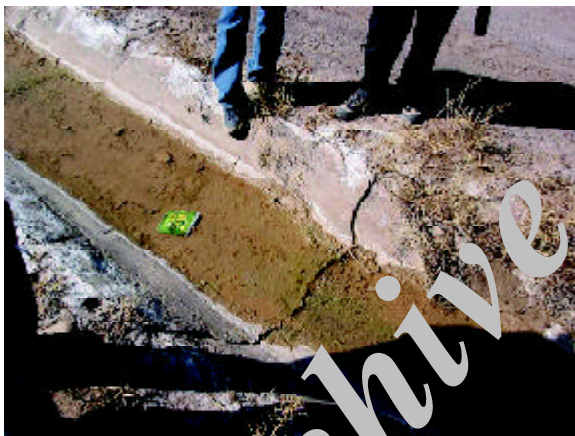
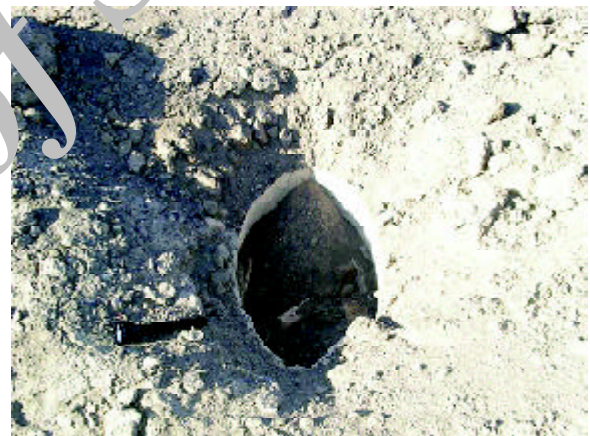
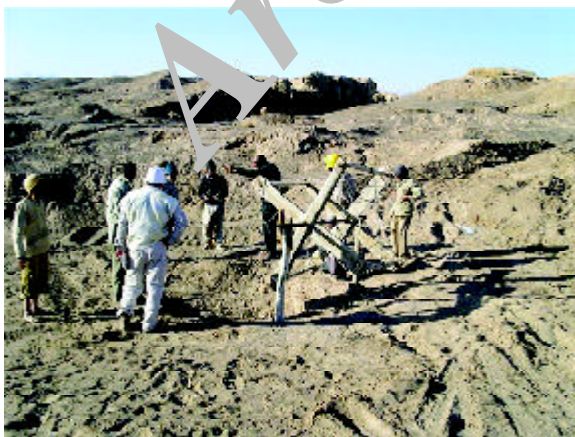
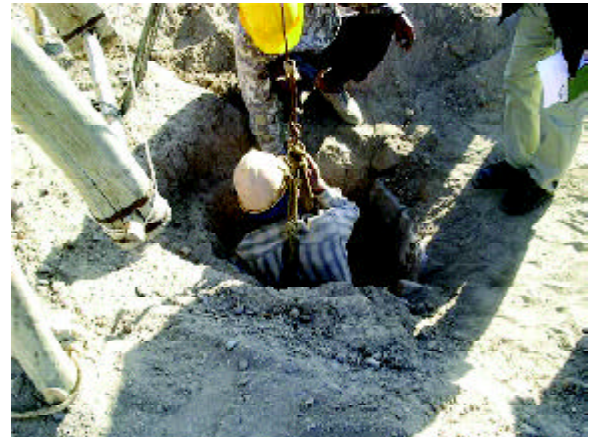
surface. One should note that the wells as well as the underground tunnels are not reinforced and are basically vertical and horizontal holes in the ground. Even without earthquakes the wells and the tunnels need regular maintenance to remove the fallen soil from the well walls and tunnels. At the time of the

**Figure 6.** The vertical wells, also used as access wells, are usually large enough for one person to be able to climb down (about 90cm across). Note the use of old tire at the entrance of one well. Damage to the qanat systems included underground tunnel collapse and closure (not shown), access well failure, which in turn causes the closure of the underground tunnel, damage to the channels. At the time of our visit a number of qanat builders had been brought from other parts of country to repair the very important qanats.

team visit a number of qanat builders from other parts of Iran had come to Bam area to clean and reconstruct the damaged qanats, see Figure (6). In addition to damage to qanat chains, the distribution surfaces channels were damaged or closed off due to collapsed garden walls or other constructions.

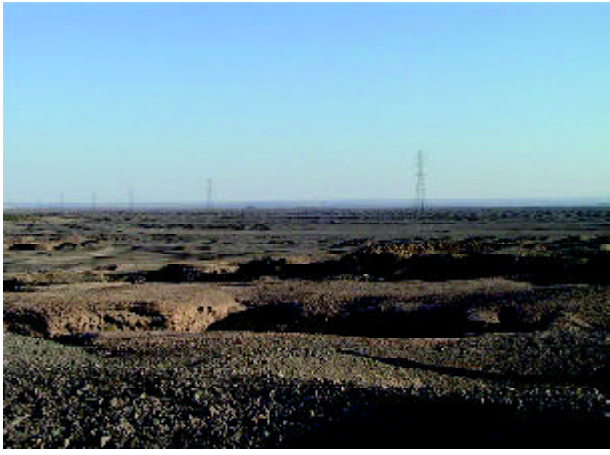
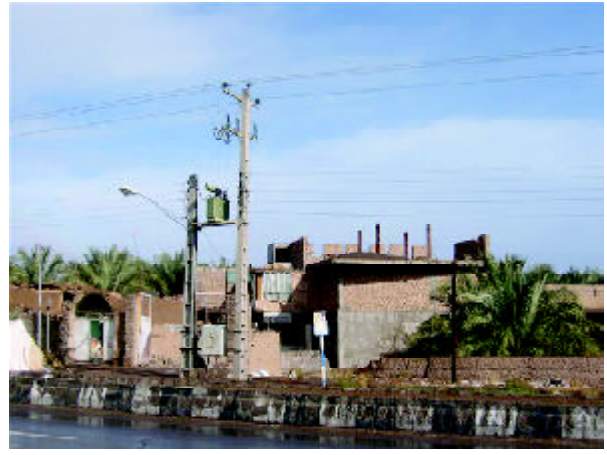
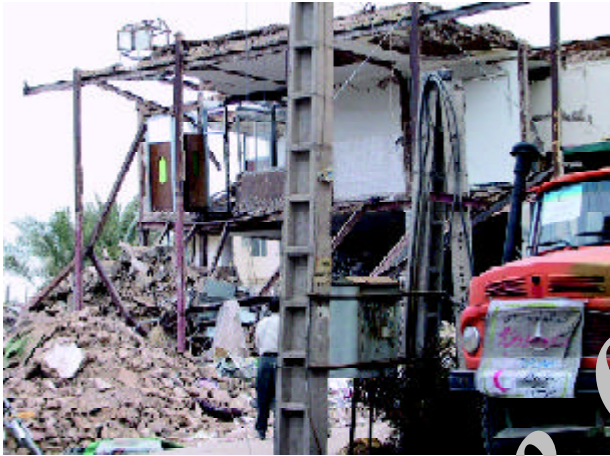
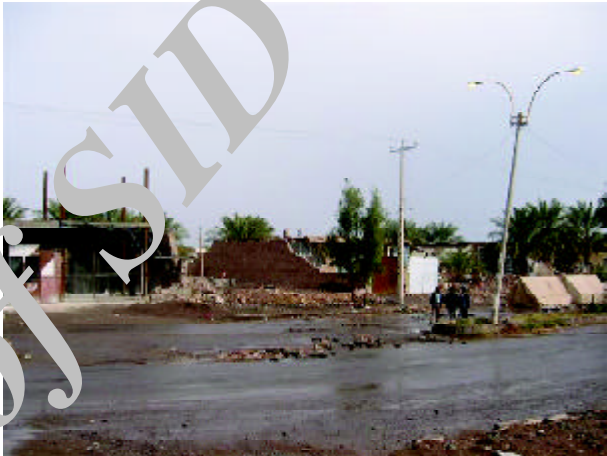
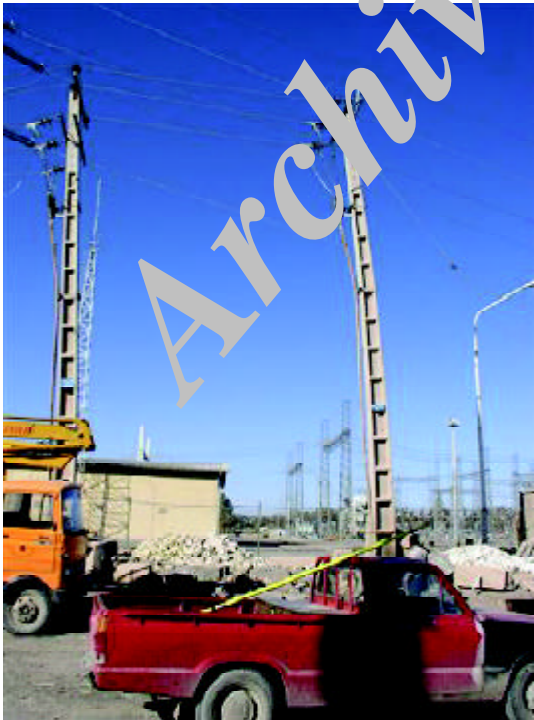
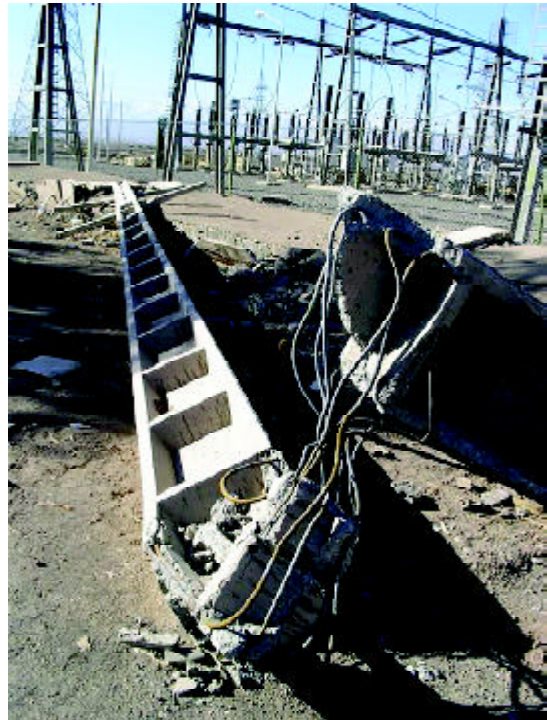
There was no damage to main 230kV transmission lines. There was however damage to concrete poles in the distribution system and streetlights. Part of the damage to the concrete poles was due to collapse of adjacent walls and buildings. We observed series of poles to be out of plumb. Damage to transformers on distribution poles was reported [8], see Figure (8).

**Figure 7.** Damage to transmission line towers was not observed. Concrete and wooden poles are used to bring electricity from substations to users. Pole top transformers convert the electricity to 220V. Many distribution poles were damaged. A large number of distribution poles and street light poles were out of plumb after the earthquake.

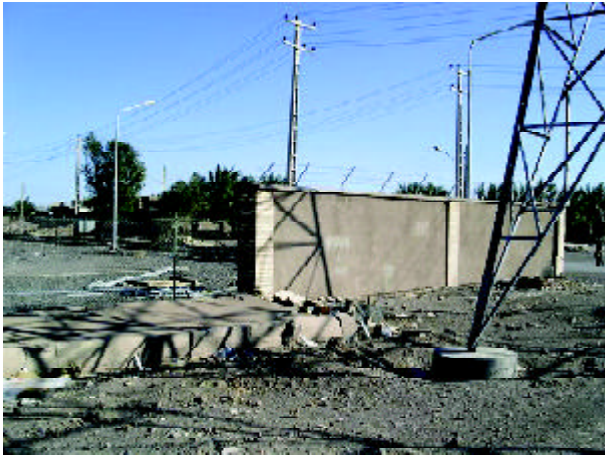
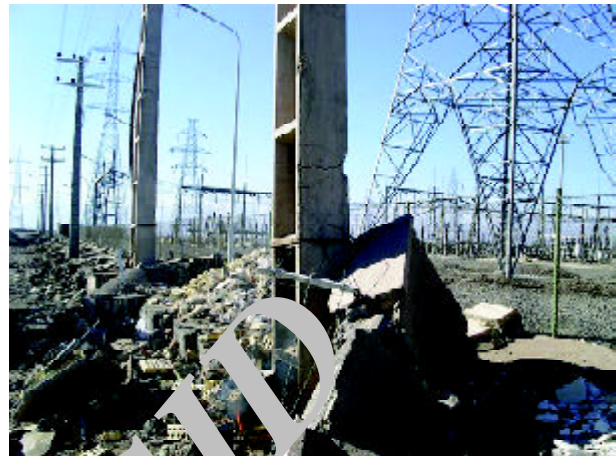
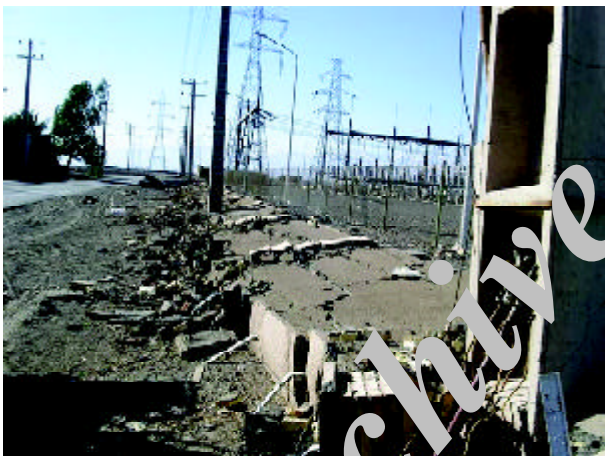
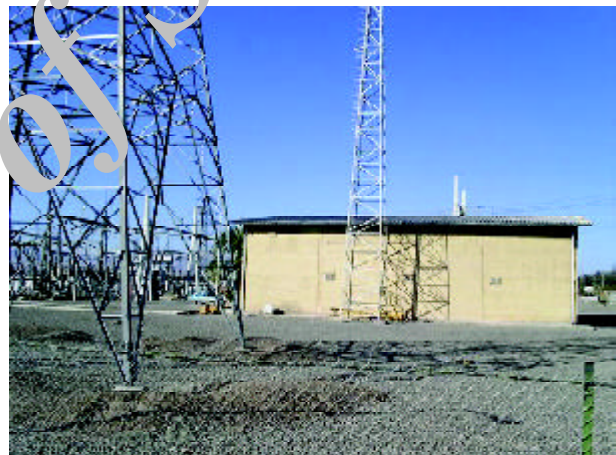
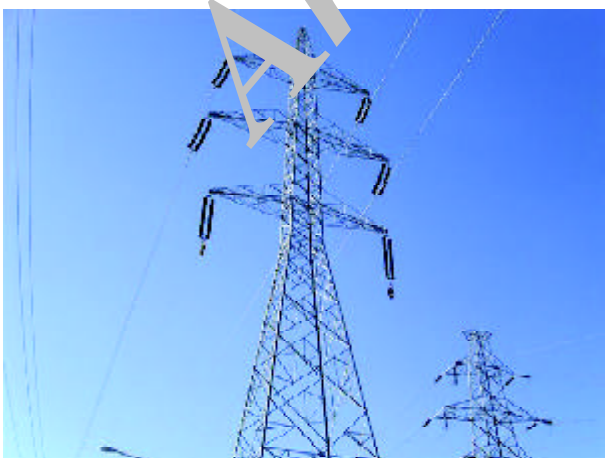
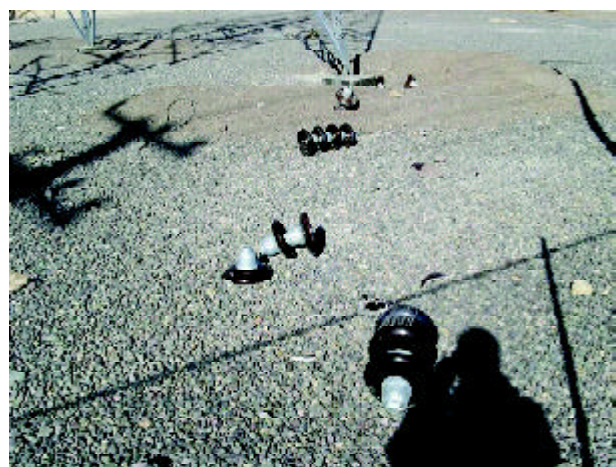
The 230kV substation in Bam experienced some damage. There was some damage to porcelain insulators and bushings at this substation. The wall around the substation collapsed. The office/control building in the substation structurally performed well, see Figures (8) and (9). This substation was about 5km distance from epicenter. At the time of our visit (one month after the earthquake), electricity had been restored throughout the city, even in the area where there was severe to complete building destruction.

**Figure 8.** The 230kV substation experienced minor damage. The wall surrounding the facility collapsed. In the process it hit the concrete poles and caused their failure. A number of porcelain insulators were broken. The office/control room did not seem to have been damaged structurally.

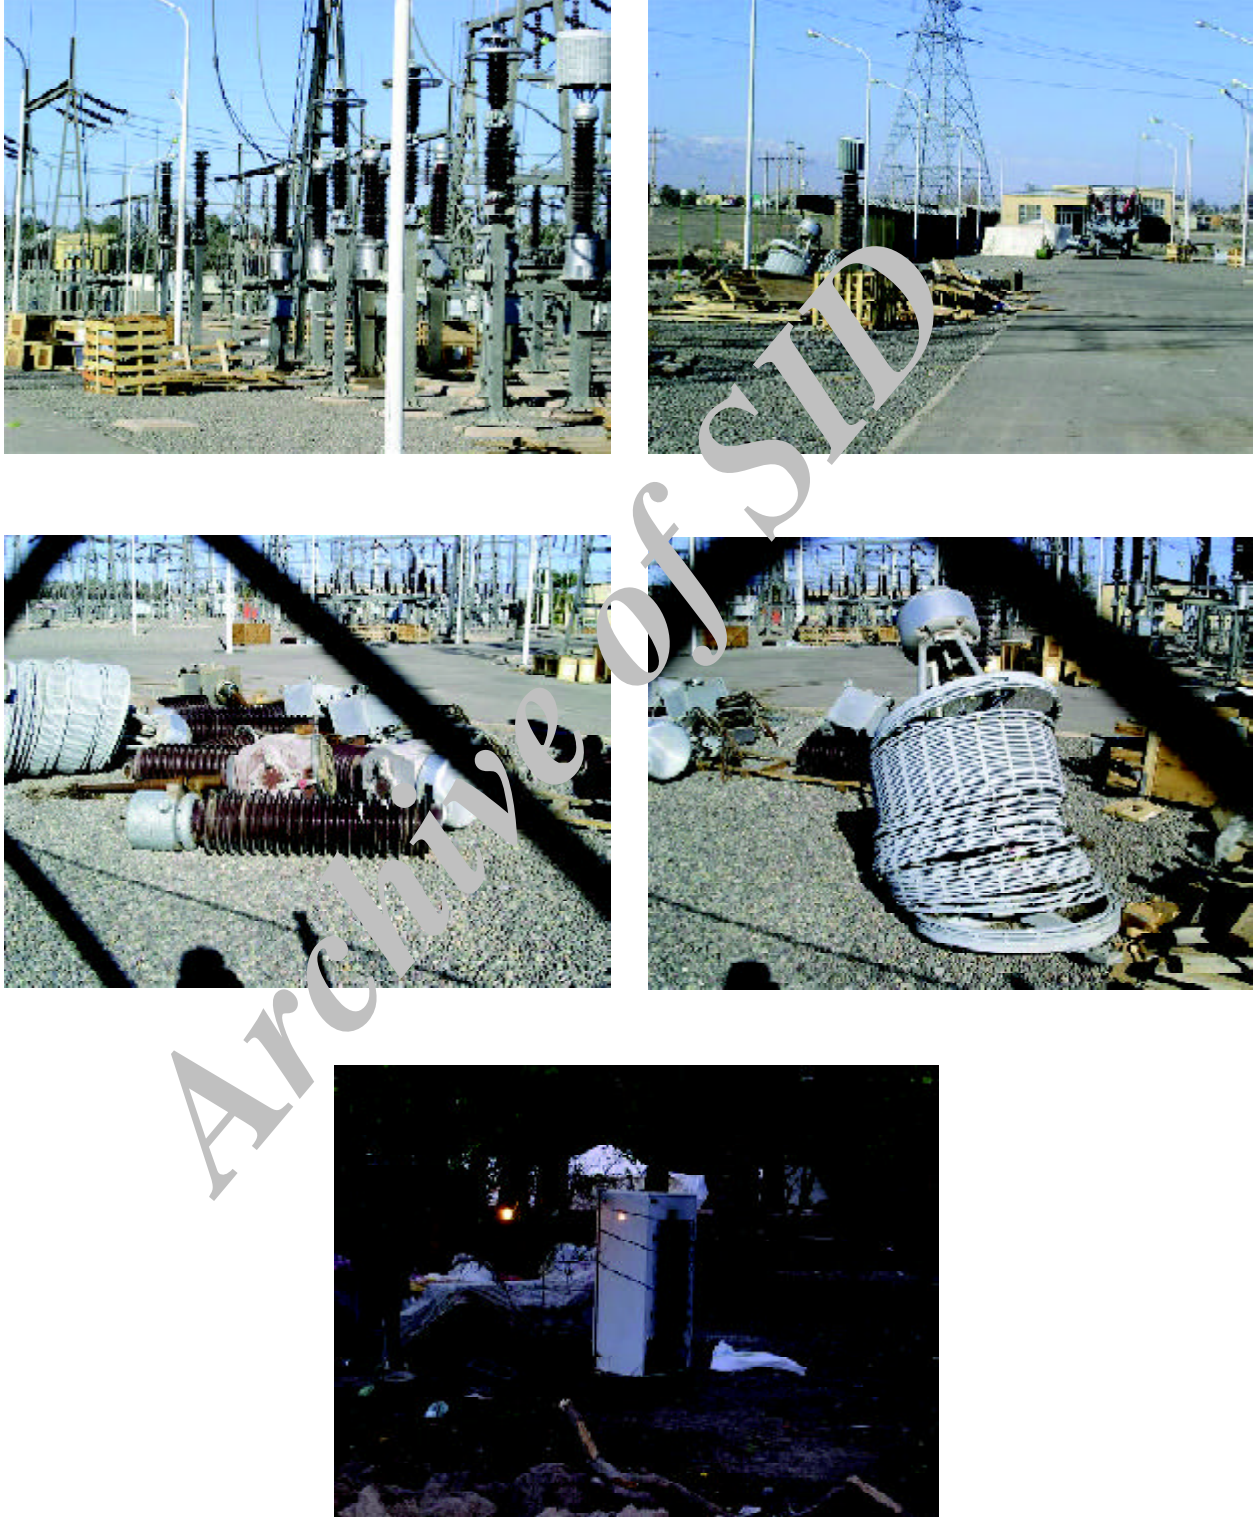
**Figure 9.** Damage to various electric equipments in the 230kV substation is observed in the above pictures. At the time of our visit (one month after earthquake) the electricity was available throughout the city, even though most of the users' buildings had been severely damaged to use the electricity.

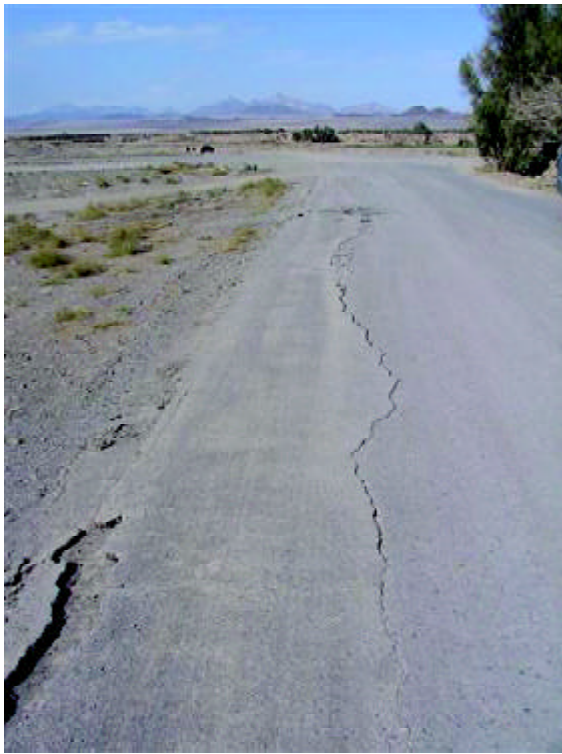
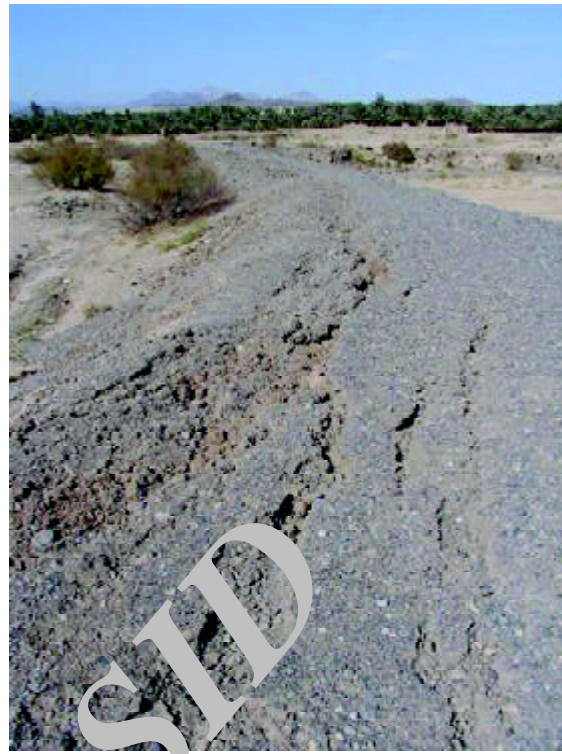
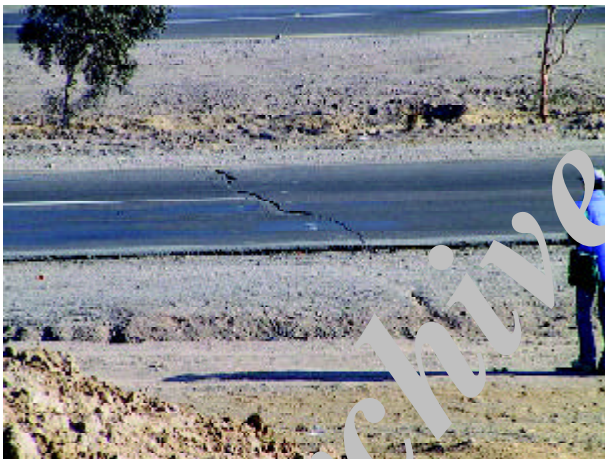
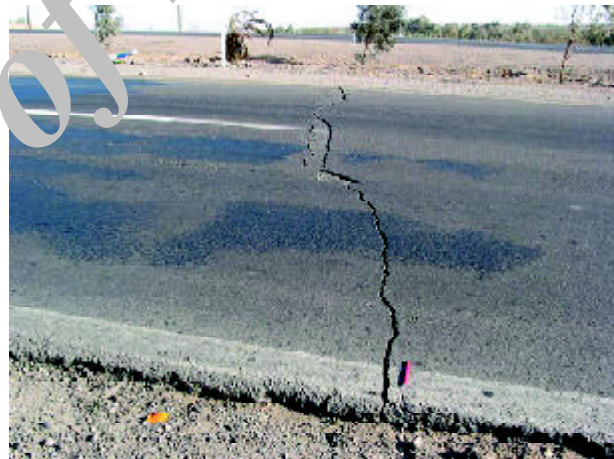
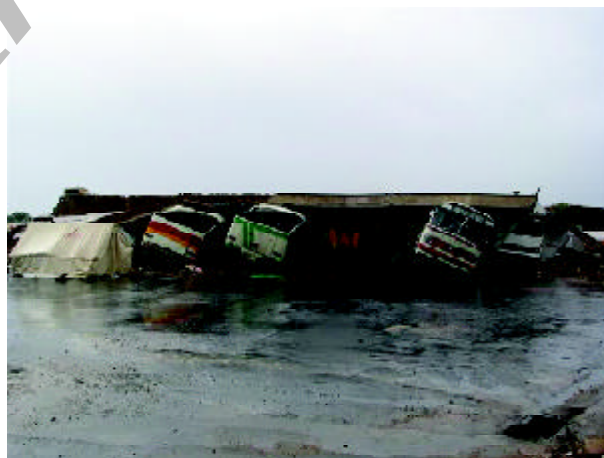
There is a main two-way highway-connecting city of Bam to Kerman on the northwest and Zahedan and Iranshahr on east and southeast of Bam. This road crosses the Bam fault scarp. Very minor damage to road embankments and surface cracks in the main highway close to Bam fault scarp were observed. For the most part, roads and streets were usable immediately after the earthquake, see Figure (10).

Cross-country bus lines are the main mode of transportation for masses in Iran especially outside the major cities. The last picture of Figure (10) shows the roof of a bus terminal building collapsed onto several busses.

**Figure 10.** There were minor damage to roads and highways. There were some damage to road embankment and surface cracks cracks in the main highway close to Bam fault scarp. For the most part roads and streets were usable immediately after the quake. The roof of bus terminal building collapsed onto several busses.

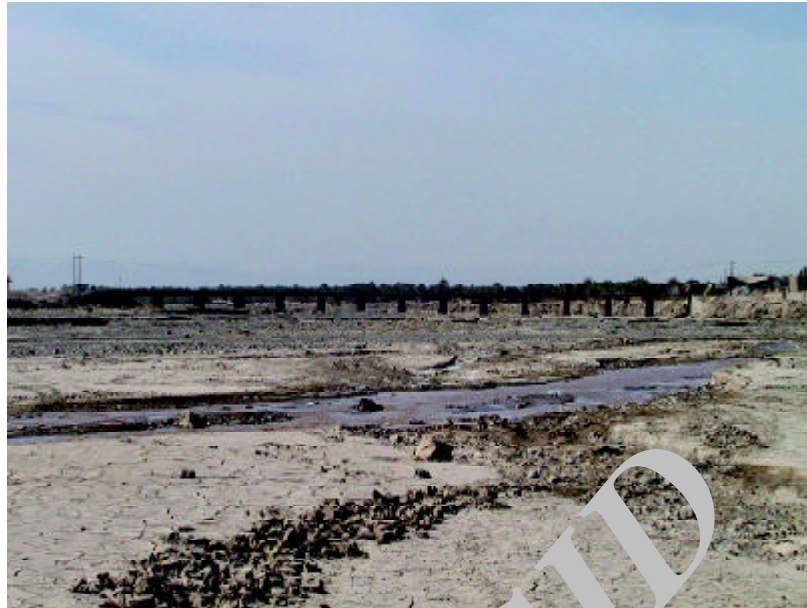
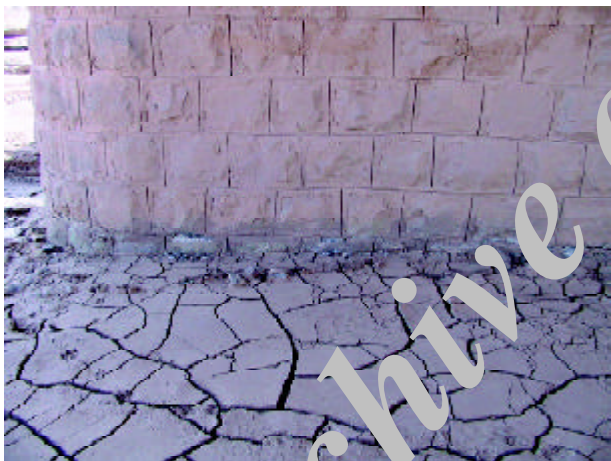
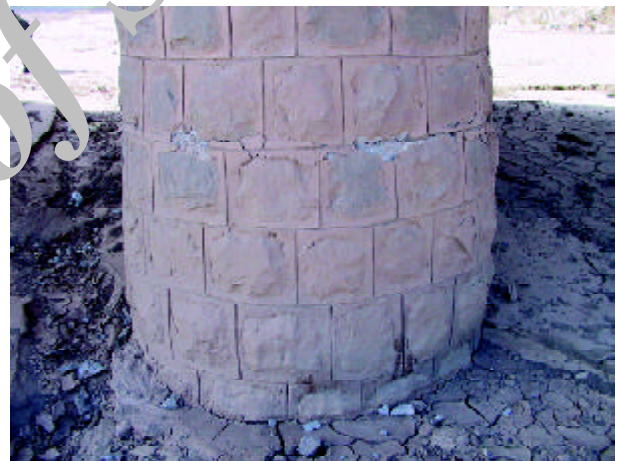
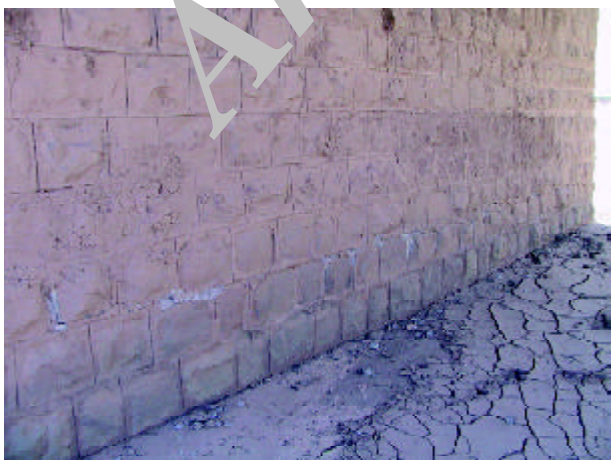
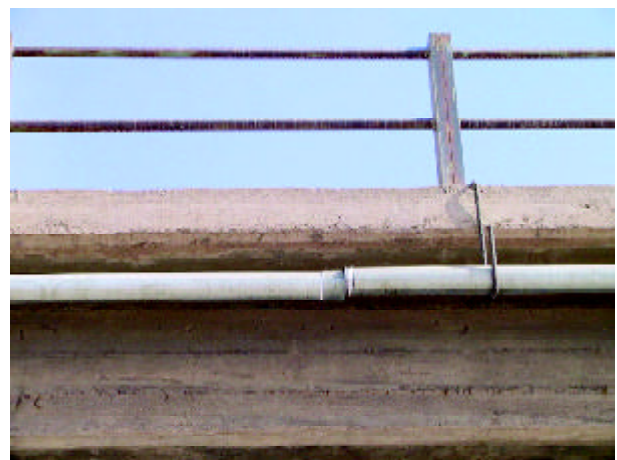
The bridges over a Bam river, called Posht-e-rud, performed relatively well. Figure (11) shows one of the main bridges over the river. There are signs of vertical movement in the base of the support walls/columns. Damage to the pipeline on the side of the bridge is observed. All of the three main bridges were

**Figure 11.** A bridge over the Posht-e-rud performed relatively well. There are signs of vertical movement in the base of the support walls/columns. Damage to pipelines is observed.

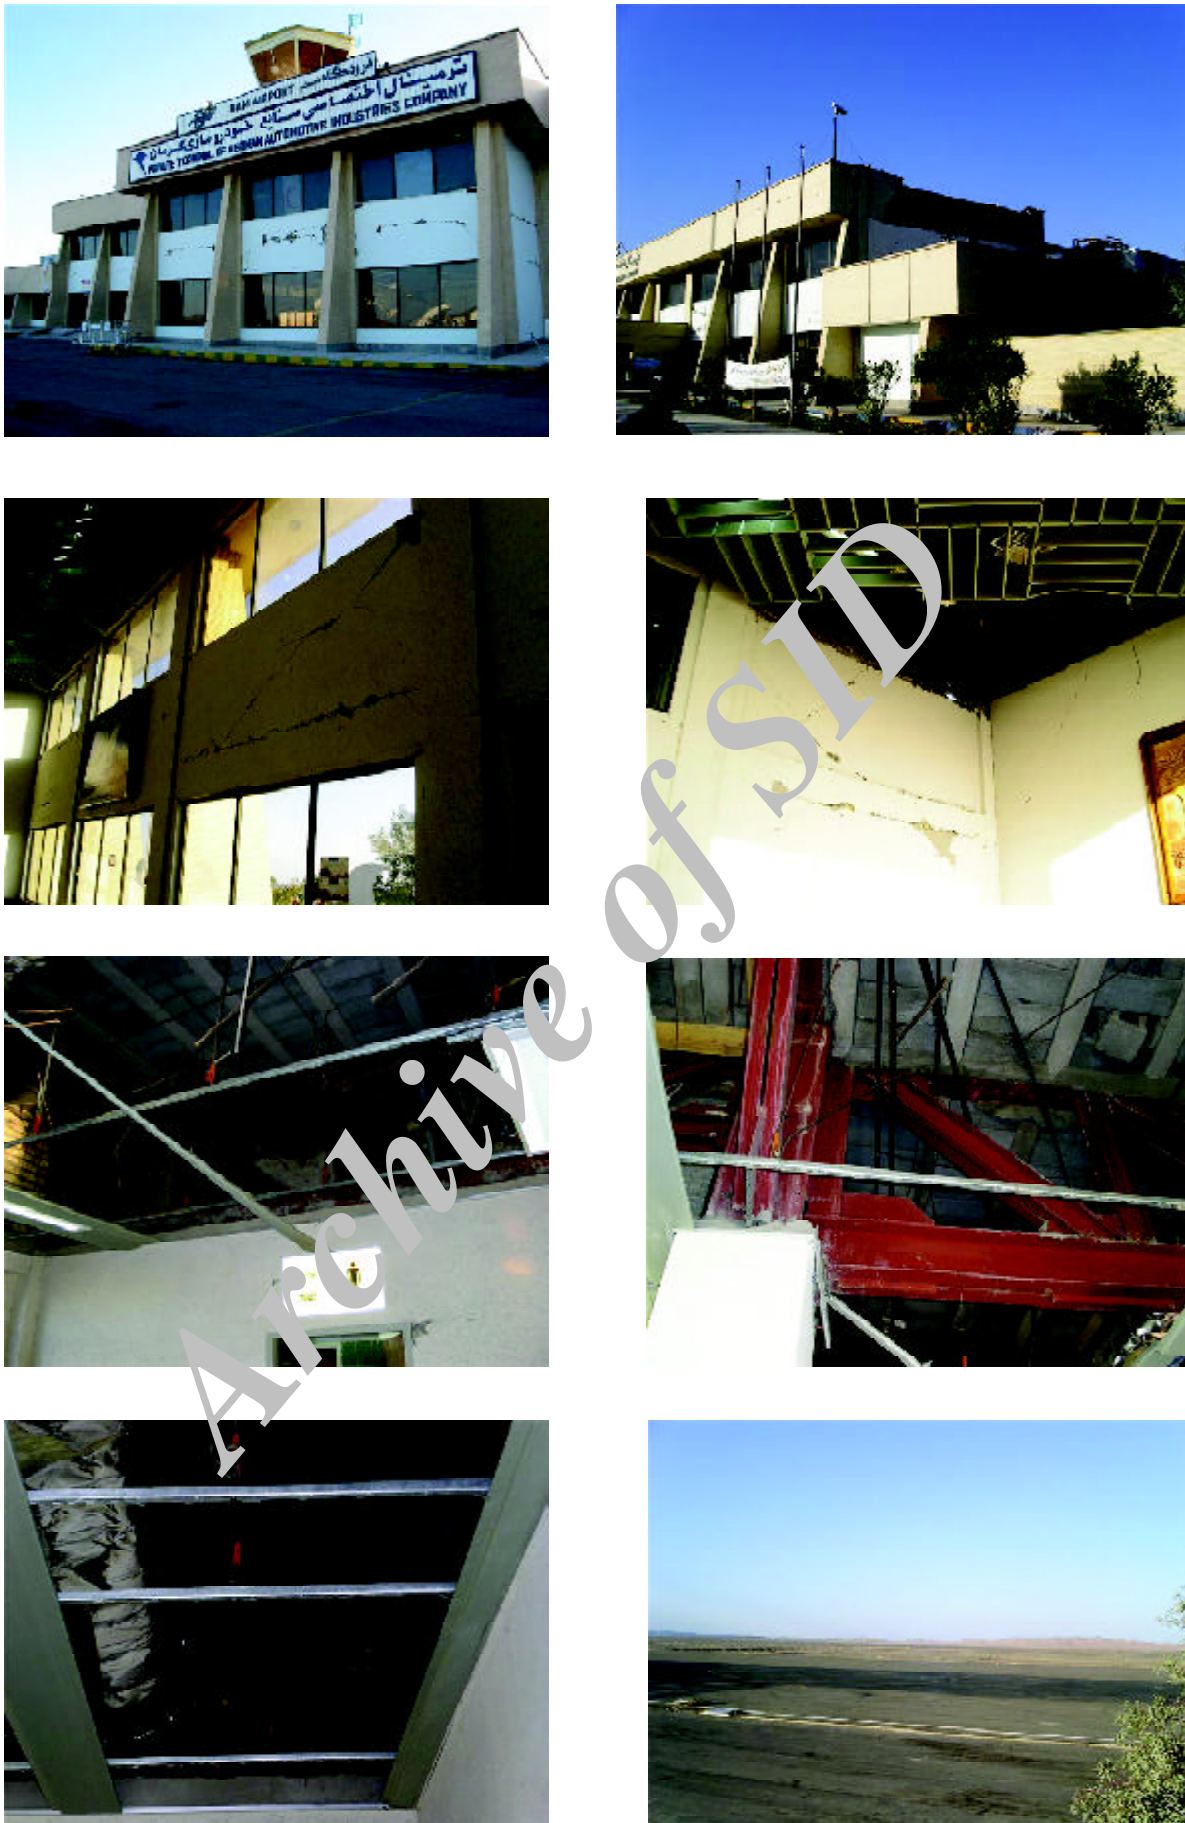
The main terminal building at the Bam airport had moderate damage, but the runway was operational immediately after the earthquake, see Figures (12). The steel frame terminal building was moderately damaged, but it withstood the quake. The masonry infill walls were damaged. The false ceilings were severely damaged. There was moderate damage to stairway to the second floor. There was nonstructural damage to airport control tower (broken windows). The airport runway had little damage and came to be extremely useful for emergency response and recovery effort. Hundreds of flights from inside of Iran and around the world landed in this airport immediately after the earthquake to bring search and rescue teams and equipment as well as much needed medical, food, blankets, tents and other supplies.

**Figure 12.** The engineered steel frame terminal building at Bam airport was moderately damaged. The masonry infill walls were damaged. The false ceilings were severely damaged. The airport runway had little damage.

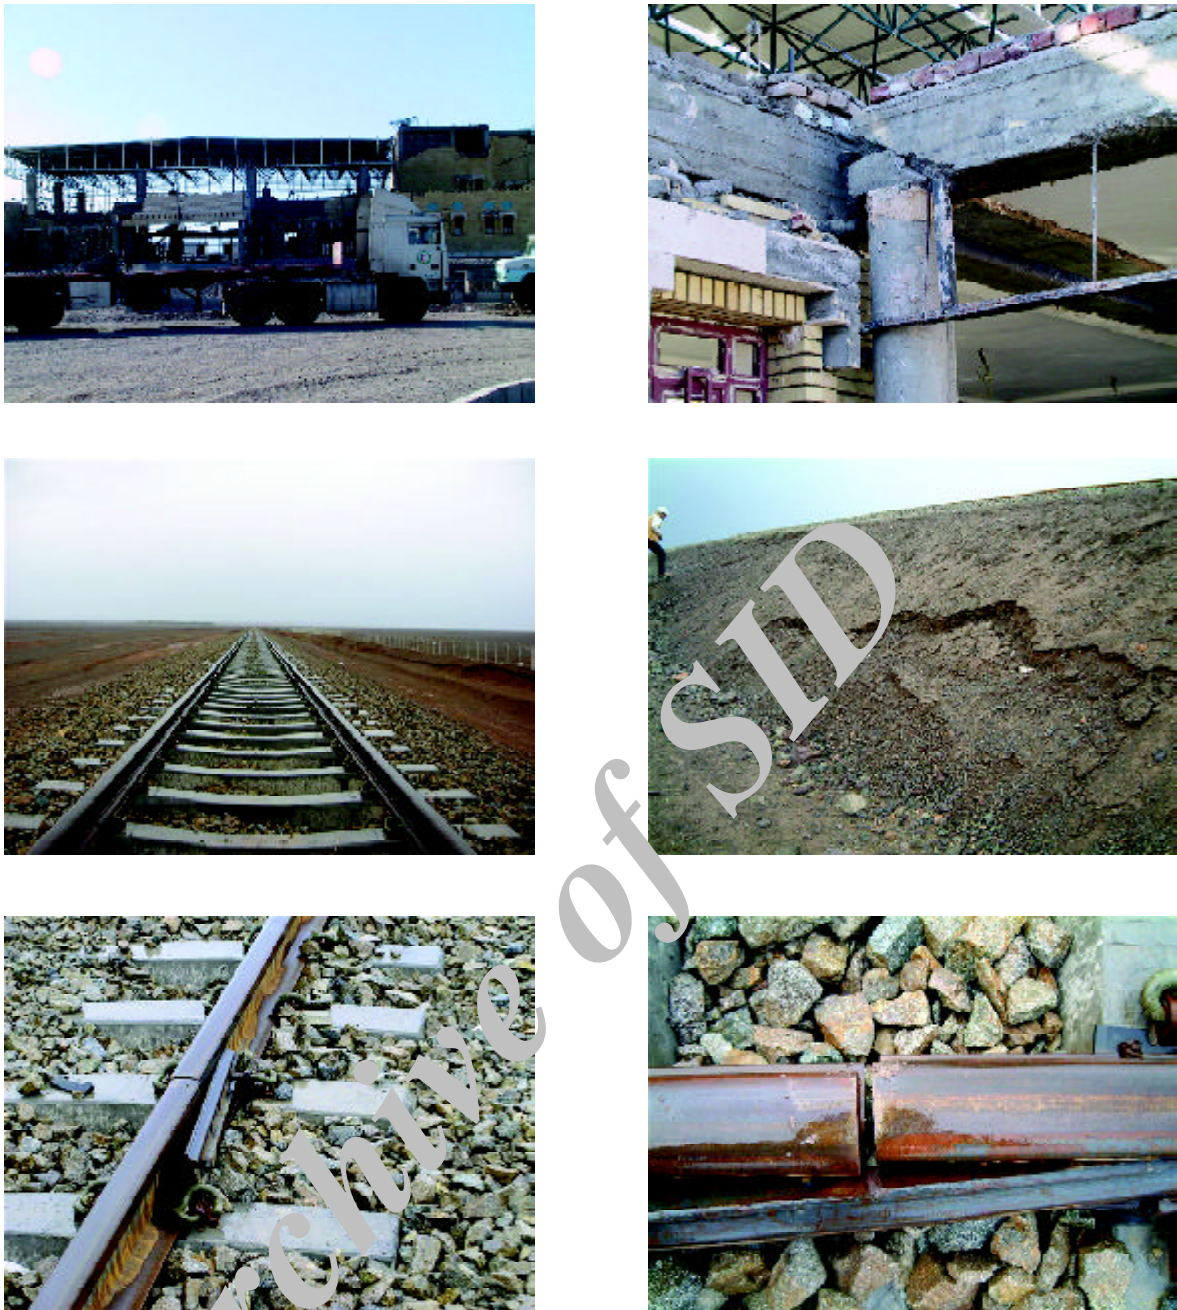
The construction of railroad to Bam had just been completed but the railroad had not been used prior to the quake. The passenger terminal located some 25km south of the city was under construction and had some damage. There was no damage to the rail tracks. There was light damage to embankment. The railroad was extremely useful for bringing supplies and help to Bam immediately after the earthquake, see Figure (13).

**Figure 13.** The passenger terminal was under construction and had minor damage. There was no damage to rail tracks. There was light damage to embankment.

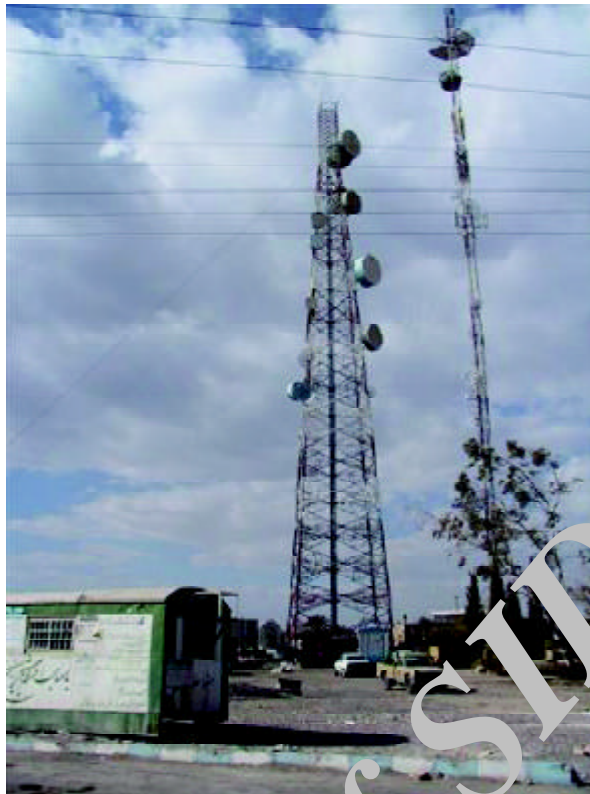
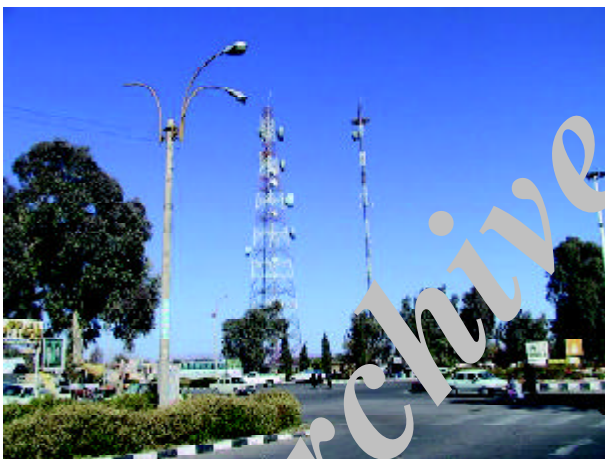
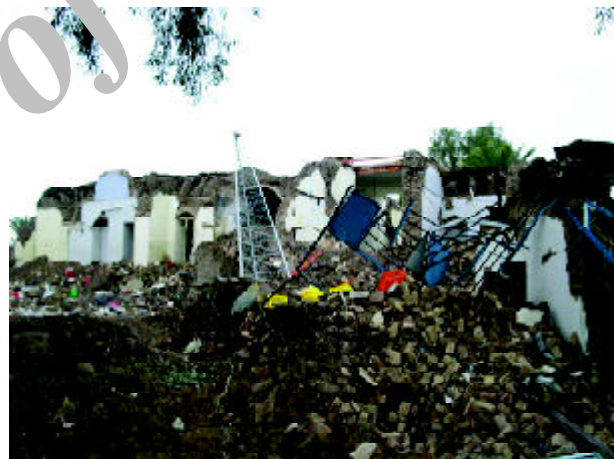
equipment. The main telecom towers mostly survived the quake. Some communication towers located on the roofs of the collapsed buildings were also damaged, see Figure (15).

**Figures 15.** The main telecommunication towers mostly survived the quake. Some communication towers located on roof of the collapsed buildings were also damaged.
