On the Nonstructural Elements and Their Behavior in the Bam Earthquake of 26 December 2003

Mahmood Hosseini

Structural Engineering Research Center, International Institute of Earthquake Engineering and Seismology (IIEES), Tehran, Iran, email: hosseini@iiees.ac.ir

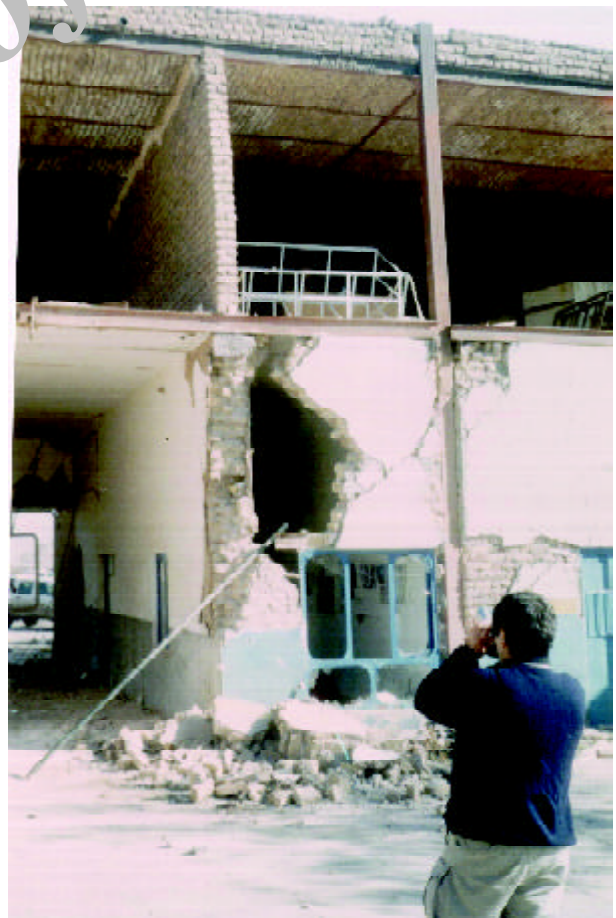
Several cases of damage to external wall masonry were observed, of which some samples are shown in Figures (1) to (4). It is seen in Figure (1), which is related to the recently constructed Emdad Khodro building located beside the Kerman-Zahedan road, that the external walls of the second story and a part of it in the first story of the building have fallen out. This building had a serious case of pounding as it is shown in the next pictures. The broken glasses of the window in the first story are also visible in the picture. Note that there is no sign of the interlocking between the remained wall in the second floor with the one formerly perpendicular to that, which is now fallen

Figure 1. Collapse of the external walls made of brick masonry in Emdad Khodro building (Photo by M. Hosseini).

out. Also note that in the middle bay at the second story the internal shelf has fallen inward the building. It is also notable that the roof parapet of the building did not get damage, which can be basically because of its short height.

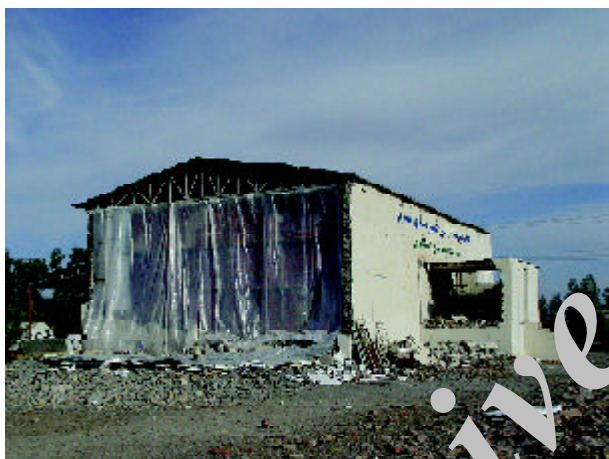
Another case of damage to the external walls is shown in Figure (2), which is related to Khormayyeh Shargh (East Date) export company. The complete collapse of the end wall of the refrigerating hall is seen in the figure. It is also seen that one wall of the motor house beside the hall has collapsed. A close up of this fallen wall is shown in Figure (3). Examination of the building showed that there was not any internal stabilizing column or external buttress in that end wall. In the case of the motor house wall just its inherent weakness and little integrity with other walls can be

Figure 2. Complete collapse of the external wall of the refrigeration saloon of Khormayyeh Shargh (east date) export company made of concrete block masonry (Photo by M. Hosseini).

the main cause of collapse.

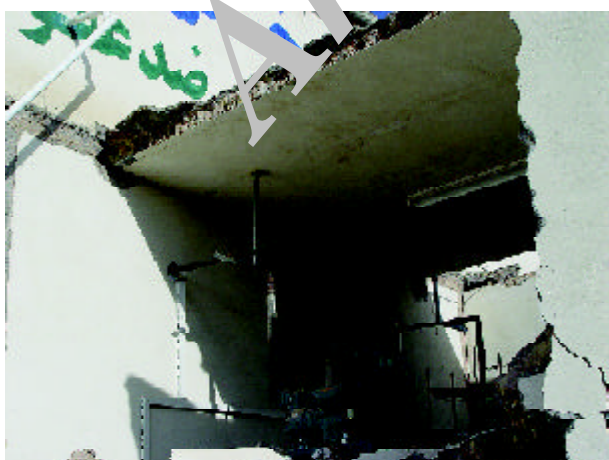
Figure 3. Complete failure of the external wall with partial collapse of the ceiling in the motor house of Khormayyeh Shargh export company (Photo by M. Hosseini).

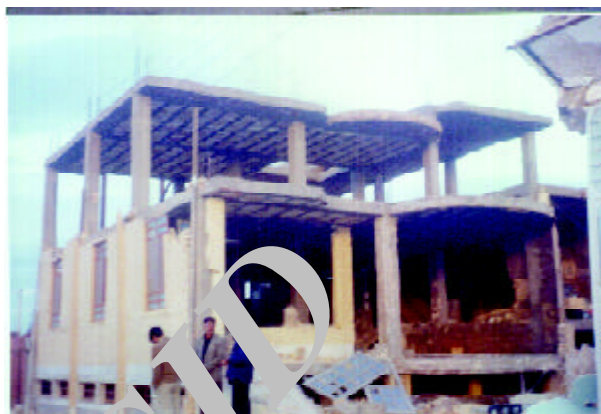
Other samples of the external walls failure are shown in Figures (4) and (5). The little integrity of these walls and their weak connections with the structures are believed to be the main causes of failure in these cases.

Figure 4. Collapse of external walls in an under construction R/C building, whose skeleton remained intact after the quake - Note to the fallen out window as well (Photo by M. Hosseini).

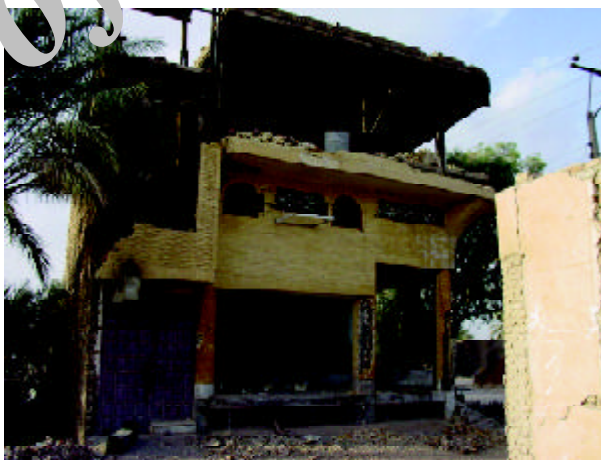
Figure 5. Collapse of the external wall masonry in the second and third stories of a 3 story steel structure building - the roof parapet has fallen as well (Photo by M. Hosseini).

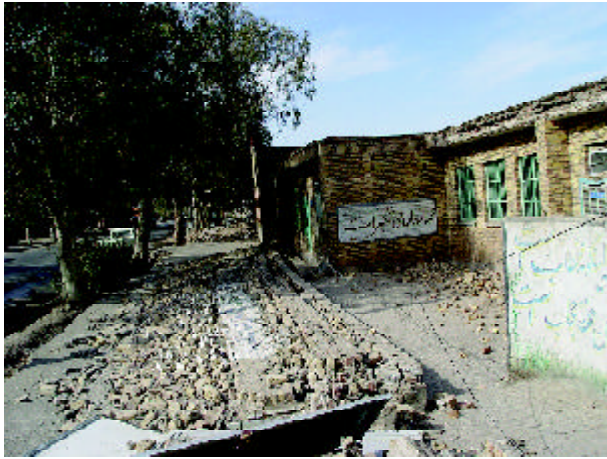
The main reason behind the collapse of these yard walls, as it can be seen in Figures 6 and 7, is in addition to their inherent weakness, the lack of, or the long distance between buttresses [loghaaz-haa].

Figure 6. Topped brick wall - Note to the fallen parapets as well (Photo by M. Hosseini).

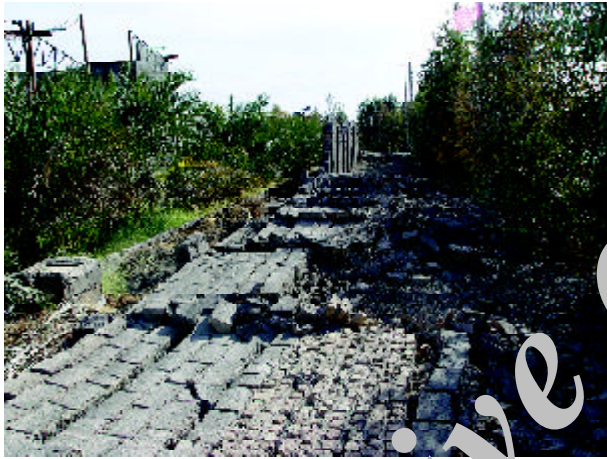
Figure 7. Topped concrete block (partially brick) wall (Photo by M. Hosseini).

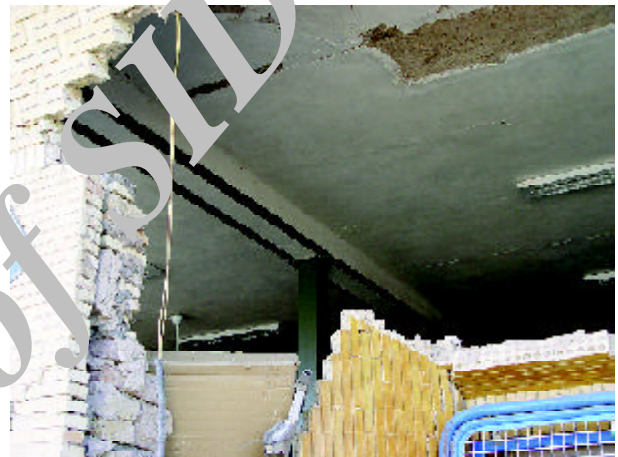
Figure 9. Severely damaged interior partition (Photo by M. Hosseini).

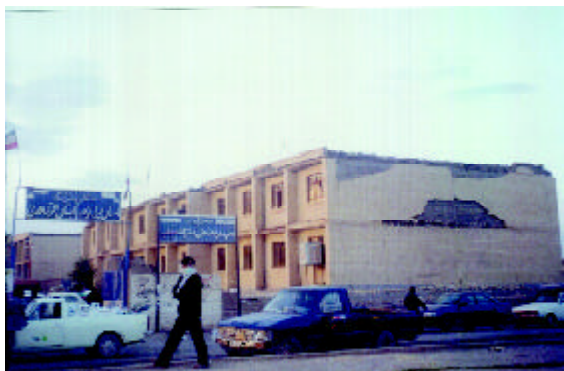
Figure 10. Damage to the so called 3cm brick facade in the second story of the Hijab girls' mid school (Photo by M. Hosseini)

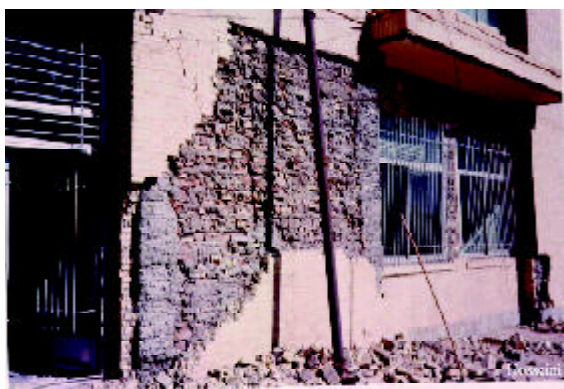
It is noticeable in Figures (11) and (12) that the window glasses have remained intact while the brick facades have gotten severely damaged. It is also notable that the parapet of the logistic building of (formerly) Azadi Hotel (presently Iran Parsian Hotel) has not fallen, which can be because of its little height. It should be noted as well that the Iran Parsian Hotel is located far from the causative fault of the earthquake comparing with the Hijab intermediate school or the city electric substation. However, this building suffered extensive nonstructural damages.

Figure 11. Damage to the so called 3-cm brick facade in the first story of the office building of the city electric substation (Photo by M. Hosseini).

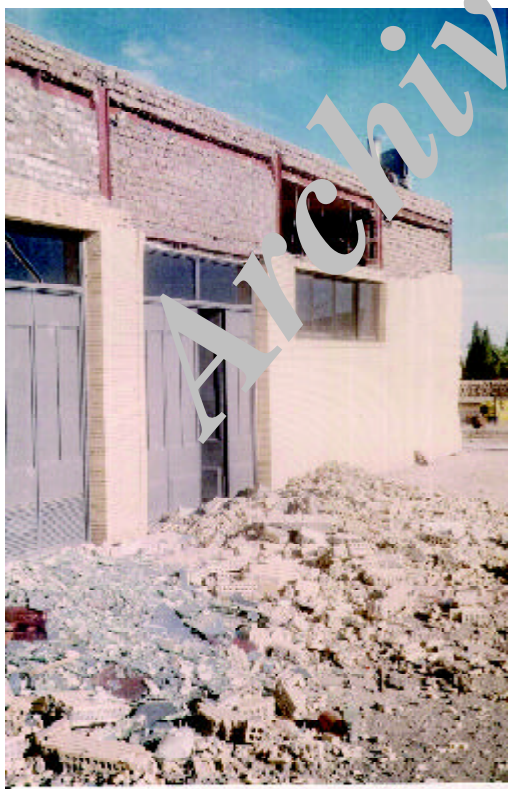
Figure 12. Damage to the brick facade in the top part of the walls in the logistic building of Azadi Hotel (Photo by M. Hosseini).

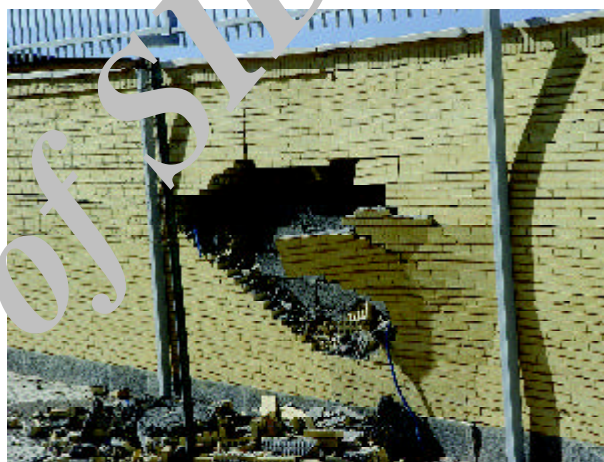
An interesting point, which is visible in Figure (13), is the lack of cohesion between the main wall masonry and the brick façade. The very clean surface of the concrete block masonry of the wall in this figure shows clearly this lack of cohesion. In the special case shown in this figure it seems the vertical box profiles of the top fence have prevented the façade from the complete collapse. Other interesting point is the detachment of the group of bricks with the used mortar behind them, which are stuck together and made a big piece of debris. It is obvious that falling of such a big piece from a high elevation can be very harmful to the subjected people. Nevertheless, this type of integrity between the bricks and the mortar can help their retrofit as described in section 5 of this paper.

Figure 13. Damage to the brick facade in a yard wall (Photo by Mahmood Hosseini).

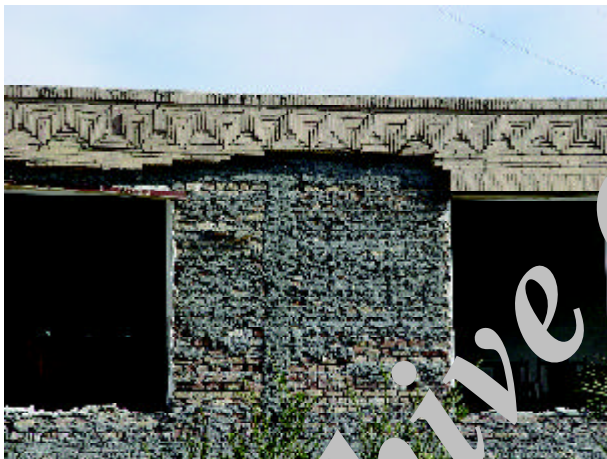
Figure 14. Failure of the brick facade on the external wall of a residential building - Note to the popped out windows as well (Photo by M. Hosseini).

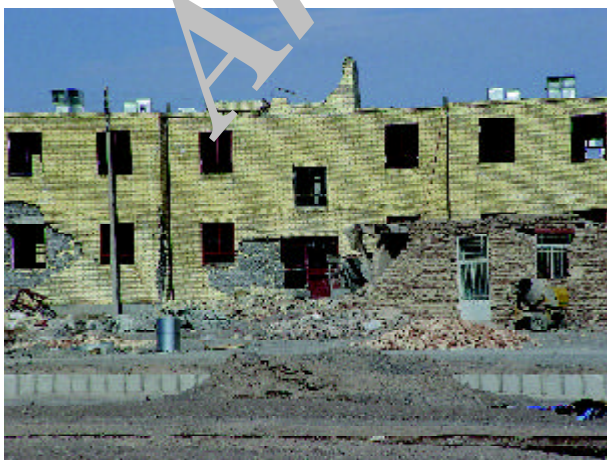
Figure 15. Damage to the brick facade in lower part of the two story residential buildings - Note to the collapsed penthouse as well (Photo by M. Hosseini).

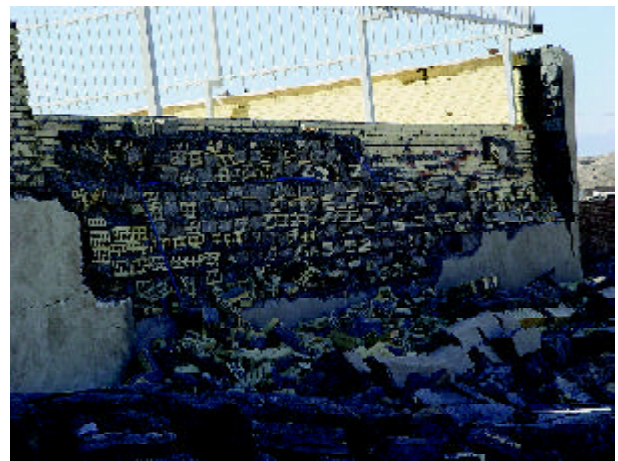
Figure 16. Damage to the plastered brick and block facade in a yard wall (Photo by M. Hosseini).

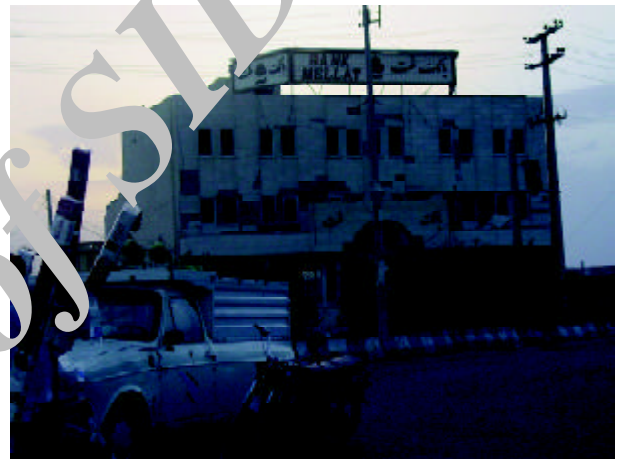
The sample of damaged stone façade is shown in Figure (17). The scattered locations of the detached tiles of the façade on the elevation of the building

Figure 17. Damage to the stone tiles facade in Bamk Mellat building (Photo by M. Hosseini).

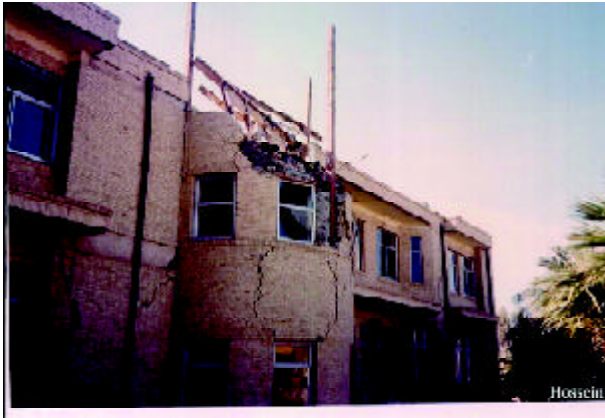
Figure 18. Severely damaged staircase roof in the office building of the city electric substation-Note to the broken glasses as well (Photo by M. Hosseini).

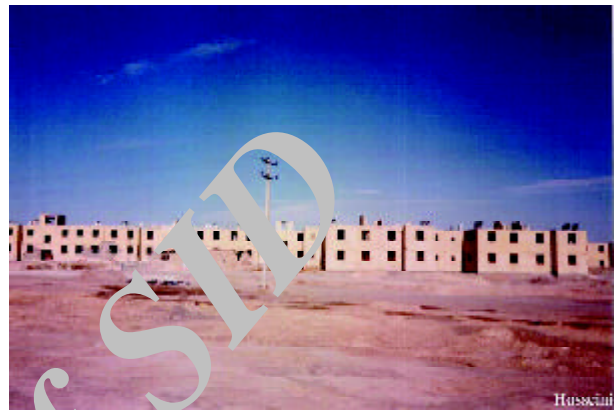
Figure 21. Severely damaged or totally collapse penthouses in the residential complex two story buildings (Photo by M. Hosseini).

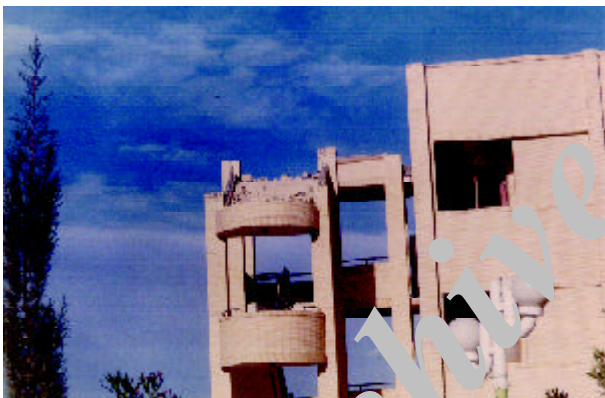
Figure 19. Damage to the staircase roof in the three story building of Azadi Hotel (Photo by M. Hosseini).

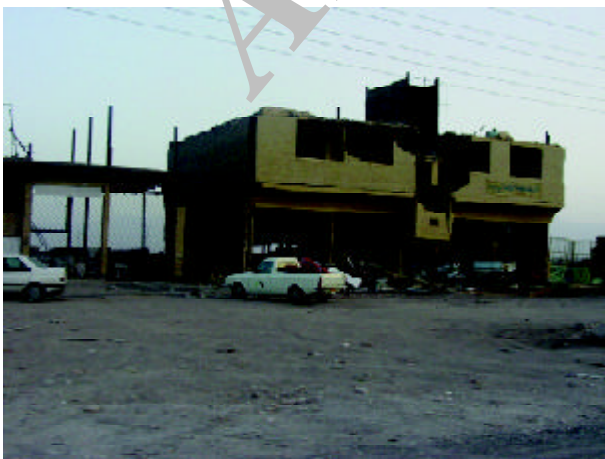
Figure 20. Severely damaged staircase in a commercial building (Photo by M. Hosseini).

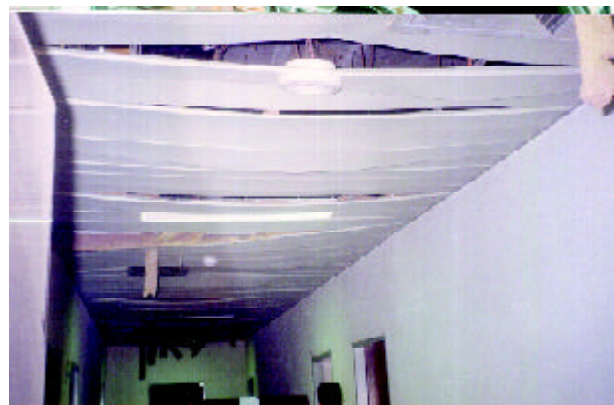
The most important building in which this kind of nonstructural damage was observed was the Bam Airport Terminal. It can be realized in Figures (22) and (23) that although the false ceiling parts seem not to be heavy, because of their high length, on the one hand, and the strong vertical component of the ground motion, on the other, they have suffered from a kind of buckling instability, resulted in their falling down.

Figure 22. The deformed parts of the false ceiling in the Bam Airport Terminal Building (Photo by Mahmood Hosseini).

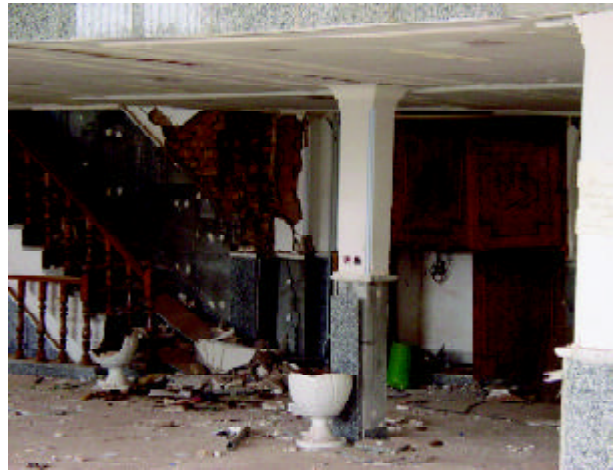
Figure 25. Severely damaged gypsum layer finishing of the interior wall of the Bank Refah Karegaran building (Photo by M. Hosseini).

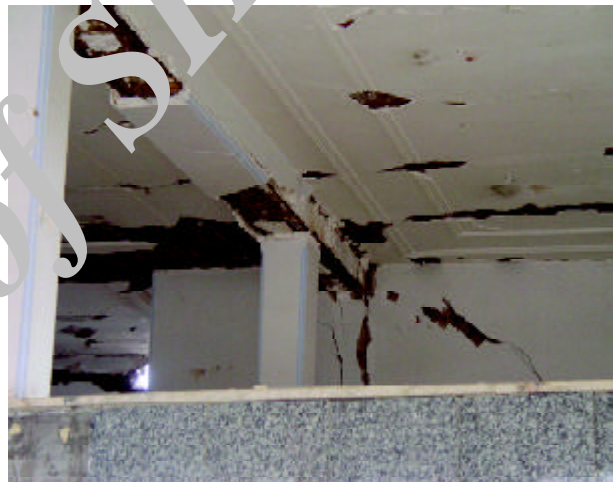
Figure 26. Severely damaged gypsum layer finishing of the ceiling of the Bank Refah Karegaran building (Photo by M. Hosseini).

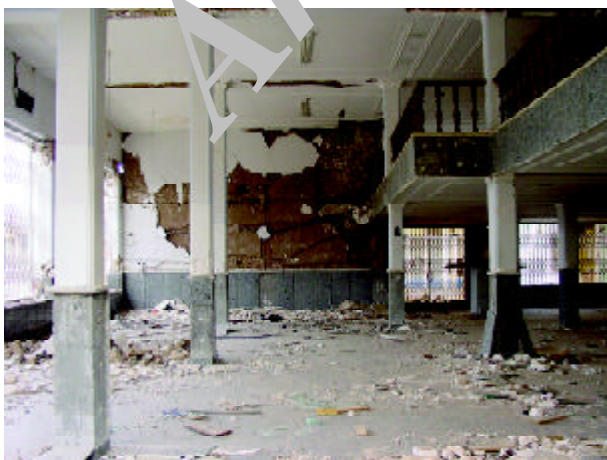
Figure 24. Severely damaged gypsum layer finishing of the interior wall of the Bank Refah Karegaran building (Photo by M. Hosseini).

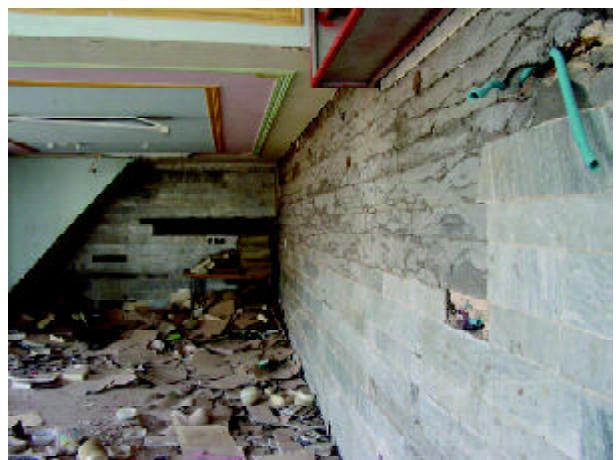
Figure 27. Severely damaged stone tile finishing of the interior wall of the Bank Refah Karegaran building (Photo by M. Hosseini).

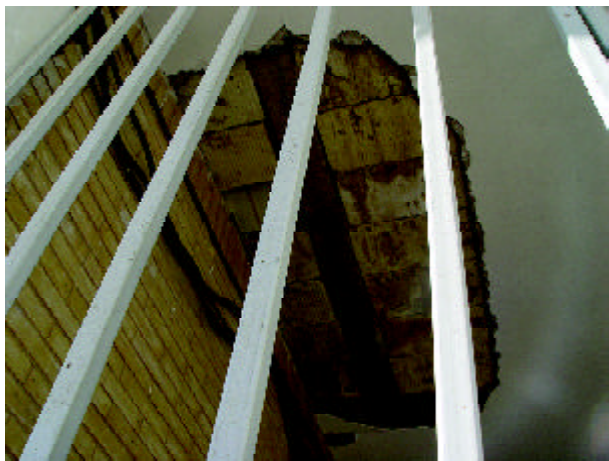
Figure 28. A big part of gypsum veneer of the ceiling has separated and fallen (Photo by M. Hosseini).

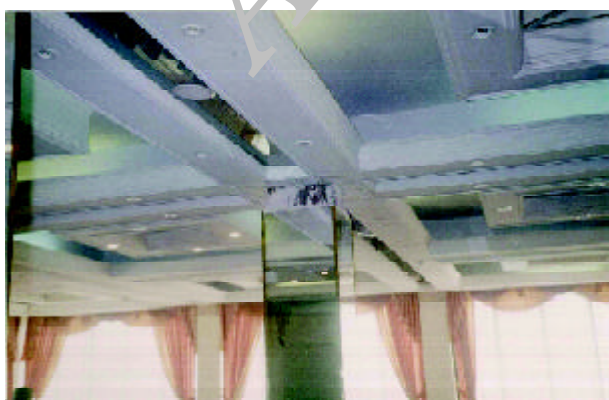
Figures (29) and (30) show the damages to the interior veneers in the Azadi (Iran Parsian) hotel. The veneers of the upper part of almost all of columns in the lobby were damaged as shown in Figure (29). There were also some damages to the ceramic tile veneers in the bathrooms of the hotel as shown in Figure (30). An interesting point is that just a small part of the column veneer as shown in Figure (29) was damaged, while the lower part which is covered

Figure 29. A sample of damages to the veneers of the columns tops in Azadi (Iran Parsian) hotel (Photo by M. Hosseini)

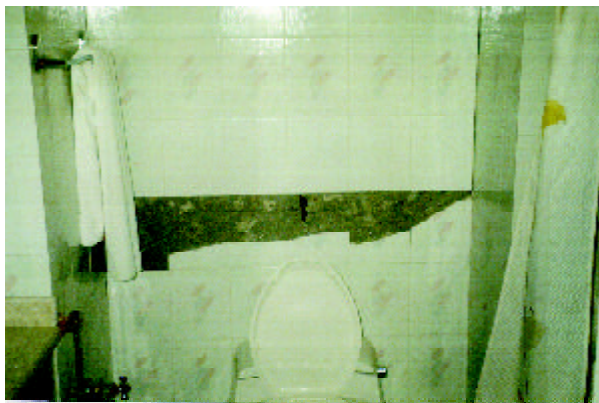
Figure 30. A sample damages to the ceramic tile interior veneers in the bath rooms of Azadi (Iran Parsian) hotel (Photo by M. Hosseini).

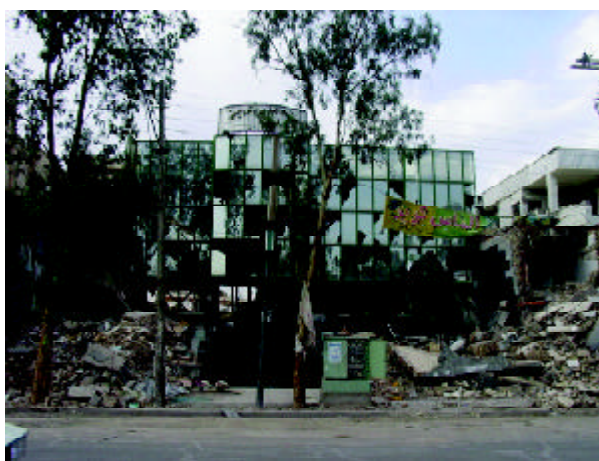
Figure 31. Damage to the glass facade of trade and tourism building (Photo by M. Hosseini).

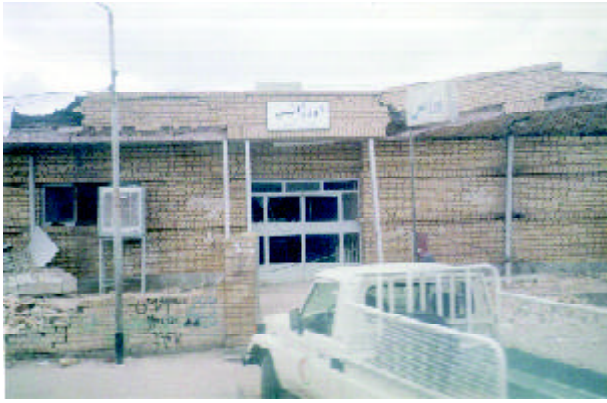
Figure 32. Damage to the glasses of widows in the Emergency Section of the city hospital (Photo by M. Hosseini).

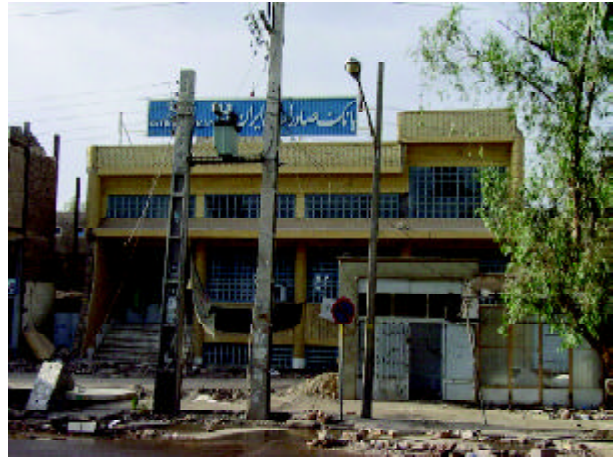
Figure 35. Damage to the glasses of widows in Bank Saderat Iran building (Iran Import Bank) (Photo by M. Hosseini).

Figure (34) shows the broken window glasses of a building, while no crack can be seen in the veneer of the walls. The same case is seen in Figures (35) and (36). This shows that the window glass is more vulnerable than the brittle facades. Nevertheless, in

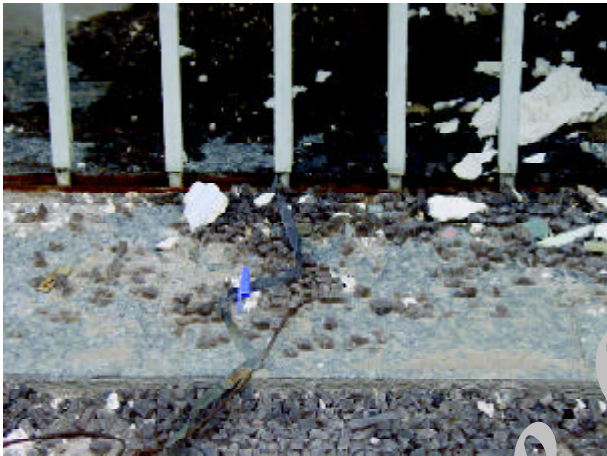
Figure 33. Splashed Parts of the broken thick glass of Bank Refah Karekaran building (Photo by M. Hosseini).

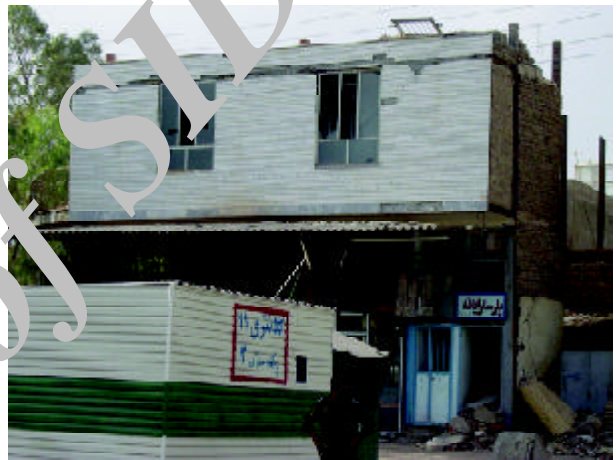
Figure 36. Damage to the glasses of widows in the second story of a residential building - Note to that horizontal damage line in the façade at the level of roof (Photo by M. Hosseini).

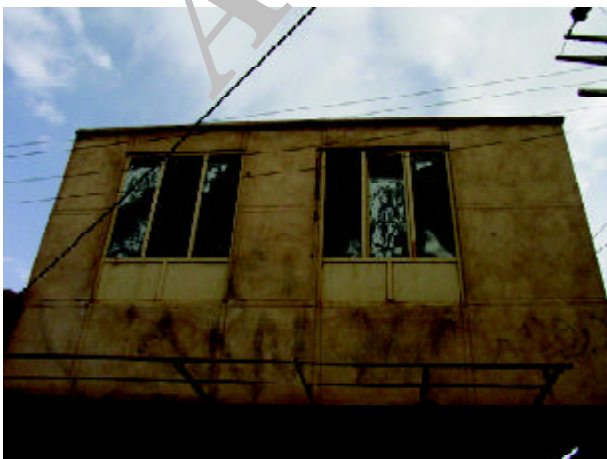
Figure 34. Damage to the glasses of widows in the second story of a residential building (Photo by M. Hosseini).

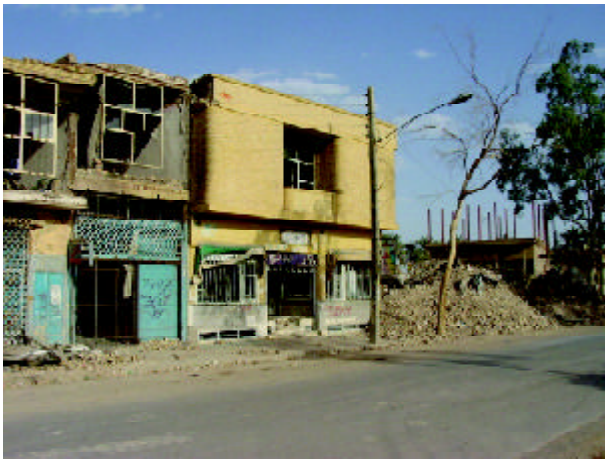
Figure 37. Damage to the glasses of widows in the second story of a residential building (Photo by M. Hosseini).

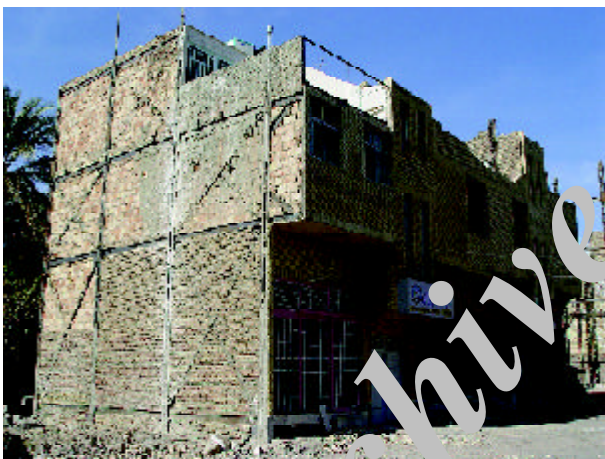
Figure 38. Collapse of parapets in the Iran Insurance Company building (Photo by M. Hosseini).

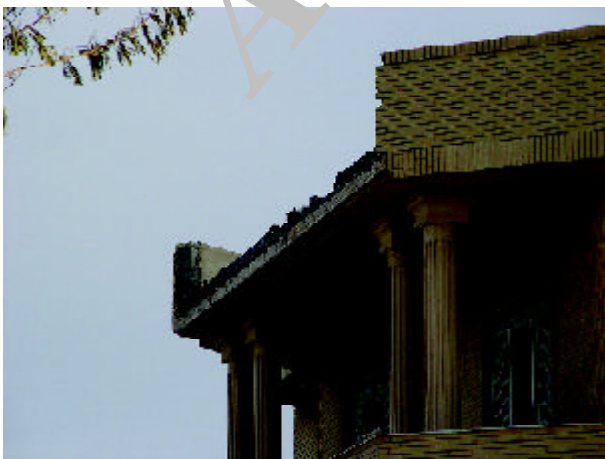
Figure 39. Partial collapse of parapets in a two story building (Photo by M. Hosseini).

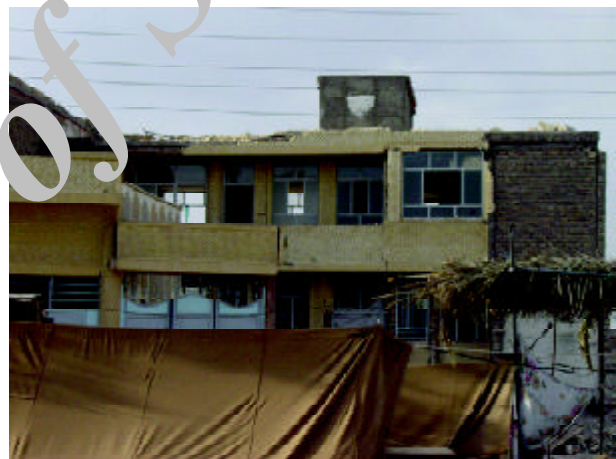
Figure 40. Complete collapse of parapets in a two story building (Photo by M. Hosseini).

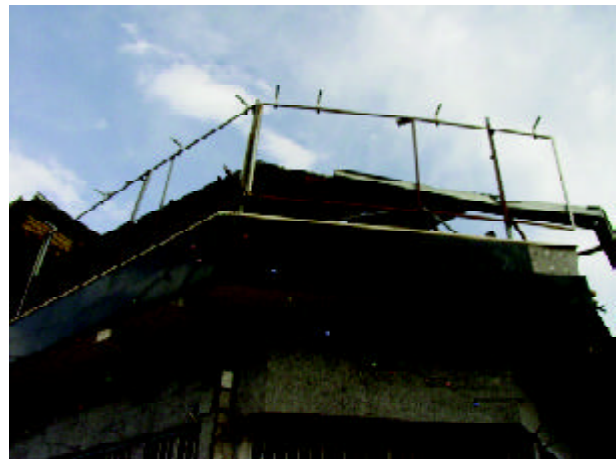
Figure (41) shows the collapsed tablets and bill board of a commercial building. Regarding the relatively low weight of the bill boards it can be claimed that the connection between the boards and their frames have not been strong enough to resist the earthquake shock. A part of the stone façade of the parapet has also failed, which is basically because of the failure of the whole parapet from that point to right (not completely shown in the picture). This again confirms the directivity effect of the earthquake.

Figure 41. Collapse of tablets and bill boards in a commercial building (Photo by M. Hosseini).

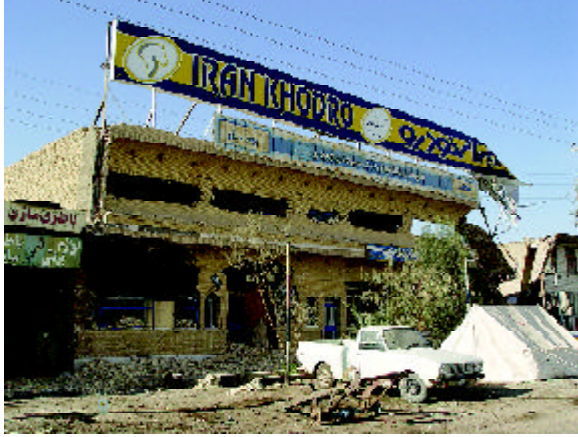
An almost newly observed phenomenon in this earthquake was the popping out of the windows and some door frames. Some samples of these cases are shown in Figures (42) to (44). This phenomenon can

Figure 42. The windows in Iran Khodro building popped out of walls (Photo by Mahmood Hosseini).

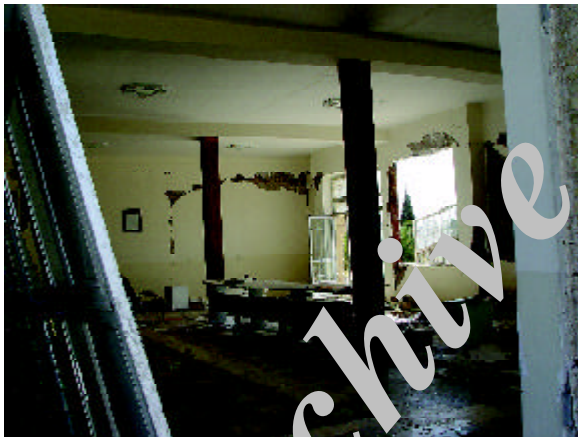
Figure 43. A popped out window in the electric substation office building (Photo by M. Hosseini).

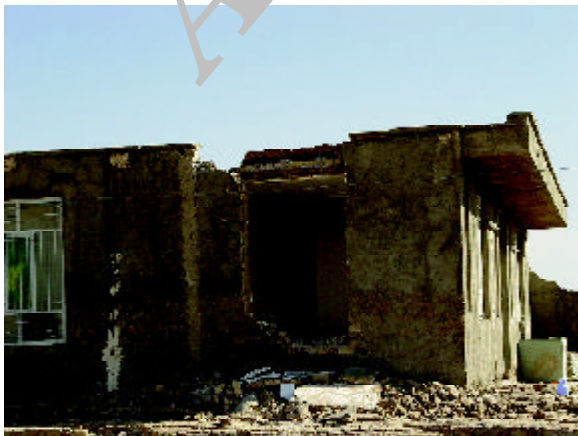
Figure 44. A popped out window in a one story residential building (Photo by M. Hosseini).

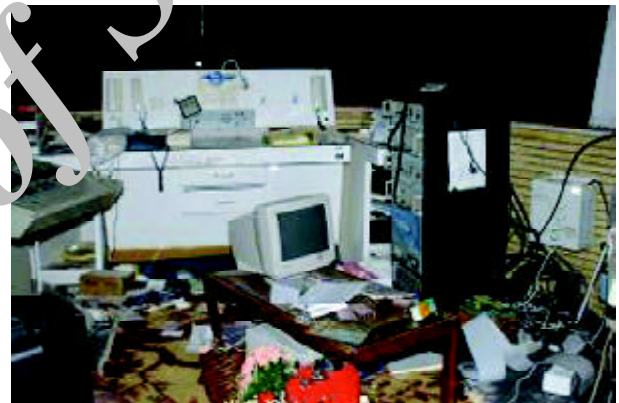
The cases of damage to mechanical and electrical facilities of building were not observed so much in this earthquake. Nevertheless, the observed cases had very adverse consequences. For example, the failure of these facilities in the Bam Airport Terminal and particularly its control tower resulted in the interruption of the airport operation for several hours. It could be understood from Figure (45) that some of electrical

Figure 45. The failure of mechanical and electrical facilities and interior equipment of the Bam airport control tower (Photo Source: http://www.irna.ir/melli/bam/photo_index6.htm)

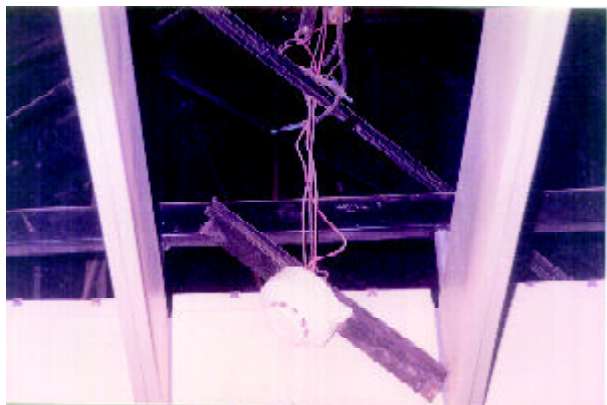
Figure 46. The failed smoke detector of the Bam airport (Photo by M. Hosseini).

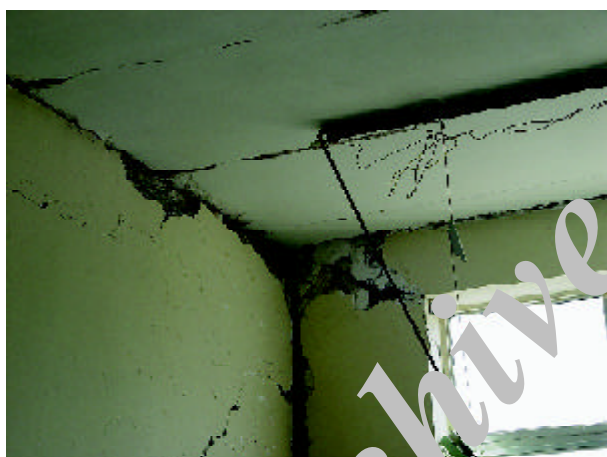
Figure 47. The failed light fixtures in the office building of the city electric power substation (Photo by M. Hosseini).

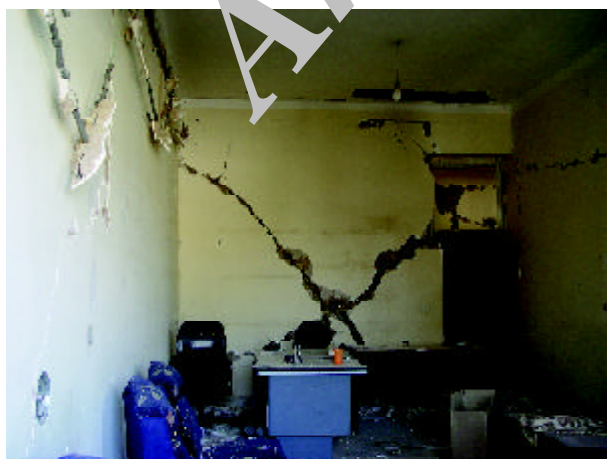
this kind of failure seems to be the potential weak lines in the finishing due to the presence of the wire protection tubes, which are in fact some mainly hollow spaces. The partial failure of the ceiling in Figure (48) is also notable. This has been in fact an

Figure 48. The pulled out protective tubes of electric wires in the office building of the city electric power substation (Photo by M. Hosseini).

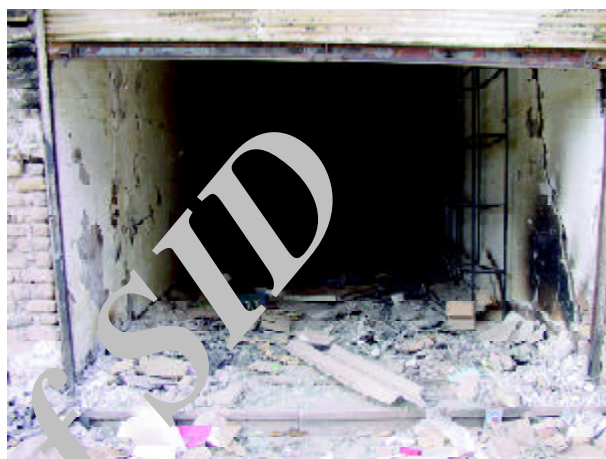
As in many of the past earthquake this event had also some cases of post earthquake fires, which were mainly due to the damage to the electrical facilities. Figure (49) shows a partially burnt shop, which caught fire because the failure of its electrical facilities. The fire caused of the deformation of the broken glass pieces as shown in Figure (50).

Figure 49. A partially burnt shop which got in fire because the failure of its electrical facilities (Photo by M. Hosseini).

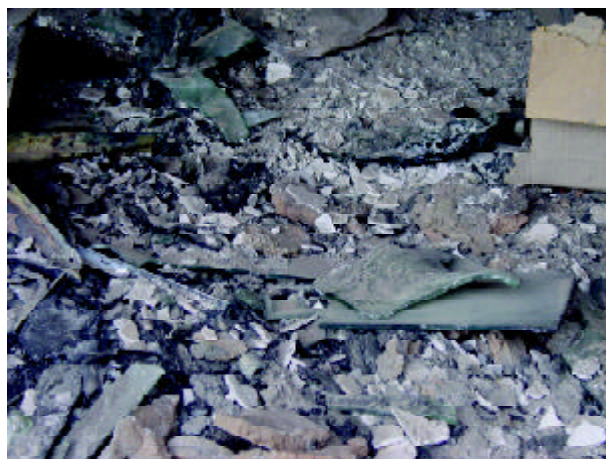
Figure 50. The deformed pieces of glass due to the fire occurred in the shop shown in Figure (49) (Photo by M. Hosseini)

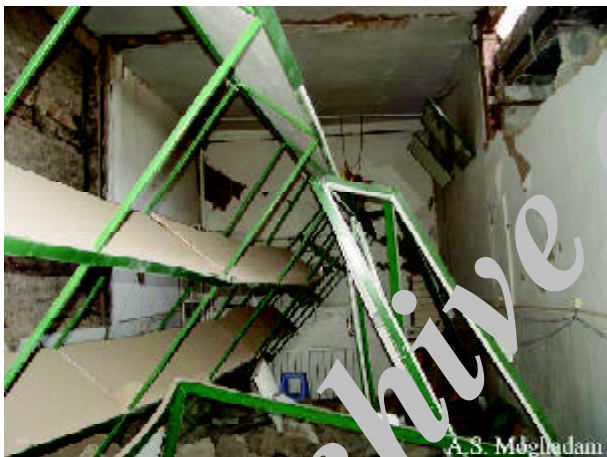
Figure 52. The toppled shelves of a shop board due to their weak connection (Photo by A.S. Moghadam).

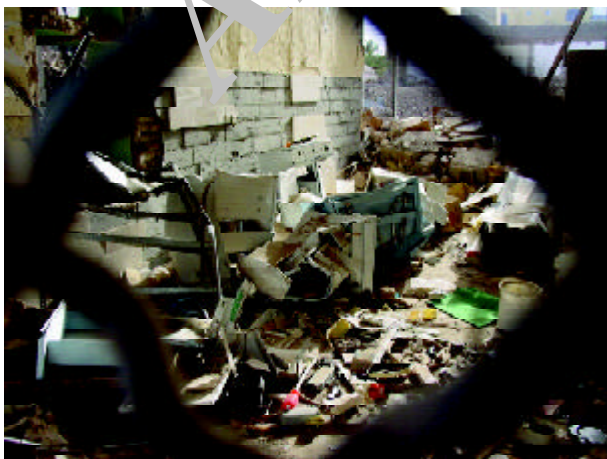
Figure 53. The entirely messed interior equipments of a shop (Photo by M. Hosseini)
