The Behavior of Special Structures During the Bam Earthquake of 26 December 2003

Sassan Eshghi and Mehran Seyed Razzaghi

Structural Engineering Research Center, International Institute of Earthquake Engineering and Seismology (IIEES), Tehran, Iran, email: s.eshghi@iiees.ac.ir

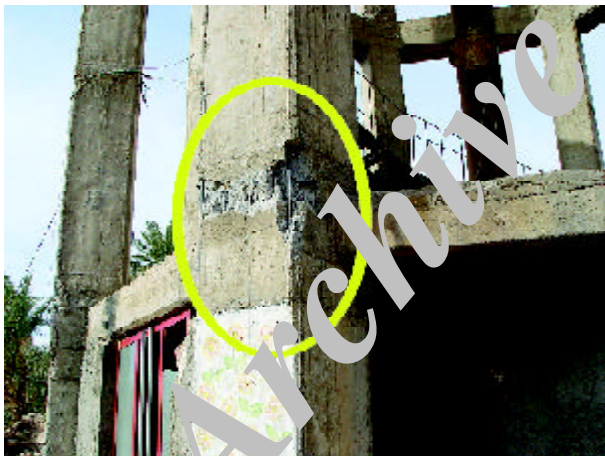
Inaccurate detailing was the major reason for the tank damage. As shown in Figure (4), the concrete column cracked near the beam-to-column connection and the longitudinal reinforcing bars buckled at that position. The main reason for this type of damage was the lack of transverse bars on the critical length of the column near the beam-to-column connection, which has a high potential for plastic hinge formation. Although according to the Iranian concrete code (SBC) [5], the maximum allowable spacing between stirrups is 250mm, the spacing between transverse stirrups in the tower RC columns was much greater. Another failure mode of the tower was damage to beams adjacent to the column joint, in which the crack penetrated to the column, see Figure (5).

Figure 4. Inaccurately detailed cracked RC column [1].

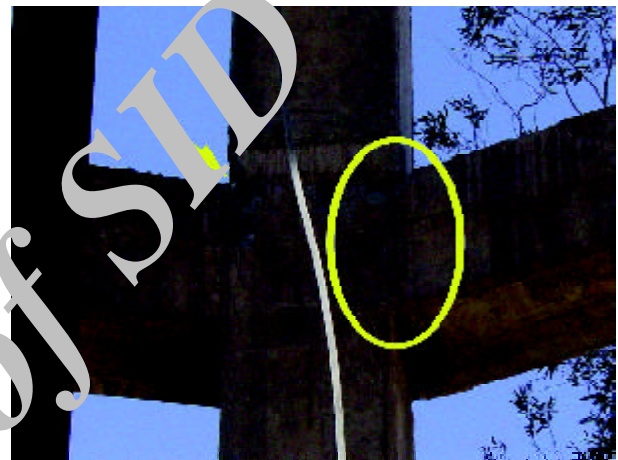
Figure 5. Damage to beam next to column joint.

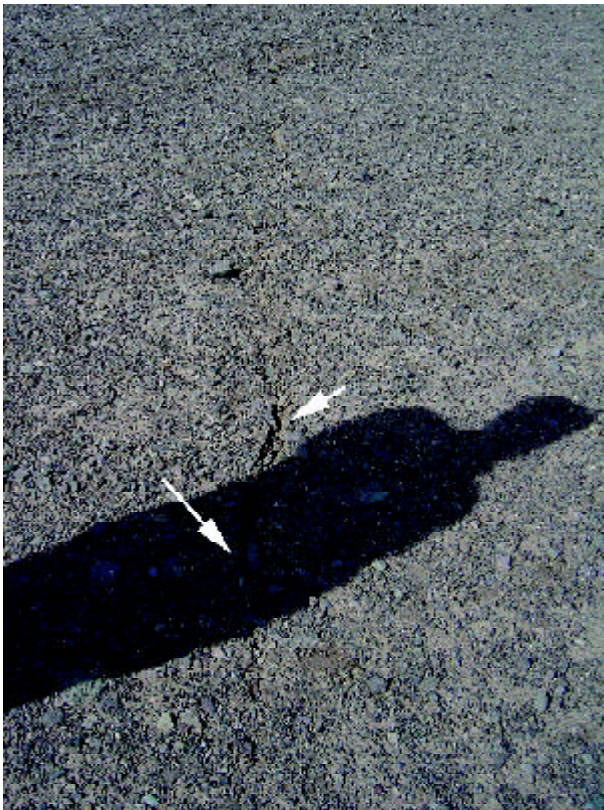
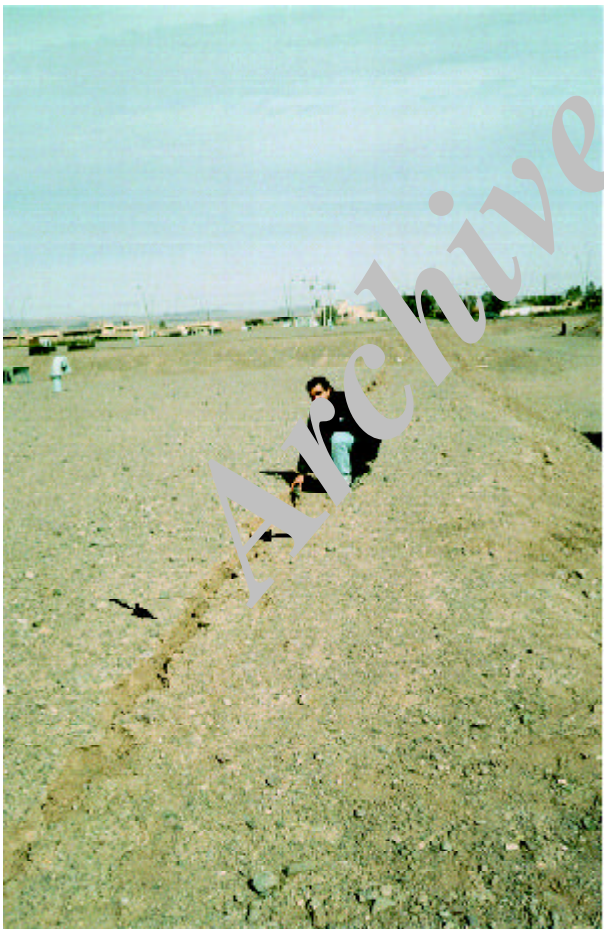
damage. Soil settlement of about 10cm took place in the earth fill of each tank and tensile cracks were observed at the top of the earth fill, see Figure (6). None of the buildings in the plant suffered serious damage and the plant was operable after the earthquake.

Figure 6. Settlement and tensile cracks observed in tank earth fill.

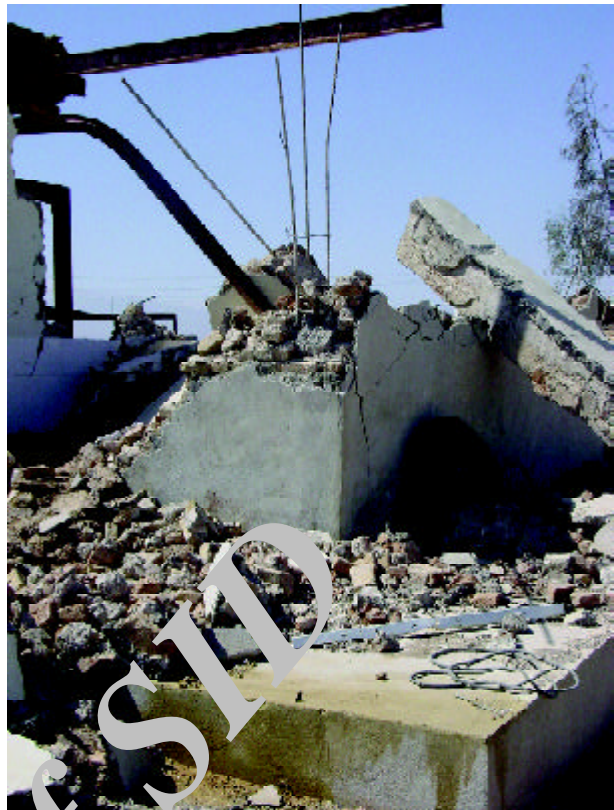
Figure 7. Collapse of chlorination building.

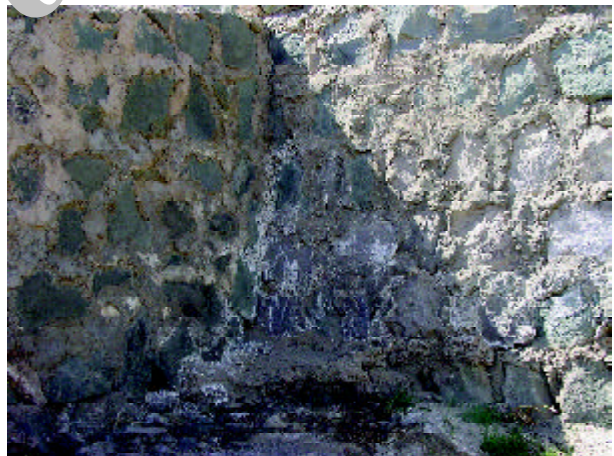
The Baravat water treatment plant is constructed over the Bam fault. There were two underground water tanks at this plant. Both tanks are stone masonry. Before the seismic event, both tanks worked at full capacity, but the plant suffered major damage to tanks and annex structures during the earthquake and was forced to shut down. All of the annex buildings, including the chlorination building, collapsed completely, see Figure (7). These structures were un-reinforced brick masonry buildings. Leakage from the tank wall and bottom occurred after the earthquake and cracks were also found at construction joints on the masonry retaining walls surrounding the tank, see Figures (8) and (9).

Figure 8. Leakage of water from tank wall.

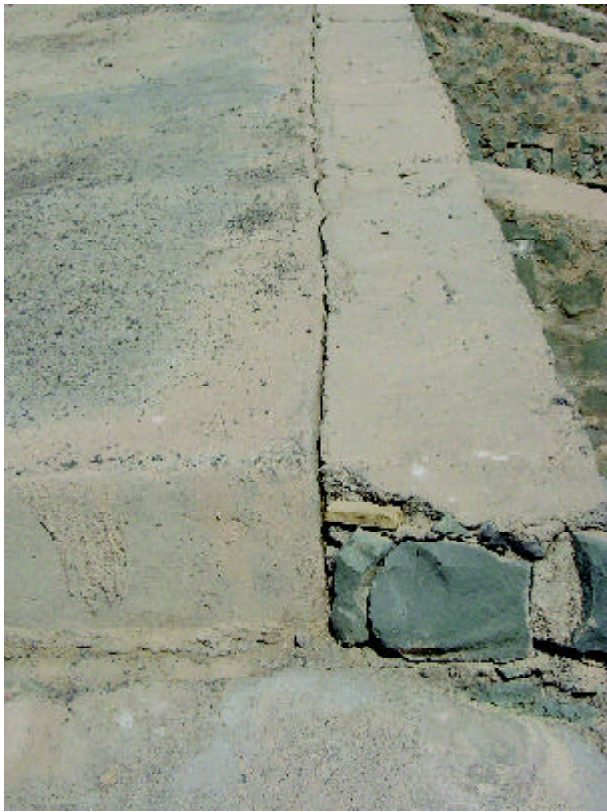
Figure 9. Cracks observed at construction joints of surrounding wall

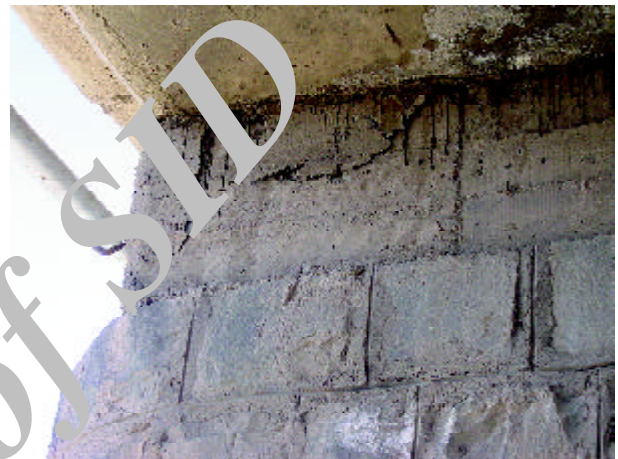
In general, bridges sustained little or no damage. The most affected bridge, Espikan Bridge north of Bam near Arg-e Bam, sustained little damage. Espikan Bridge is a uniform bridge with an RC deck and stone masonry columns and 14 spans across the Poshtrood River, see Figure (10). As shown in Figure (11), the RC bent caps of the bridge cracked with the longitudinal movement of the deck in the north-south direction. No visible damage occurred to

Figure 11. Damage to RC bent caps from deck movement.

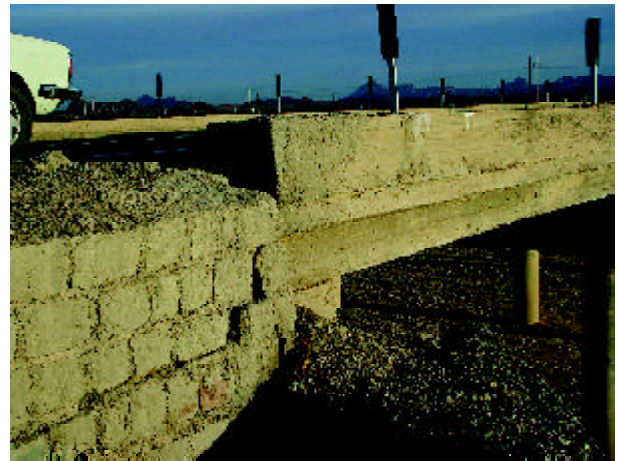
The Darzin Bridge also experienced longitudinal movement of the superstructure and the stone abutment cracked as a result of settlement of the abutment, see Figure (12). However, the bridge was still safe for use after the earthquake. No structural damage occurred to other observed bridges in the affected region.

Figure 12. Settlement of Darzin bridge abutment.

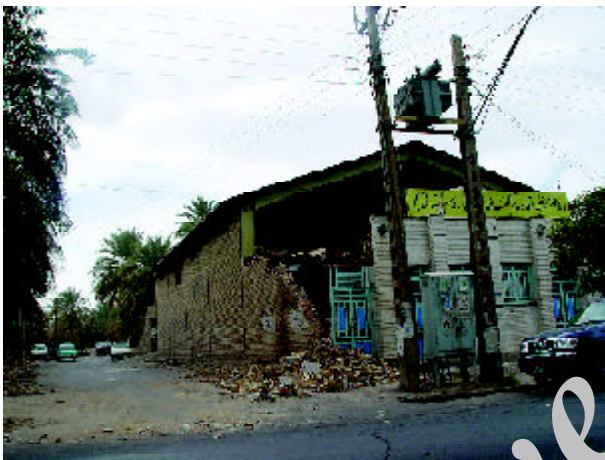
As shown in Figure (13), failure of annex buildings was a typical damage mode for industrial structures with annex buildings. Annex buildings are generally brick masonry low-rise buildings constructed with adjacent gable frames without joints. Failure of annex buildings was, in most cases, caused by torsion due to asymmetric distribution of resistant walls or pounding of an adjacent industrial structure.

Figure 13. Damage to annex building of an industrial plant [1].

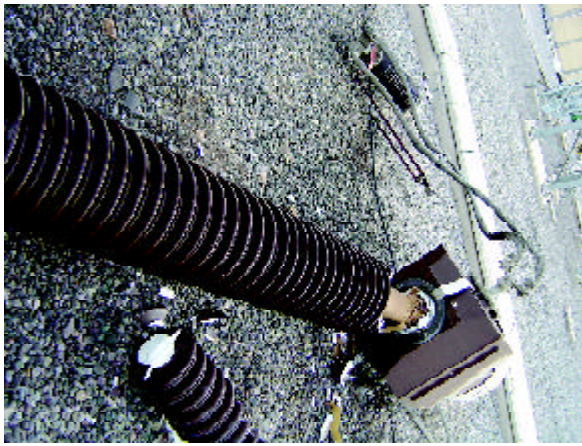
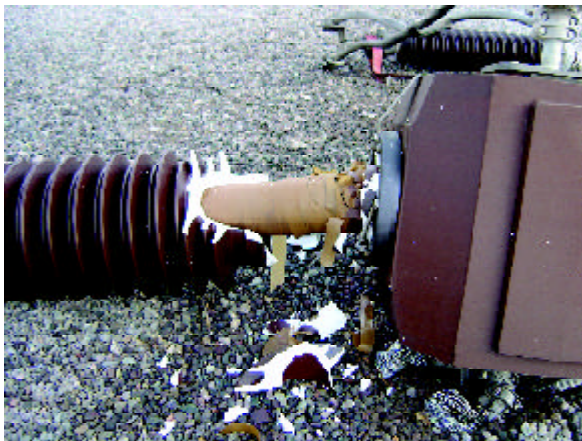
As mentioned before, the electrical substation was one of the critical facilities of the affected area. It is composed of two sections for 230kV and 132kV. The equipment in this station sustained heavy damage. In general the extent of damage in the 230kV section was greater than the 132kV section. More than 13 bushings in the 132kV section cracked and collapsed, see Figure (16). Both 132kV and 230kV transformers moved due to the sliding response of equipment. One 230kV transformer moved about 40cm from its original position. The movement of transformers caused the base rails to sustain plastic deformation. Figure (17) indicates the sliding response of the 230kV transformer to ground shaking.

Figure 16. Damage to bushings at Bam station on.

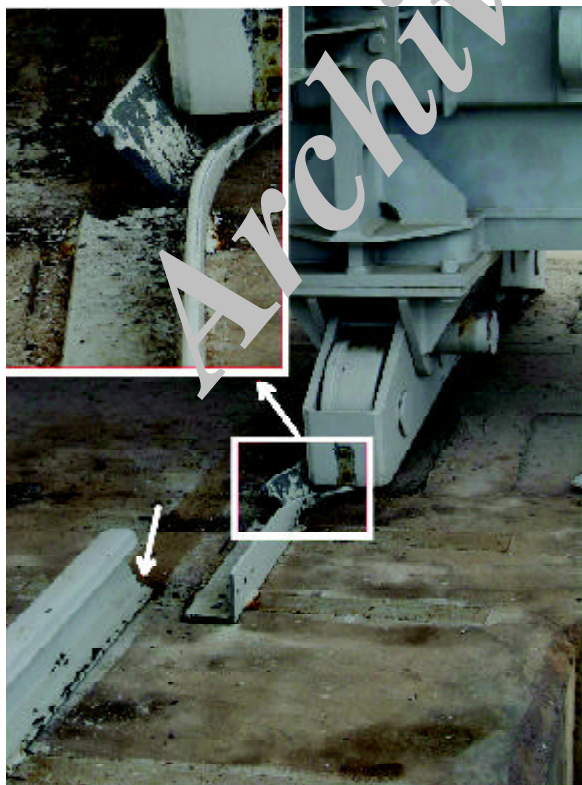
Figure 17. Displaced 230kV transformer [1].

As indicated in Figure (29), the peak ground acceleration required for the overturning of a transformer of $\alpha = 25^\circ$ is $0.61g$, which is less than the *PGA* of the Bam earthquake in the fault-normal direction. It seems that the existence of base rails and connections to the transformers was the main reason for the stability of the transformers in the Bam station.

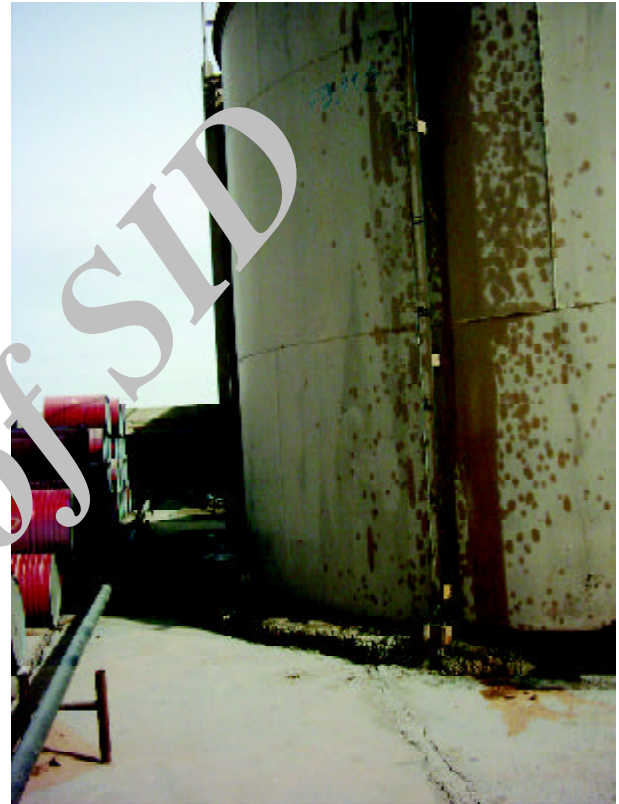
Three out of six on-grade steel oil tanks at Roghan Jonub Company (see part 3) experienced leakage of liquid from roof-to-wall junctions from sloshing during the quake. Other damage modes such as elephant foot buckling, rupture of rigid piping, and tank were not observed in these tanks. Figure (18) shows the leakage of oil from on-grade tanks.

Figure 18. Leakage of oil from tank due to sloshing [1].

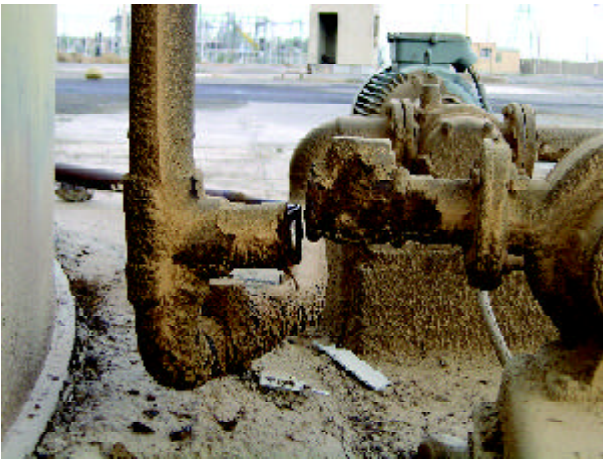
A cylindrical on-grade gasoline tank next to Bam electrical power station, which was nearly empty, suffered heavy damage. Rigid piping connected to the tank ruptured, probably from the inaccurate erection of the pipes, see Figure (19). The tank foundation was damaged due to tank uplift, but shell buckling did not occur, see Figure (20).

Figure 19. Rupture of pipe connections.

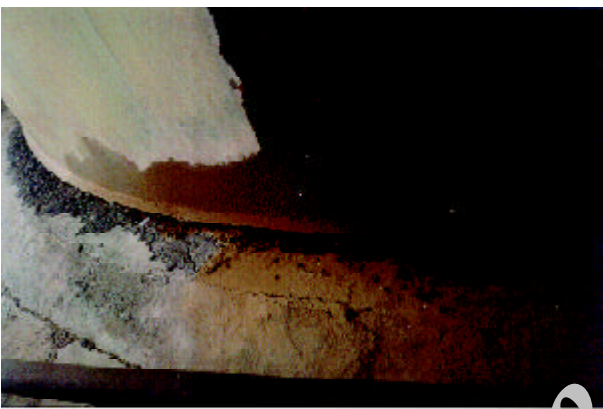
Figure 20. Damage to tank foundation due to tank uplift.

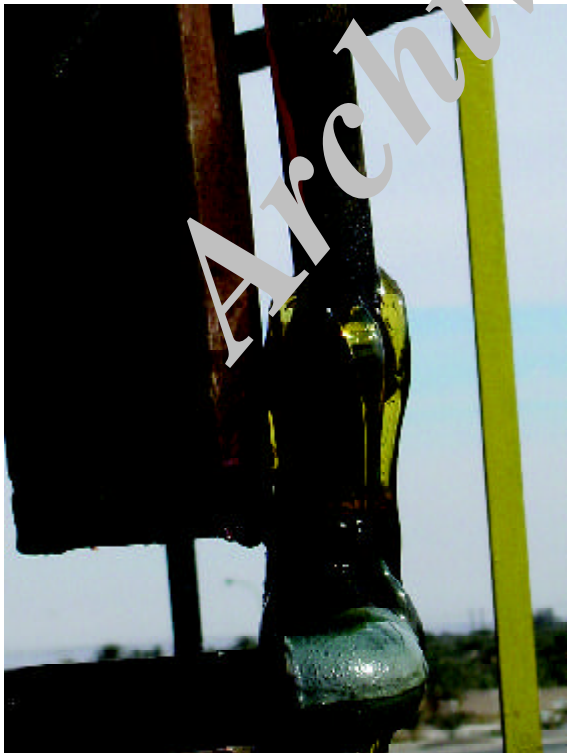
Elevated oil tanks at the Roghan Jonub plant were severely damaged and failed to contain the oil because of the failure of piping connections, see Figure (21). Also, as shown in Figure (22), a tank tower column punched the tank shell.

Figure 21. Leakage of oil due to rupture of pipes [1].

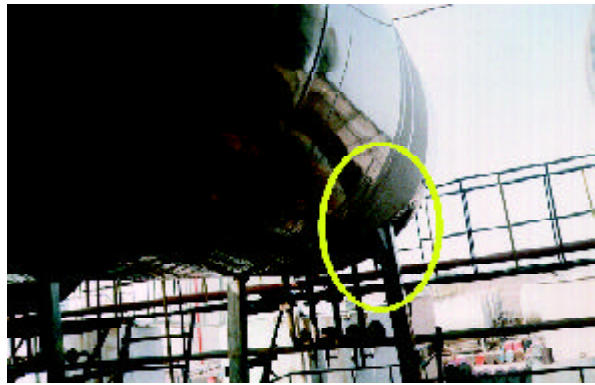
Figure 22. Punching of tank shell [1].

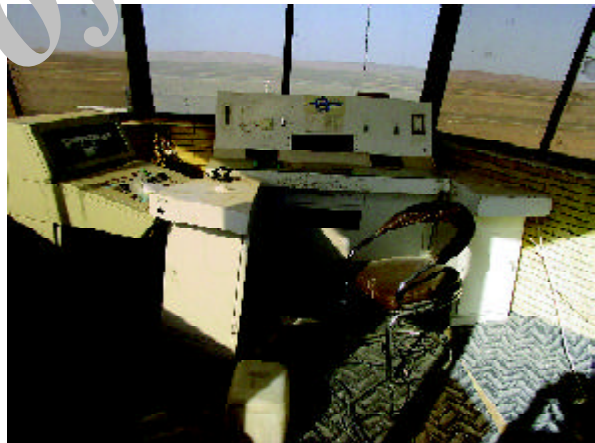
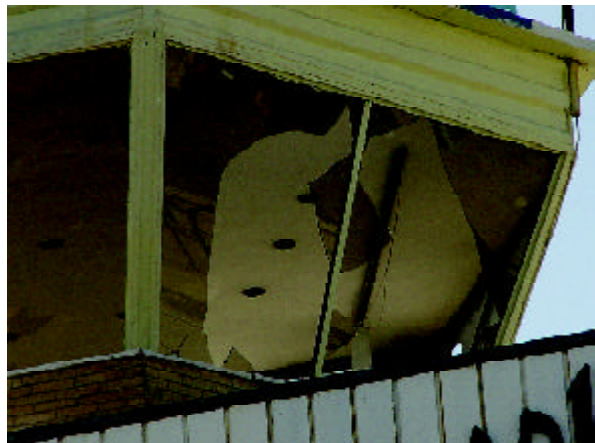
Bam Airport is located north of Bam between Baravat and Arg-e-Jadid. The control tower of the airport was closed because of heavy non-structural damage, see Figure (23). Since no structural member suffered serious damage, the airport brought back to full operation with the use of a portable control unit. No structural components also suffered heavy

Figure 23. Damage to airport control tower.

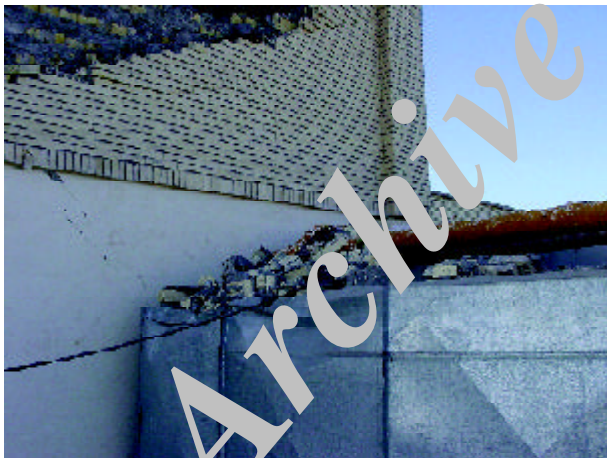
Most masonry infill walls at the airport cracked, Figure (24). Some false ceiling panels concealing power cables and such fell. No structural damage occurred due to the pounding of adjacent blocks, but finishing surfaces cracked or fell off at construction joints. The facade bricks of the terminal building fell off and damaged equipment and air conditioners, see Figure (25).

Figure 25. Damage to air conditioners.

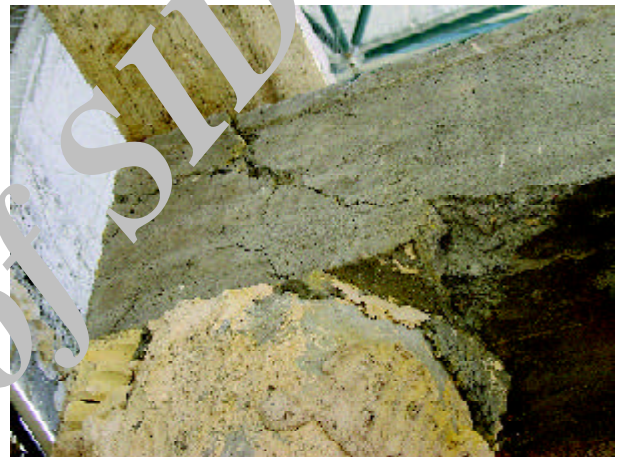
The Bam train station is under construction at a site south of Bam city. The structural system of the main terminal is a moment resisting RC frame with light-weight space trusses for the ceiling. Infill walls in the main building were cracked and facades were damaged from the strong ground motion, see Figure (26). Figure (27) shows shear cracks that occurred at some beam-to-column connections in the one-story RC frames.

Figure 27. Shear cracks observed on beam-to-column joints at train station.
