# Repair of Earthquake-Damaged Square R/C Columns with Glass Fiber-Reinforced Polymer

Sassan Eshghi<sup>1</sup>, Vahid Zanjanizadeh<sup>2</sup>

**Abstract:** This paper presents an experimental study on seismic repair of damaged square reinforced concrete columns with poor lap splices, 90-degree hooks and widely spaced transverse bars in plastic hinge regions according to ACI detailing (pre.1971) and (318-02) using GFRP wraps. Three specimens were tested in "as built" condition and retested after they were repaired by glass fiber-reinforced plastic sheets. They were tested under numerous reversed lateral cyclic loading with a constant axial load ratio. FRP composite wraps were used for repairing of concrete columns in critically stressed areas near the column footings. Physical and mechanical properties of composite wraps are described. Seismic performance and ductility of the repaired columns in terms of the hysteretic response are evaluated and compared with those of the original columns. The results indicated that GFRP wraps can be an effective repair measure for poorly confined R/C columns due to short splice length and widely spaced ties with 90-degree anchorage hooks. Both

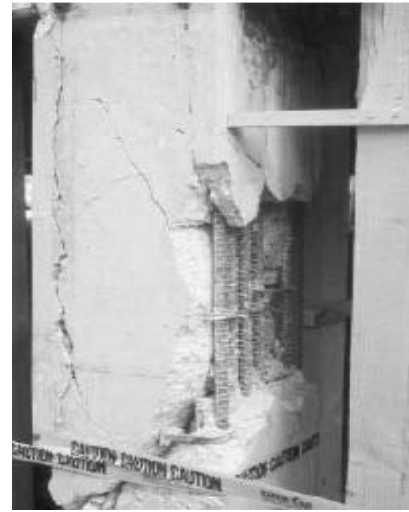
The most common types of non-ductile details are short splice length and wide ties with 90° hooks. These details had led to considerable damages in recent earthquakes. Fig.1 and Fig.2 show two-column damage in Izmit and Northridge earthquakes due to such detailing.

**Fig.2** Failure of lap splice due to insufficient splice length and widely spaced ties with 90° hooks (Northridge-1994)

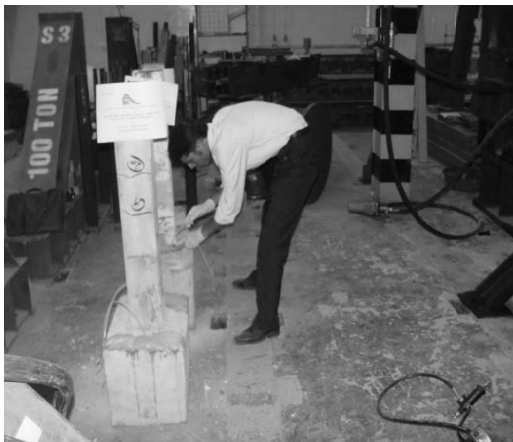
Fig.8 Cleanig surface of the damaged columns

All three specimens in as-built condition were tested and then were repaired by first replacing the loosened concrete with quickset cement then were cleaned with a high pressure gun and completely dried before the vinyl ester was applied to their surfaces (Fig.8). Special measures were taken to ensure that there were no voids between the

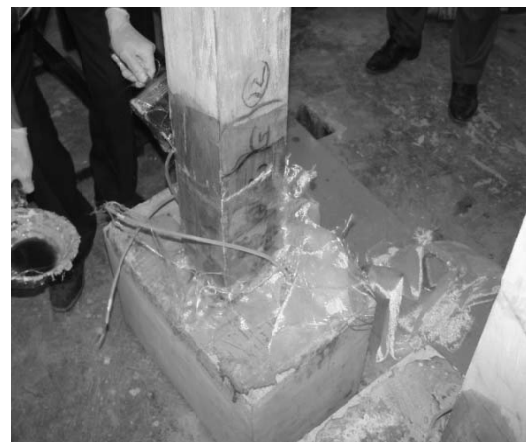
Fig.9 Installation of prefabricated composit sheets

The wrapping of the columns continued to the upper region of the column (Fig.9). All the repaired specimens were cured at least for 7 days to ensure that full strength had obtained before testing.

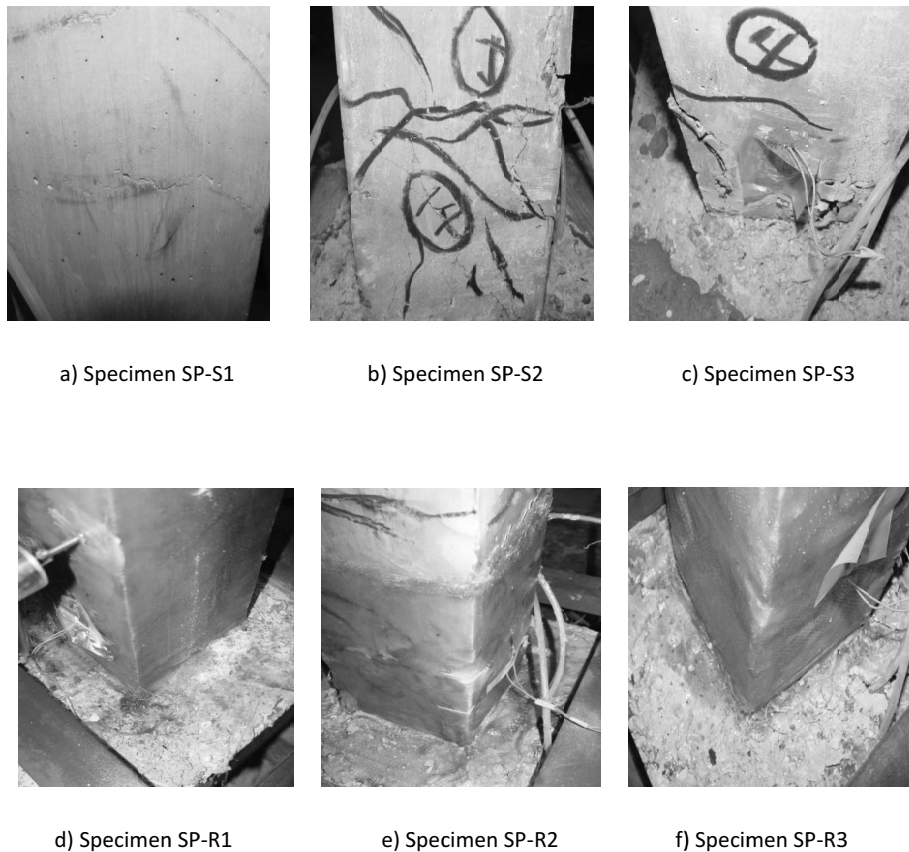
**Fig.12** Specimens at end of testing

splice length. Some flexural cracks appeared along the splice length during the test but the length and width of these cracks did not increase significantly (Fig.12a).

In specimen SP-S2 flexural cracks on the column face started as early as at 1% lateral drift ratio. At this time longitudinal cracks were formed at right and left sides of the specimen. During the second cycle at 3.5% drift as fairly large sections of the concrete cover spalled at the column footing interface. The lateral load strength diminished, indicating that bond along the spliced bars was deteriorating. Shear cracking was observed at 2.5% drift but these cracks were not significant throughout the test. Damage in this specimen was severer than that in the

previous one (Fig.12b).

Specimen Sp-S3 was subjected to a  $(0.15 A_g f'_c)$  constant axial load and initial flexural longitudinal cracks suddenly appeared at 1.5% drift ratio. In this test, cracking formed later but cracking propagation developed suddenly as the load applied. In this specimen the cover spalled completely at the corner at 4.5% drift ratio and the longitudinal bars were clearly visible. Along the splice length, there was severe damage. Shear cracks were observed at 3.5% drift ratio on the right and left faces of the columns and concrete crushing and spalling were observed just before the end of the test. In this specimen damage was generally severer than SP-S1 and SP-S2 (Fig.12c).

Stiffness of the repaired specimens had been deteriorated under large reversed cyclic loading. Large amount of the damages were concentrated in FRP sheets and some small sheet rupture was observed in high drift ratio. Damage in the concrete of repaired columns was slight. Vertical and horizontal flexural cracking, that occurred above the FRP jacket in past testing, opened and closed during retesting. Nevertheless, in the SP-R1, damage was very low and very little stress concentration was occurred in FRP sheets. Some new cracks were observed in all repaired specimens but they were not significant. At the end of the test, cracks in all specimens propagated along the columns but in SP-R3 the sustained damage was more serious than two others. Cracks in SP-R1 were little and narrow. During the test, cracks at the column footing interface of SP-R3 were very serious and some spalling and crushing were appeared. So it indicated that high axial load led to more serious damage in the specimens. SP-R1 behaved better and no delaminating or rupture across the fibers of the jackets was observed in this specimen

(Fig.12d, 12e, 12f).
