PERFORMANCE OF TRADITIONAL ARCHES, VAULTS AND DOMES IN THE 2003 BAM EARTHQUAKE

T. Mahdi^{*}

Department of Structual Engineering, Building and Housing Resarch Center, Tehran, Iran

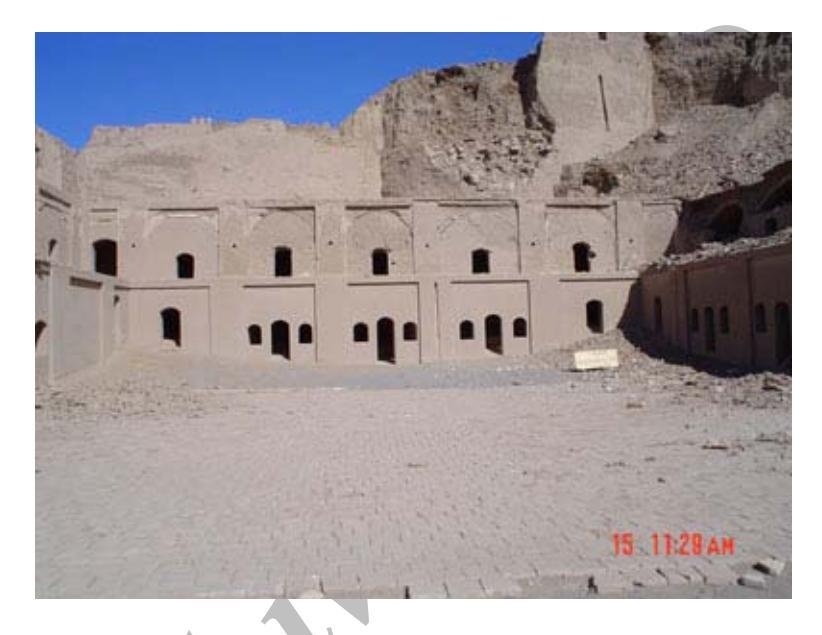
Figure 2. The east-west wall of the Military citadel in Arg-e-Bam.

architectural system, arches are used to face the central courtyard of the building, as shown in Figure 2. The small arches shown in this figure is merely a facade that is hiding the main structure behind it and merely worked as a shear wall. For the arches perpendicular to this direction, a complete separation between the facade wall and original structure had occurred, which led to partial failure of these walls as shown in Figure 3. As a structural component, and as shown in Figure 4, arches are used to transfer loads from a dome to its pillars. In this structure, arches of different sizes and shapes have been assembled to fulfill this function. It is clear from this figure that earthquake forces had led to serious sliding and opening of joints in the pillars. This partial failure was caused by the unbalanced thrust transmitted from the adjacent arches. This problem was observed in single-span vaulted roofs as well. To resist the horizontal seismic movement, the joint between the arch and the pillar must be inclined and the pillar must have enough width to keep the resultant forces within the central part. It is clear from Figure 4 that this later condition has not been met. Many of the buildings that survive the earthquake have successfully fulfilled these rules as shown in Figure3.

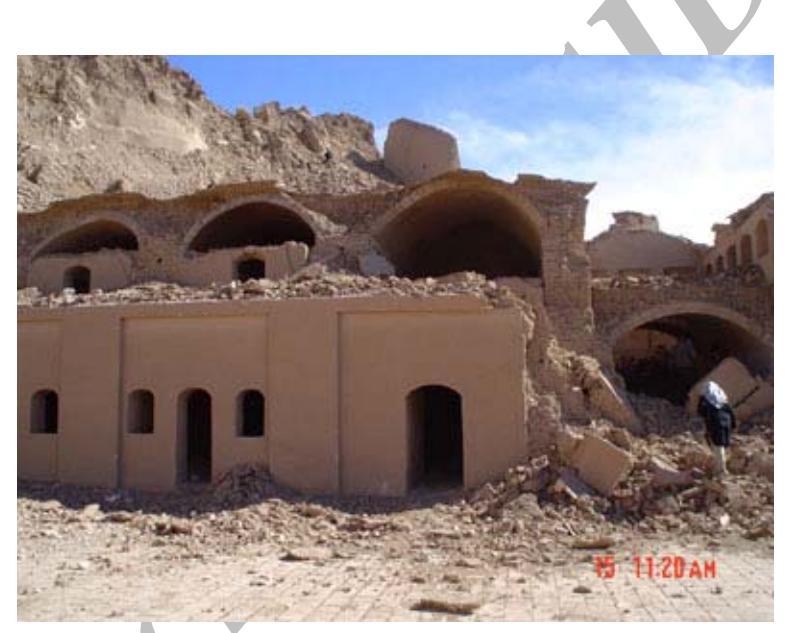
Figure 3. The north-south wall of the military citadel in Arg-e-Bam.

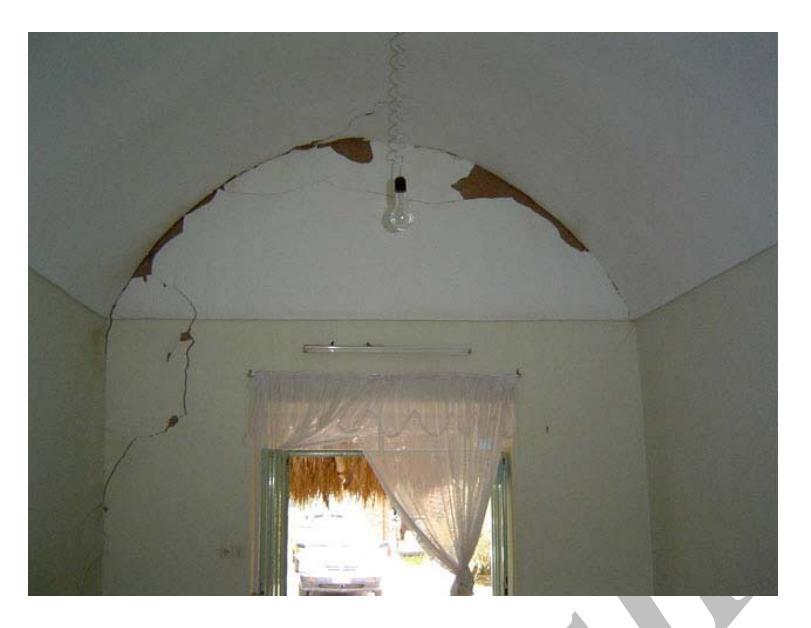
The failure of these types of structures is resulted when excessive displacements perpendicular to the vault generator occurred. However, when the displacement is relatively small as shown in Figure 6, only minor cracks occurs at the intersection of the roof with the end plates.

Figure 6. Cracks at the intersection line of the vault with the end plate

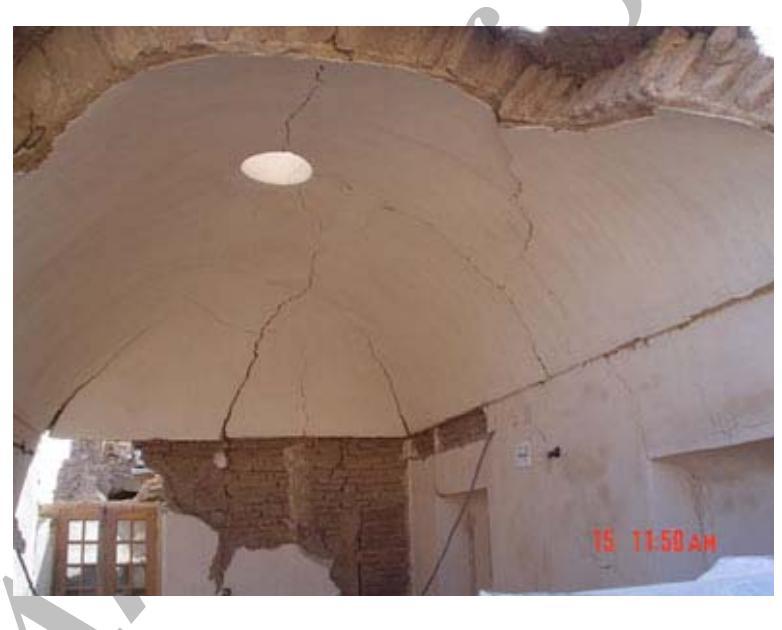
Figure 7. A vault with cracks in Arg-e-Bam

The surviving roofs can be seen all over the cities of Bam, Paravat and even at Arg-ebam at short distance from hypocenter. In Arg-e-Bam, many vaults were destroyed in the earthquake. However, others had escaped with minor cracks. Although it is very difficult to understand the reason of this good behavior, it has been noticed that the thickness of buildings' roofs inside Arg-e-Bam is much less than the corresponding ones elsewhere. Furthermore, it has been noticed that some of the buildings that survived the quake are located on rock. Figure 7 shows another example of such roofs. It can be seen from this figure that bearing walls had minor cracks compared to those appeared in the roof. The pattern of cracks in the roof indicates clearly that some vertical forces were applied to it. That can be explained by the high vertical acceleration component of this earthquake.

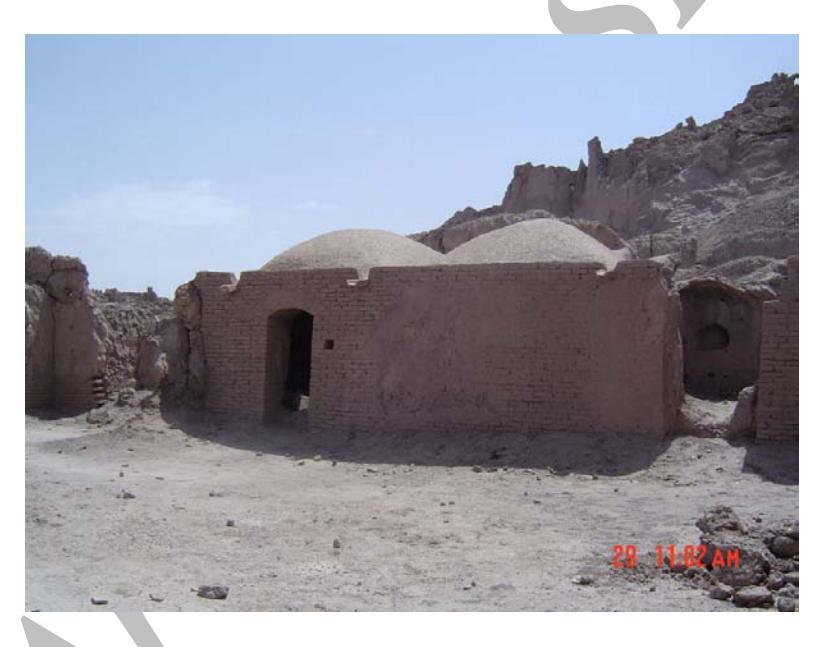
In the majority of cases, a complete destruction of adobe buildings including their domes was observed. However, example of good performance of domes can be also seen as shown in Figure 8. The building shown in the figure is located at Konari neighborhood in Arg-e-Bam and it has two domes. With the exception of some cracks at the Intersection of perpendicular walls, no other failure has been observed. On the other hand, many examples of massive and wide destruction had been observed few meters from the structure of Figure 8. As an example, the stable courtyard inside Arg-e-Bam is shown in Figure 9. Around the courtyard, many surrounding buildings are shown before and after the earthquake. The majority of domes shown in Figure 9a were destroyed completely as shown in Figure 9b. Supporting walls were also destroyed partially or completely. For walls situated parallel to

Figure 8, Domes located in Konari neighborhood in Arg-e-Bam

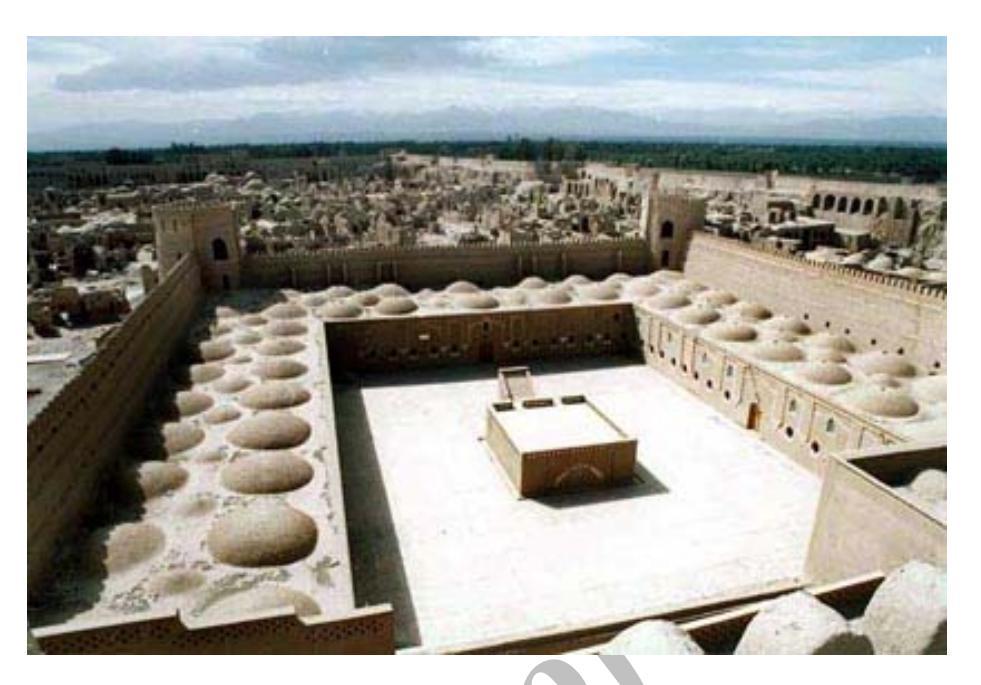
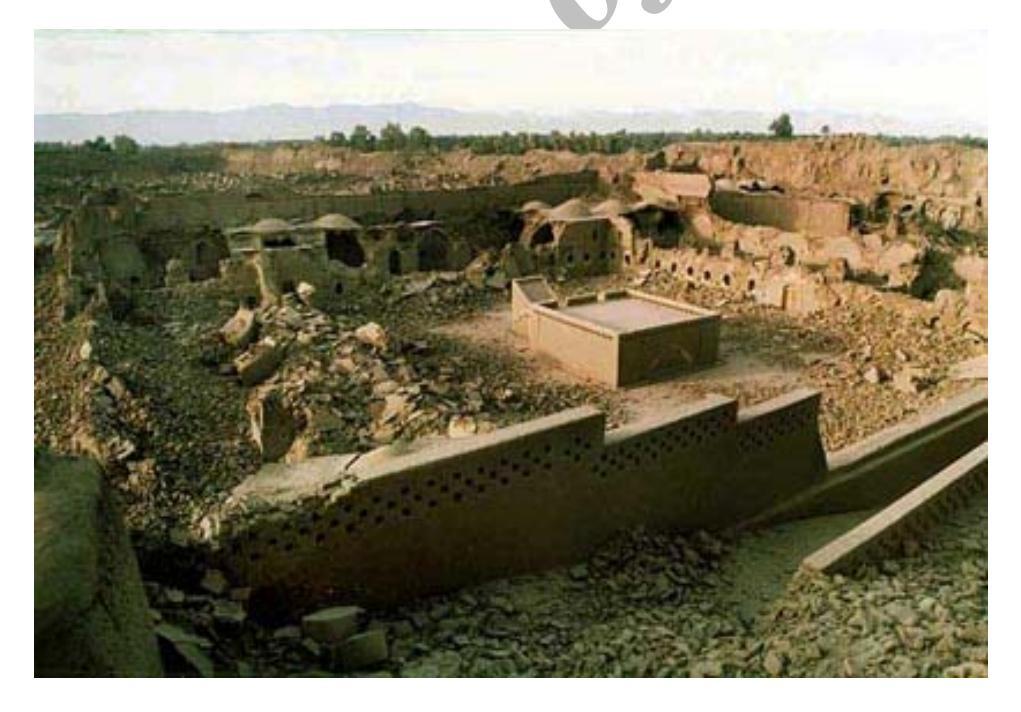
Figure 9a. A courtyard in Arg-e-Bam before earthquake.

Figure 9b. A courtyard in Arg-e-Bam after earthquake

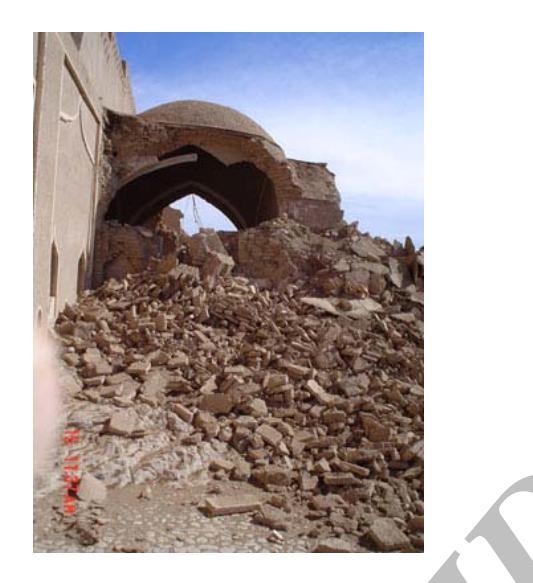
the earthquake direction, and due to the presence of vertical forces, the ability of these walls to resist shear forces has been reduced considerably. However, for walls perpendicular to the earthquake direction, it is believed that the combination of the normal forces to the wall plane and the vertical acceleration forces had caused their failures. However, it is interesting to note that some of these buildings that are located in the right corner of Figure 9 had survived the earthquake by taking advantage of their adjacency to two relatively rigid walls. In the author's opinion, the reaction applied by these two walls during the earthquake had increased the capacity of these parts to resist vertical forces applied by the vertical acceleration component. Prominent among the surviving domes in the stable courtyard, are those shown in Figures 10. The vaulted roof shown in Figure 10 has been used to support some of these domes. In this figure, additional arched panels had been added to this structure in order to relieve the bearing walls from parts of their loads. Accordingly, two arches and two walls support each dome. In Bam's earthquake, the forces applied were perpendicular to the plane of the arched panels and parallel to the wall. Arches in this case had fulfilled the role of bracings in inactive walls and distributed the loads between active walls to prevent partial failure. As it is clear from Figure 10, one of the arches had suffered minor failures. This failure reflects the disability of the arch panel to transfer forces between active walls.

Figure 10. A dome supported by two walls and two arch panels.

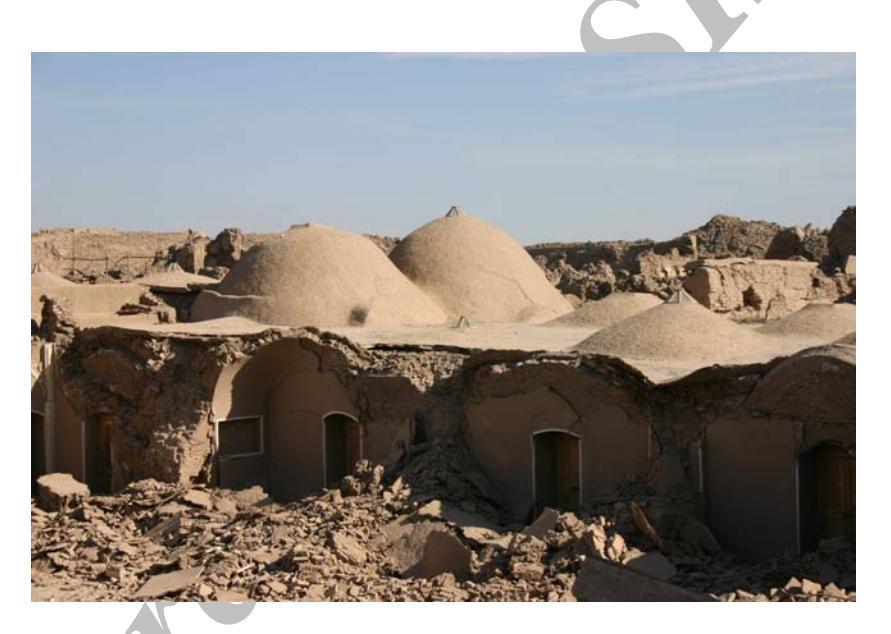
Figure 11. A meridian cracks in the dome
