ASIAN JOURNAL OF CIVIL ENGINEERING (BUILDING AND HOUSING) VOL. 8, NO. 3 (2007) PAGES 329-342

DESTRUCTIVE EFFECTS OF THE 2003 BAM EARTHQUAKE ON STRUCTURES

S.M. Zahrai^{*} and M. Heidarzadeh Center of Excellence in infrastructural Engineering and Management, School of Civil Engineering, University of Tehran, Tehran, Iran

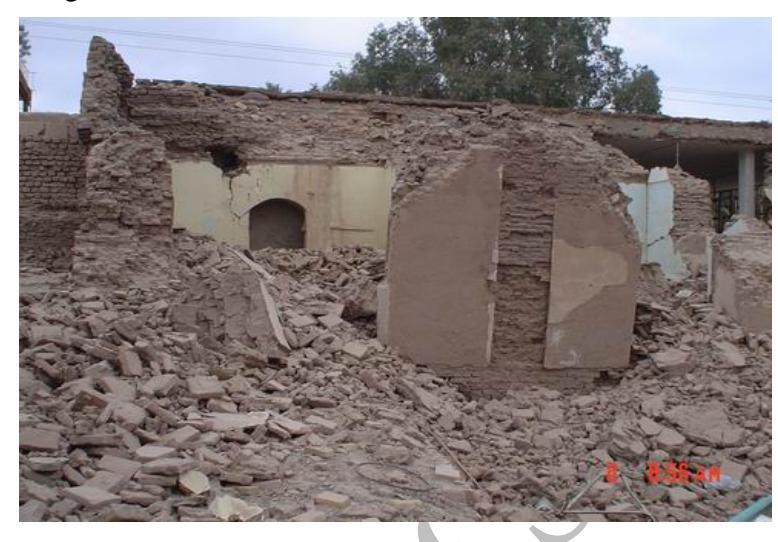
Most houses in the epicentral area are adobe construction, usually one-story made of sundried brick walls, and domed roofs or vaults with clay or mud mortar. This type of construction is common in the dry areas of Iran because adobe houses need only local materials and can be built by farmers when their work is lax. The walls and roofs of these houses are thick (usually 40 to 80 cm) and heavy so that they easily protect their inhabitants from the cold and hot weather, but they are very weak in resisting horizontal vibrations particularly at the junctions of vertical walls and domed roof (Figure 4). Based on the reconnaissance visit, most adobe houses in the epicentral region are either partially or totally collapsed. Their failure normally started in a corner by separation of the walls from the domed roof. In some region the ground shaking was so severe that the abode houses were turned into their original sun-dried bricks.

Figure 4. Heavy walls-thickness of wall in some adobe houses is around 1 m

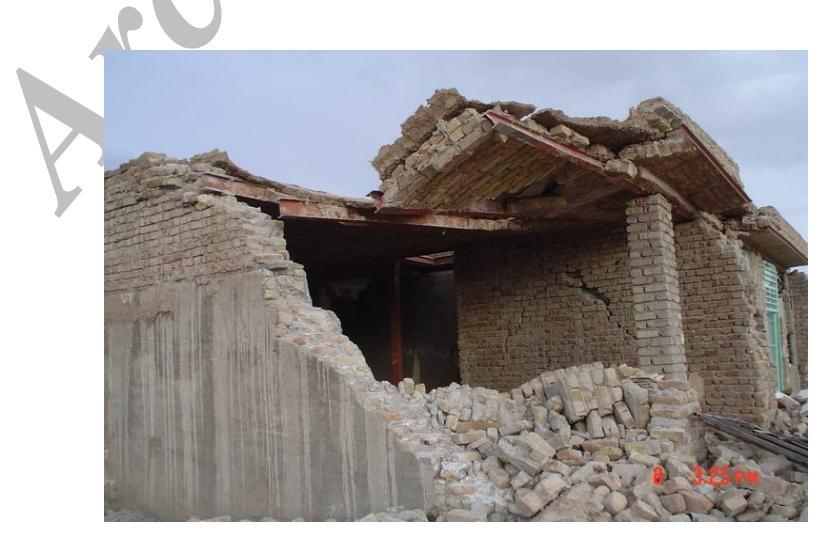
Masonry buildings are the second most common type of buildings in the earthquake-affected area. They normally consist of brick walls with shallow Jack arch roofs supported by steel **I** shaped beams which is discussed before. The mortar used in these buildings is sand-lime-cement, or sometimes sand-cement. The performance of un-reinforced masonry buildings which lack tie beam or jack arch tie rods was not so better than adobe buildings. The common modes of failure of these buildings were shear failure of walls, separation of walls from the roof, and separation of roof beams from each other (Figure 5). In most cases the steel beams of the roof were not braced together by steel bars or joists. As a result, dropping of the bricks between them during the earthquake could be expected.

Figure 5. Shear failure of walls, separation of walls from the roof, and separation of roof beams from each other are observed in typical brick buildings

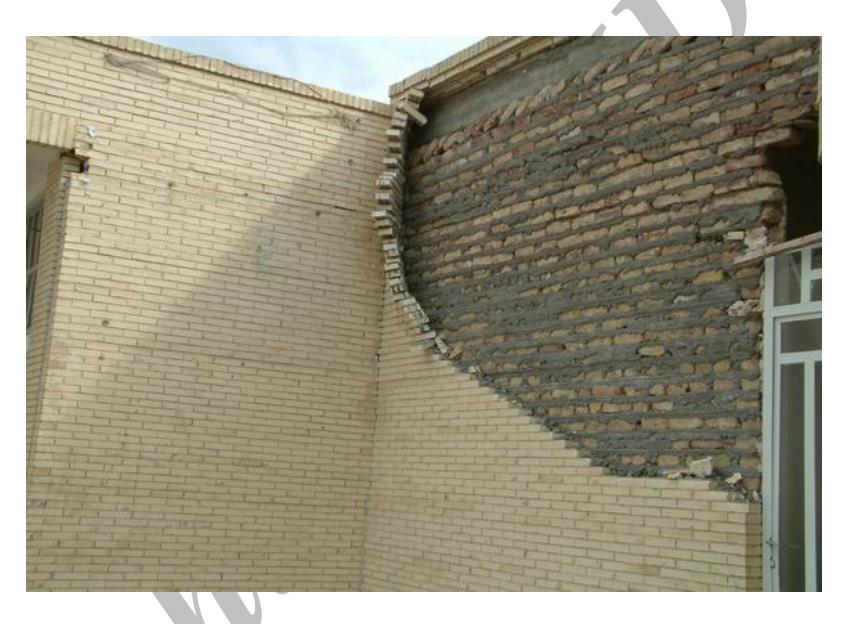
A number of reinforced masonry buildings, with vertical and horizontal reinforcing tie beams, were recently built in the city. The performance of these structures was good and in many cases saved the lives of their inhabitants (Figure 6). In many cases the material used for tie beams or their execution quality was so bad that the element hardly could resist earthquake. It is found that the philosophy of the tie beam to protect the unity and integrity of the walls was not understood well. For example in some cases the bond between tie beams at the wall corners has poor conditions. However, wherever the tie beam had a relatively good condition, the performance was satisfactory.

Figure 6. An example of reinforced brick buildings in the earthquake-affected area with a relatively good performance

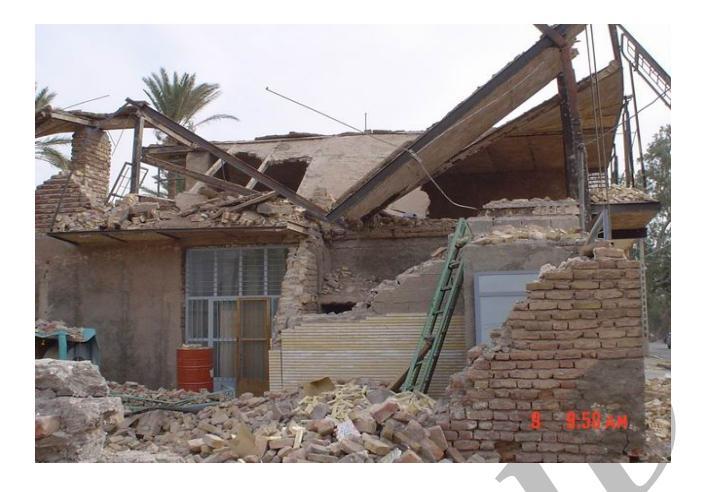
Many modern residential and office buildings in Bam are steel building structures that can be divided into two groups. The first group includes buildings with steel internal columns, load-bearing external brick walls, and roofs, often, made of shallow Jack arches with steel **I**–beams. The performance of this type of construction as a sort of un-reinforced masonry structure was very poor. The flexible steel columns tended to displace much more than the rigid external walls resulting in inclining of the steel columns and mostly the collapse of the whole structure (Figure 7). This earthquake clearly demonstrated that the combination of relatively rigid load-bearing external brick walls and flexible internal steel columns is very hazardous. This type of structure is not limited to Bam, and it can be easily observed in most of the cities in the country.

Figure 7. First group of steel buildings, combination of steel internal columns and load-bearing external brick-walls

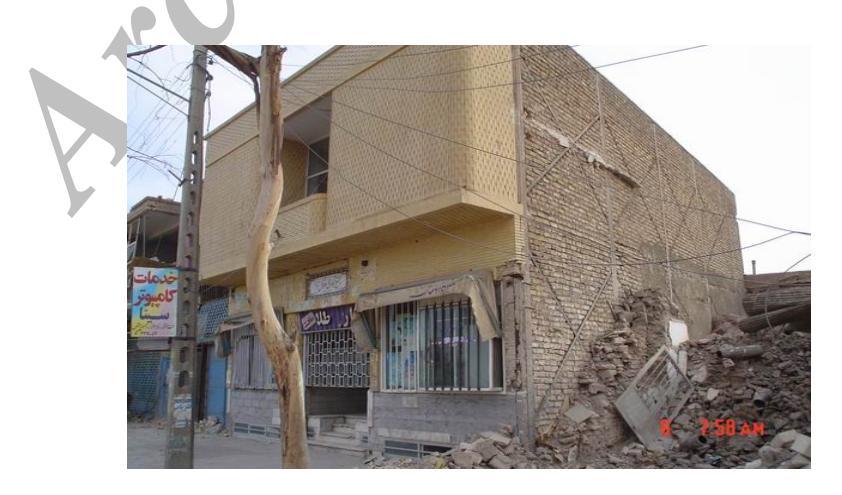
The second group of steel buildings consists of steel frames just in one direction with bracing in one or two directions. They are actually designed for some horizontal forces. The performance of this type of construction was generally satisfactory (Figure 8). Exceptions are made when the bracing were placed non-symmetrically or incorrectly. In these cases, the infill or curtain walls usually experienced severe damage; i.e. due to the weakness of the lateral load bearing element, the infill or curtain walls had been activated during the earthquake and resisted the applied loads resulting in their severe damage. In braced steel structures, the bracing and their connections had different defects like insufficient cross section area, insufficient connection plate, improper connection execution, and so on. Therefore most of them could not effectively resist applied loads. In fact this earthquake proved that use of steel beams and columns in building structures without observing proper seismic code provisions for earthquake resistance showed no improvement over non-engineered buildings.

Figure 8. Steel building with good performance during the Bam 26.12.2003 earthquake

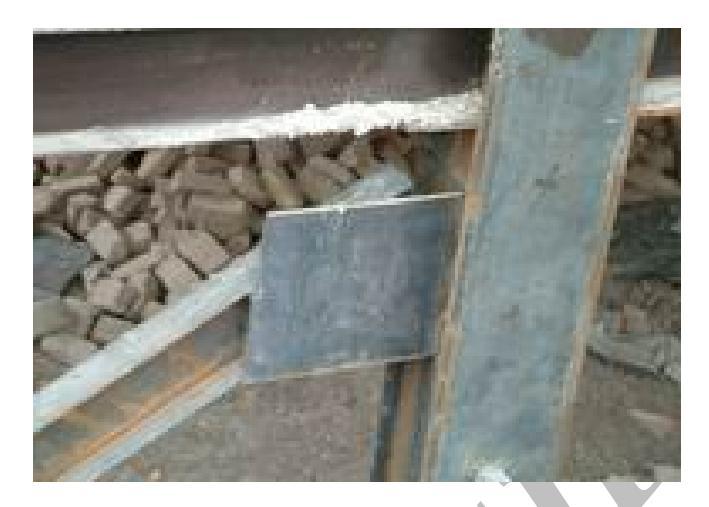
Figure 9. Incorrectly bracing with single I shaped brace only connected to the column

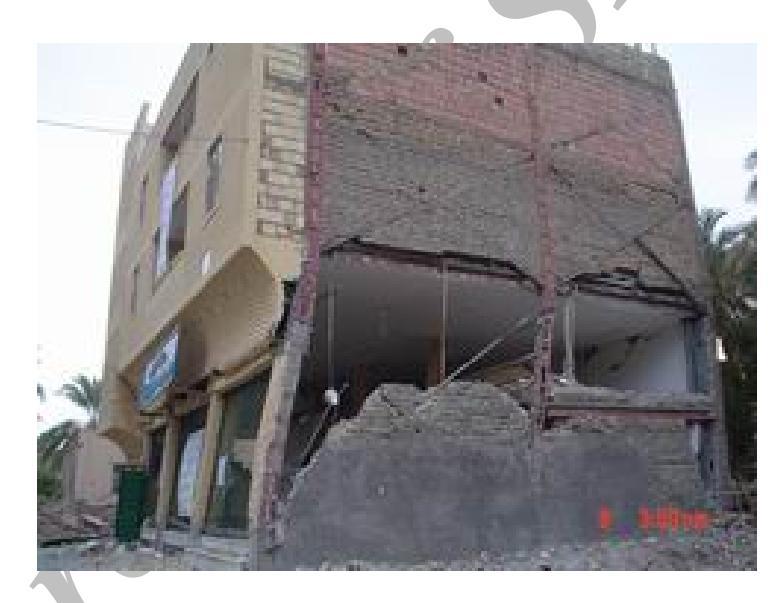
Figure 10. Unacceptable bracing system where the cross-section of bracing member is insufficient

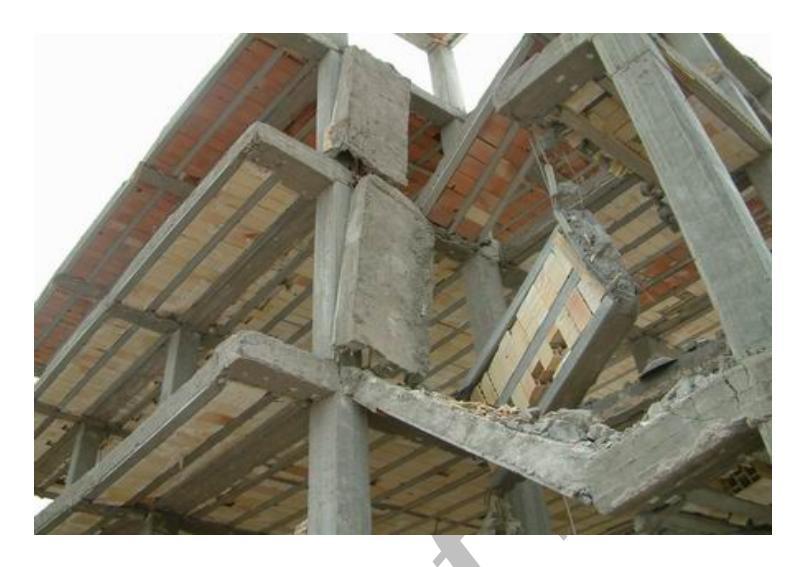
- A. Poor performance of stairs as shown in Figure 11.
- B. Poor quality of concrete.

Figure 11. Poor performance of stairs in reinforced concrete structures

As a result, authors believe that most problems of reinforced concrete structures would be removed if they were designed and constructed properly. Even, higher RC buildings might be equipped with earthquake resisting elements other than the conventional moment resisting frames such as shear walls. In this order authors propose that the responsible authorities such as national regulations on seismic design (No. 2800 regulations) impose tough rules on construction quality control or limiting the use of moment resisting frames alone at least in the areas with high seismicity.

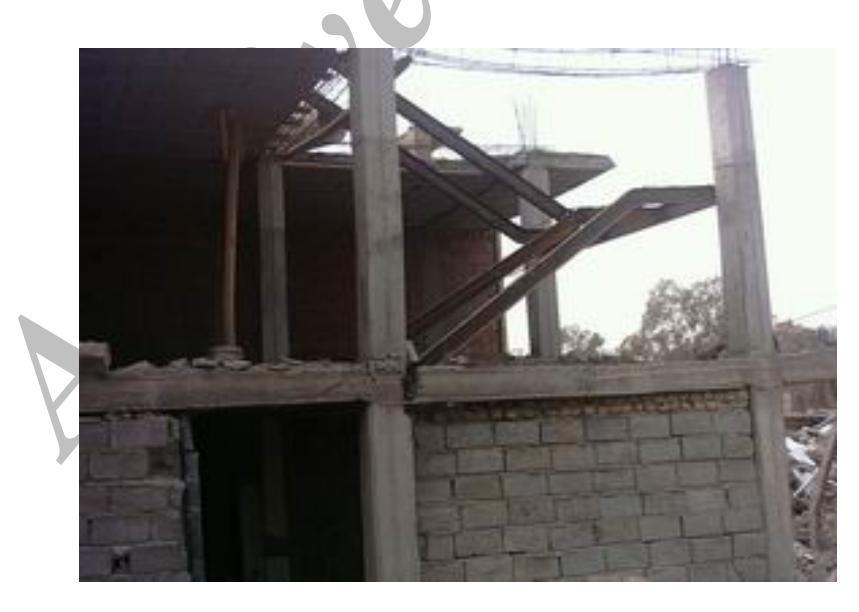
A. Lack of homogenity between the structural components. For example in one case in a reinforced concrete structure, steel stair case was used (Figure 12).

Figure 12. Use of steel stair in a reinforced concrete structure

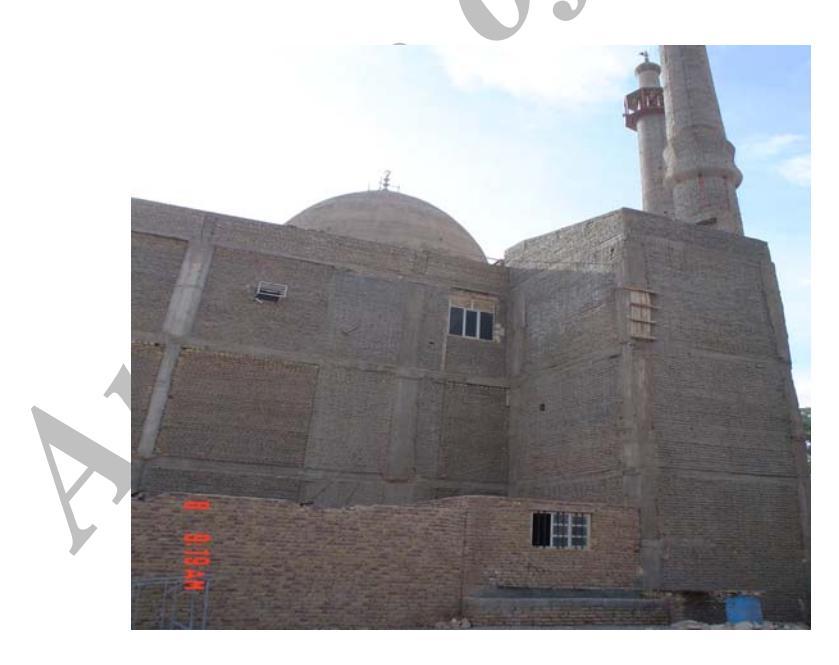
Figure 13. A reinforced concrete mosque after the earthquake which had a satisfactory performance

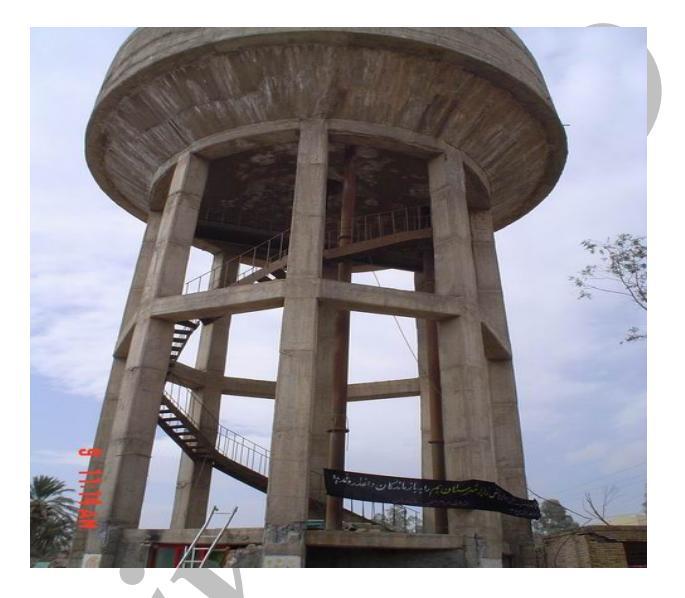
The tower has eight legs. The tank was apparently full of water during the earthquake.

Figure 14. The elevated reinforced concrete water tank tower, where some cracks in the structural joints can be seen but the general performance is satisfactory.

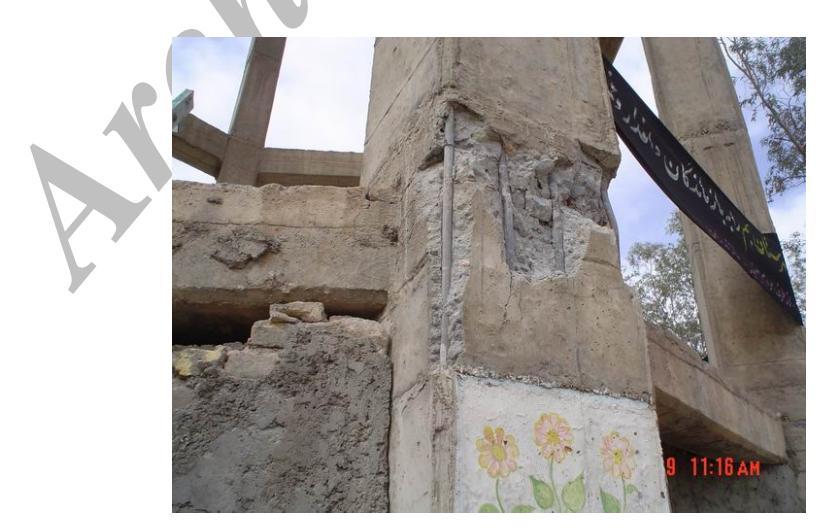
According to Figure15, the general performance of the structure was good but as shown in Figure15, some joints cracked so that the steel bars can be seen. As a matter of fact the only observed defect in this structure was improper reinforcement detailing. Investigations showed that the used steel rebars in the structure were round ones to which the cracks to some extent can be related. In addition, one will be surprised knowing that the columns are not reinforced with ties (at least in the joints). It is believed that the cracks in the joints to a great extent are related to the lack of ties in the joints.

Figure 15. Clos-up view of the cracks in the structural joints of the elevated reinforced concrete water tank tower (note the rebars with no threads).

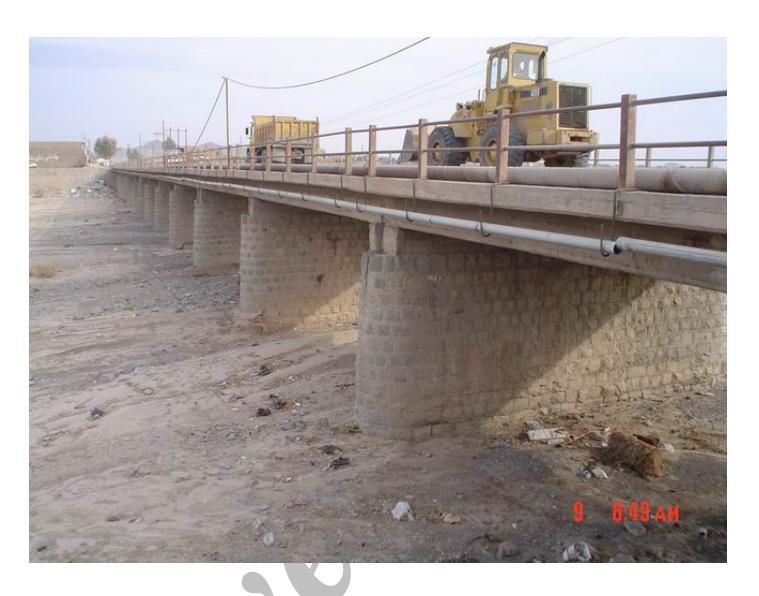
The other important structure in the area is a reinforced concrete bridge having piers lined by stone to resist against the river flow and its probable erosion (Figure 16). Like the mosque and the water tank tower, the mentioned bridge had good conditions being under service after the earthquake. Some parts of abutments cracked slightly, but there was no lateral displacement. Some spans got separated about 3 centimeters from the abutments (Figure 17). As a result we can conclude that this bridge withstood the intense earthquake approximately without significant damage.

Figure 16. General view of the multi spans Reinforced Concrete Bridge after the earthquake which is in good condition and of course under service.

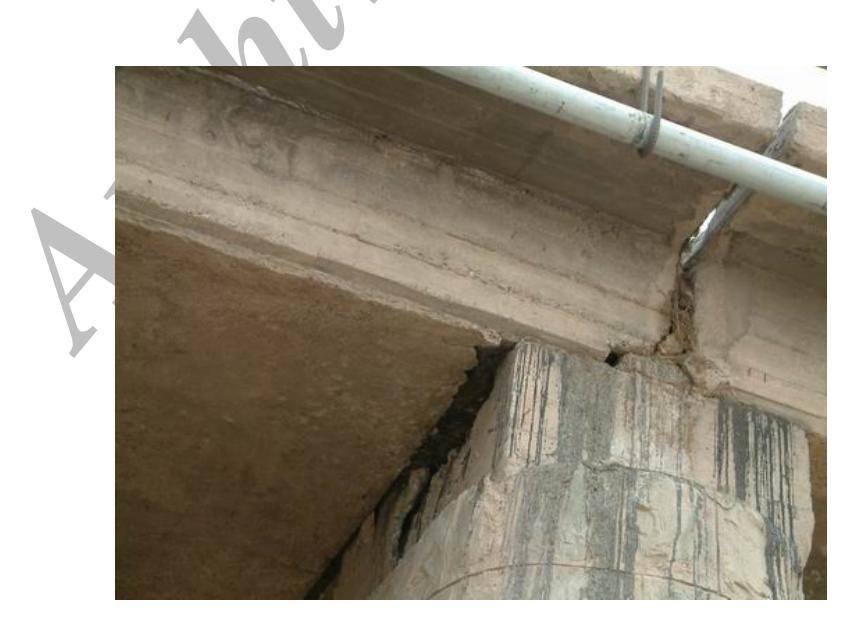
Figure 17. Separation of bridge Spans from the abutment
