## FAILURE ANALYSIS OF GE-F9 GAS TURBINE JOURNAL BEARINGS<sup>\*</sup>

**Abstract**– This paper presents a failure analysis of journal bearings used in GE-F9 gas turbines. Detailed studies including visual examination, optical microscopy, scanning electron microscopy, XRD and oil analysis were performed to determine the root causes of failure. Based on the results, it was determined that fretting, sulfur attack and fatigue were the main causes of failure.

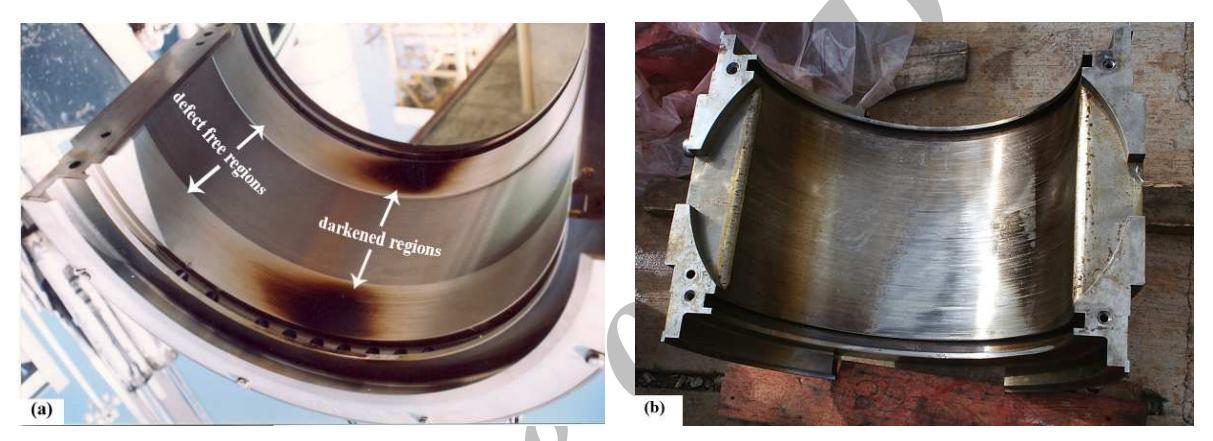
A visual examination of the bearing showed, clearly two black regions in the center of the upper half of the bearing, as shown in Fig. 1. The damage is confined to the upper half, with the bottom half of the bearing showing signs of normal wear.

Fig. 1. a) Upper half of the bearing, b) and bottom half of the bearing

Careful stereo-binocular examination on the surface of the bearing lining revealed some cracks on the failed (darkened) regions. No dirt or other foreign particles were found on the surface of either bearing half. The bearing surface contained no evidence of wiping or cavitation.

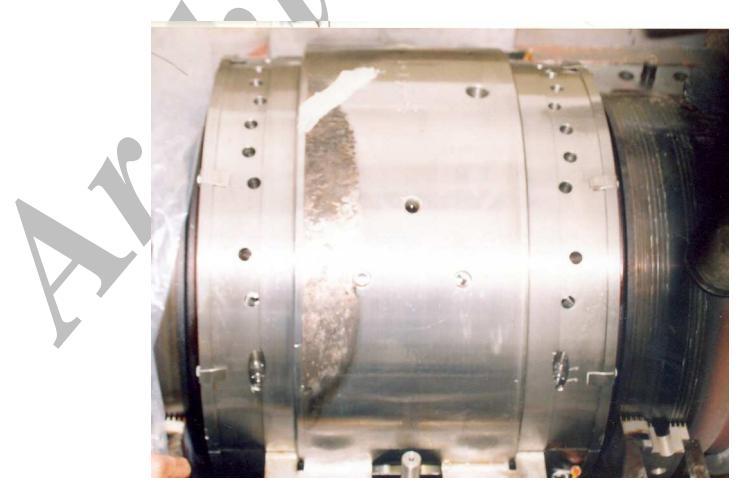
The outside surface of the upper half of the bearing backing was also damaged. It is easy to identify the severe fretting damage from the outer surface of the steel backing of the upper half shown in Fig. 2.

Fig. 2. Outside surface of upper half of bearing backing

Fretting of the outside of the bearing backing occurs as a result of small relative movements between mating surfaces. Movement may occur when there is insufficient press fit between the bearing and the housing. Lack of press fit can result when housing bores are oversize or when bolts are insufficiently tightened. The inner surface of housing also showed evidence of fretting.

- Relative movement between the bearing backing and the housing has been the main cause of failure. This movement resulted in the fretting of the outer surface of the bearing backing. Probably, the best measure to reduce or totally eliminate this movement is to use anti-rotation pins which keep the bearing and housing firmly together.

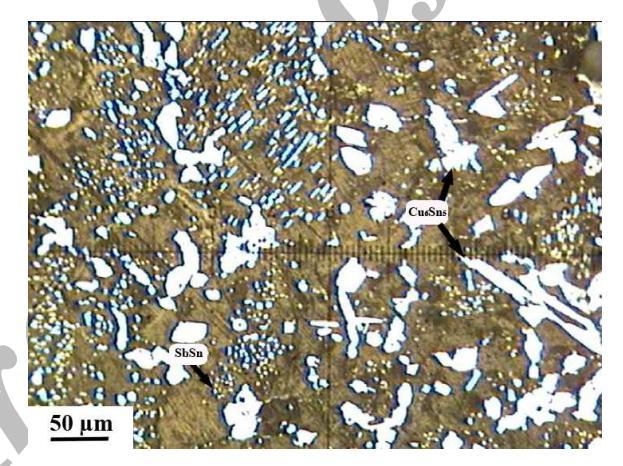
Metallographic analysis of the bearing material has been conducted. The micrograph in Fig. 3 shows a lining microstructure, where hard and small SbSn cuboids and hard  $Cu_6Sn_5$  needles are embedded in the soft solid solution matrix of antimony in tin. There was no difference between the microstructures in the darkened region and the defect free region.

Hardness measurements were also carried out. Microhardness  $H_v$  of individual phases is as follows: matrix: 25.2; cuboids: 77.2; needles: 89.3. Metallographic analysis confirmed that lining chemical composition, microhardness and microstructure correspond to tin-based babbitt alloy.

Fig. 3. Microstructure of bearing lining.

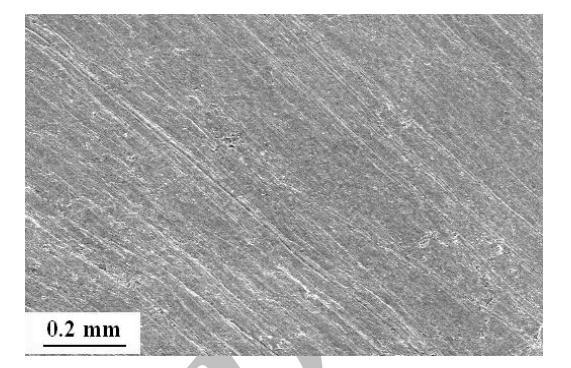
fatigue damage. In other regions of the bearing surface (Fig. 5) there was no sign of fatigue or other damage.

Fig. 5. Surface of defect free region

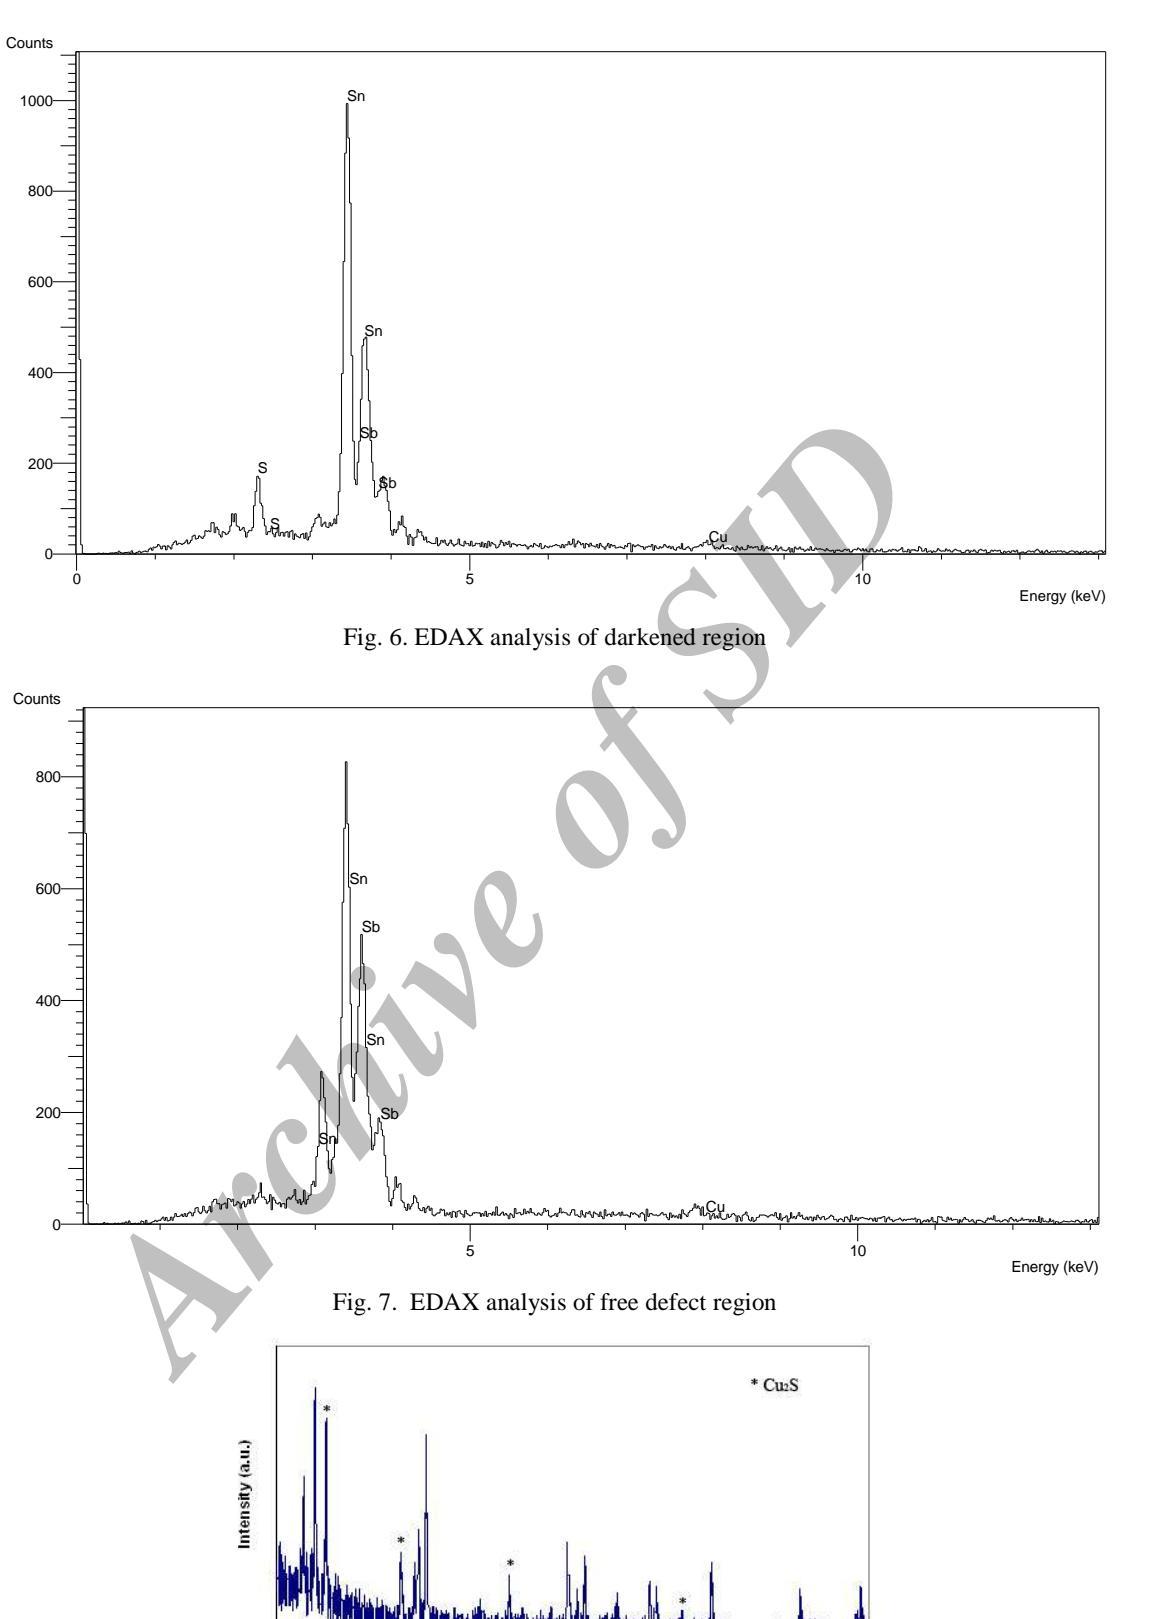
SEM-EDAX analysis was carried out to determine if there is any change in the composition of the bearing lining on the surface. The results for darkened and free defect regions are respectively shown in Fig. 6 and Fig. 7. One notable feature is the presence of sulfur at significant levels in the darkened regions. X-ray diffraction analysis was used for the specific identification of deposits. Some picks which correspond to copper sulfide ( $Cu_2S$ ) picks are marked in Fig. 8. Since the surface of the bearing lining was not completely smooth, some additional noises are observed in the XRD pattern. The sulfide was formed by the action of sulfur acids in the lubricating oil on the copper in the bearing material. The decomposition of sulfur compounds in the lubricating oil usually occurs when moisture is present in the oil and when the operating temperature is high and exceeds a normal condition. In the present case, the frictional heat due to the oscillation of the bearing in the housing bore has stimulated a sulfur attack.

Tow theta (degrees) Fig. 8. XRD pattern of the sample taken from the darkened region

- 2. The dark corrosion product that covered the bearing surface was identified as copper sulfide  $(Cu_2S)$ . The reaction of copper sulfide formation is a temperature dependent one; therefore preventing the rise of the operating temperature and changing the oil before sulfur acids accumulate to a harmful level can reduce the corrosive attack on the bearing material. Using sulfur-free oil additives is also a reliable measure which prohibits a sulfur attack.

Additives are chemical agents added to lubricating oil to improve oil properties. Oxidation inhibitors (phenolics and dithiophosphate) and rust inhibitors (organic acids and sodium petroleum sulfonate) are among the additives which are extensively used in gas turbine lubricating oil. In contrast to phenolics and organic acids, dithiophosphate and sodium petroleum sulfonate include sulfur. It is clear that a sulfur attack can be prevented by using sulfur-free additives.
