TECHNICAL NOTE

CAUSES OF CATASTROPHIC FAILURE OF HIGH MN STEEL UTILIZED AS CRUSHER OVERLAYING SHIELDS

S. R. Allahkaram

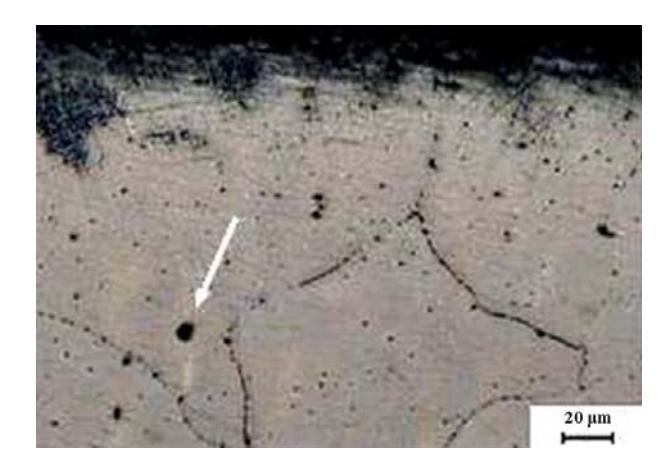
Figures 2a and 2b show the microstructure of the internal surface layer of the shield. The micrographs taken from two different sites of the internal surface indicate inhomogeneity in the sizes of the grains at these regions. As it could be observed, some voids appeared within the grains and grain boundaries with an average diameter of 5µm scattering all over the internal surface of the shield, which were probably due to the removal of the inclusions during grinding.

Figure 2. Two micrographs of internal surface structures of cone crusher shield at two different sites, indicating inhomogeneity in grain sizes.

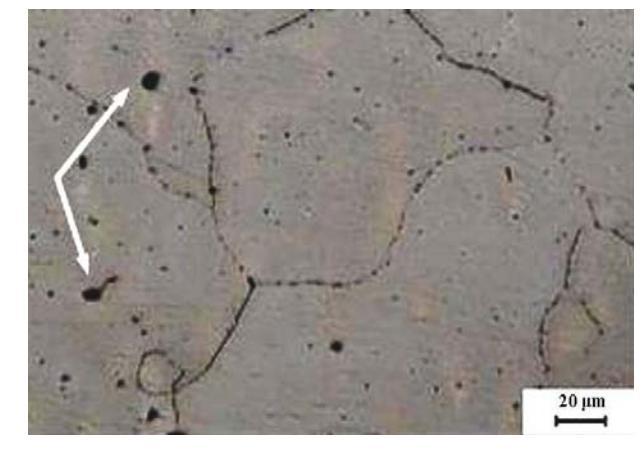
Figures 4a and 4b indicate the microstructures at the inner surface and at 0.5 mm below the inner surface of the shield, respectively. Figures 5a and 6a show the microstructures at 1 mm and 5 mm below the inner surface, respectively.

Figure 4. Structural sites near the internal surface of cone crusher shield (x-sectional traverse). (a) Close to the internal surface. (b) At 0.5 mm depth. Note the dark pits indicated by the arrows, probably due to the segregation of precipitated particles.

The average size of the grains at 1 mm depth was about 250 μ m, which was almost twice larger than those at 0.5 mm depth (Figures 4b and 6b).

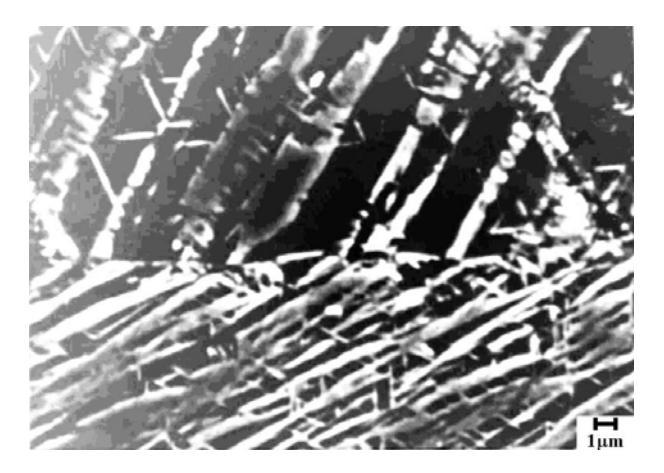
Figure 3 illustrates the twin martensite branches across the boundaries of two neighboring grains of the internal subsurface layer of the shield. According to Tiantu, et al [2], although deformation twins and strain-induced martensite in the subsurface layer of a worn specimen brings about higher work-hardening capacity and hardness, which is beneficial to wear resistance, but at the same time, brittleness of work-hardened layers increases.

Figure 3. Internal surface structure, scanning electron micrograph.

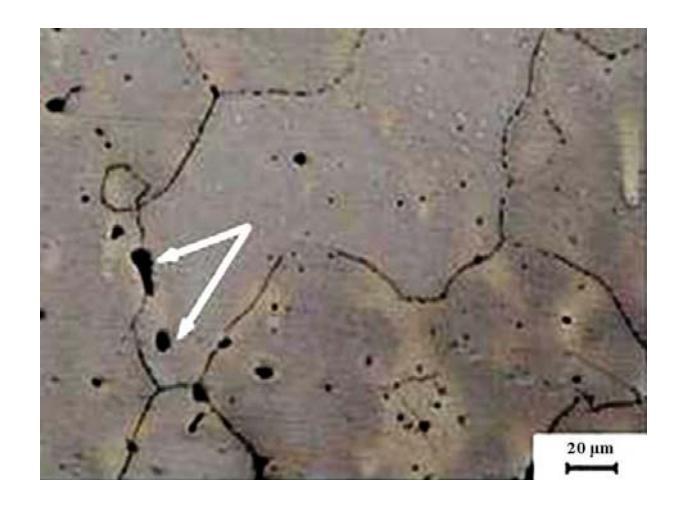
A more detailed examination of the crack direction revealed that the inclusions and/or the voids were preferable sites for crack propagation though the boundaries. These are illustrated in Figures 5b, 6a and 6b.

Figure 5. A grain boundary crack at (a) 1 mm depth below the internal surface and (b) 1 mm depth below the surface.

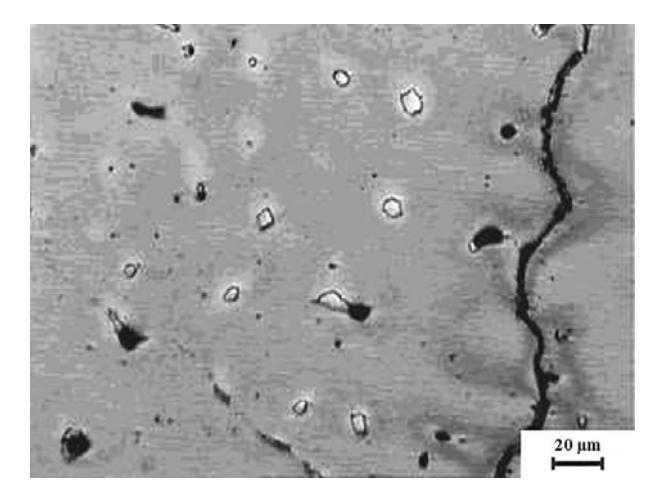
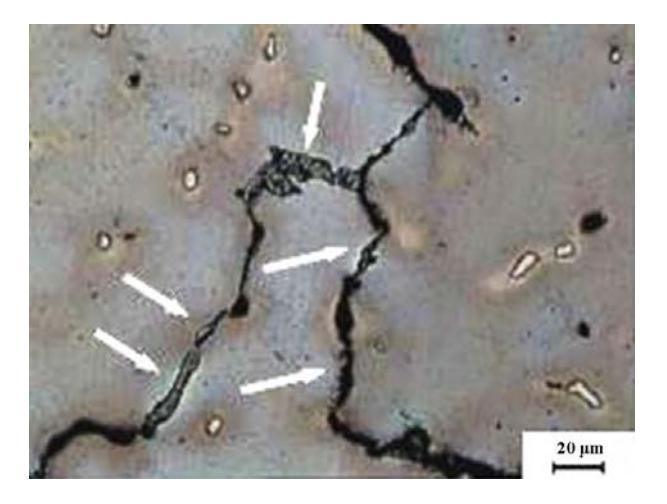
Figure 6. Microstructure at (a) 5 mm depth below the internal surface of the shield indicating internal grain boundary crack propagation and (b) precipitated particles within grain boundary crakes shown by arrows.

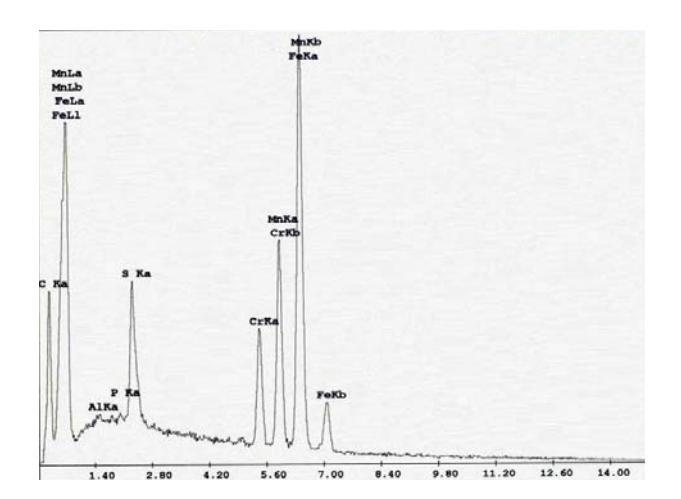
Figures 7 and 8 show the EDX spectroscopy of a precipitated particle within a grain boundary crack and in the austenitic base of the shield, respectively. By comparing these two analyses, it can be clearly observed that the presence of higher carbon content in an isolated particle within a growing crack, compared to the base metal can confirm carbide precipitation in the grain boundary. This indicates the occurrence of

Figure 7. EDS analysis of a precipitated particle within a grain boundary crack.

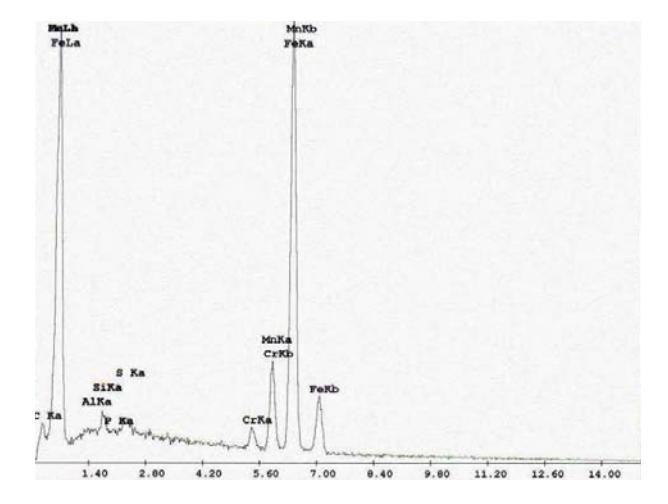
Figure 8. EDS analysis from austenitic base.

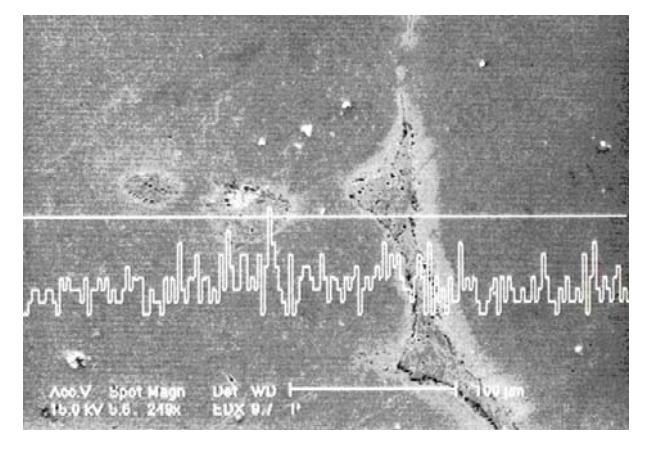
For investigating elemental distributions and variations of their concentration within the material, line-scan was employed. Figures 9 and 10 illustrate the line-scan results for phosphorous taken across a grain and a grain boundary, respectively. It can be deduced from these semiquantitative analytical results that the concentration of phosphorous within the grain boundary is almost twice as much as the concentration in the grain. Baring in mind that the phosphorous concentration in the alloy was found

Figure 9. Phosphorous line-scan taken across a particle within a grain.

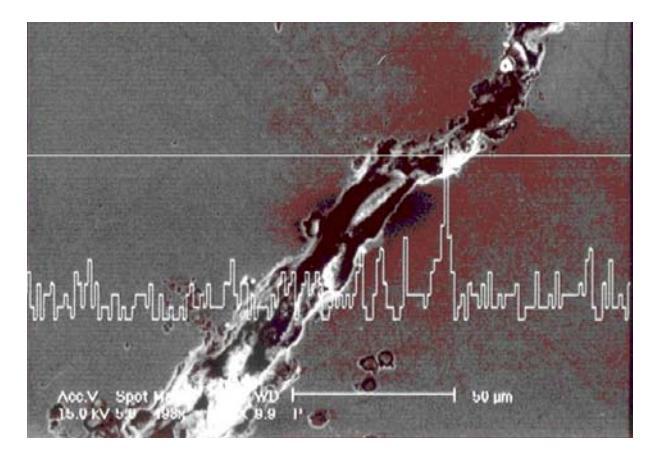
Figure 10. Phosphorous line-scan taken across a grain boundary.

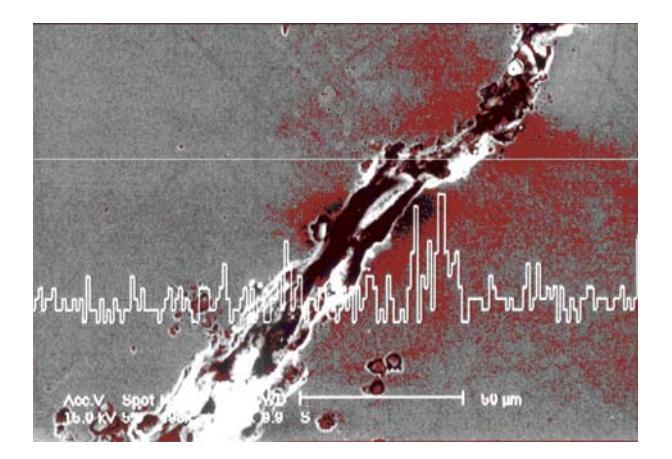
This can be further influenced due to higher concentration of interstitial sulfur diffused toward the grain boundaries. According to Figure 11, the amount of sulfur in a particle within the grain boundary is almost twice as much as the base metal.

Figure 11. Sulfur line-scan taken across a particle within a grain boundary.

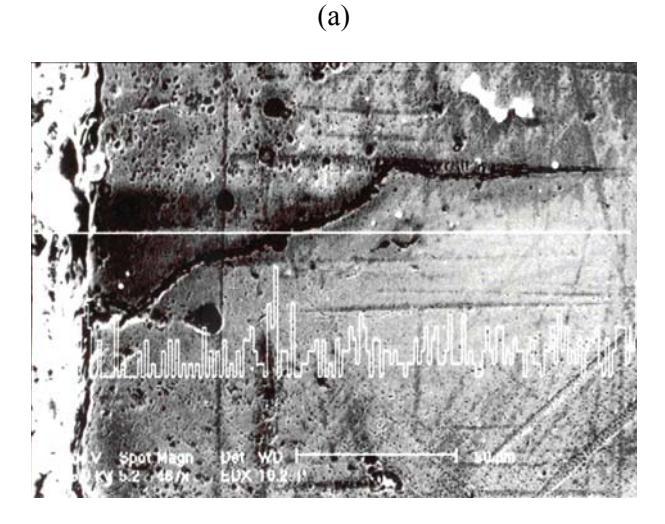
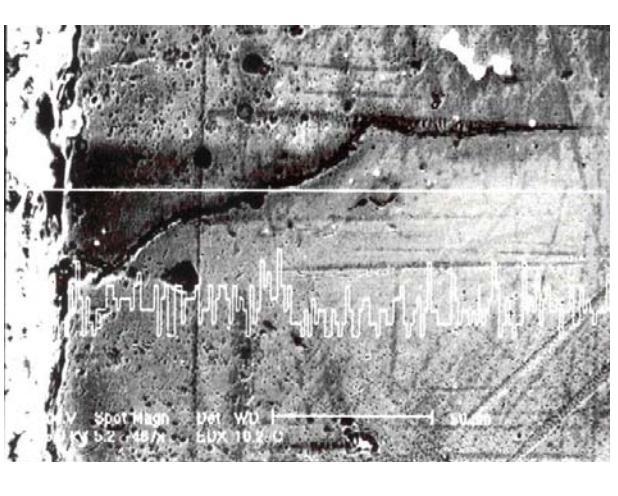
Figures 12a, b and c illustrate the results of linescans for variations of (a) sulfur, (b) and (c) carbon concentrations through the base metal across a crack, starting from the inner surface of the shield. The scan results indicate that phosphorous and sulfur contents within the crack are higher than those of the base metal. Figure 12c also illustrates that the variation of carbon within the crack was slightly higher than that of the base metal. These results confirm that sulfide and carbide inclusions within the grain boundaries provide available sites for a growing crack.

Figure 12. Variations of concentrations of (a) sulfur, (b) phosphorous and (c) carbon in a known crack path adjacent to the internal surface obtained by line-scan. Arrows show the internal surface of the shield.

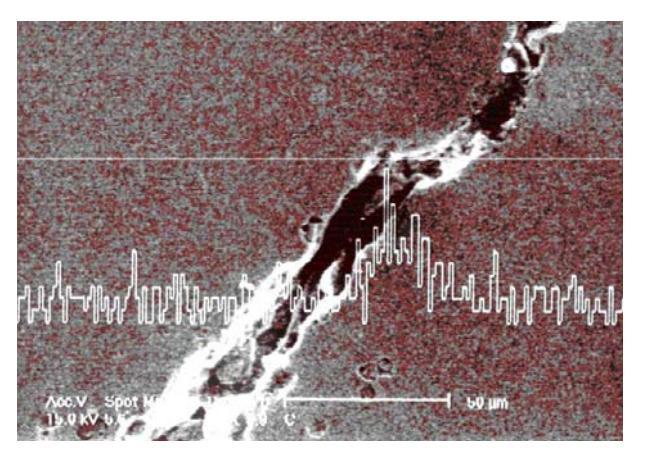
Figure 13 indicates the line-scan result for carbon variations within a grain boundary at a further distance away from the internal surface of the shield. This micrograph also illustrates that the carbon content within the grain boundary is almost twice that of the base metal as well as in the vicinities adjacent to the grain boundary. Figure 14 shows the eutectoid substructure and its associated line-scan for the carbon in a selected path.

Figure 13. Carbon line-scan taken across a particle within a grain.

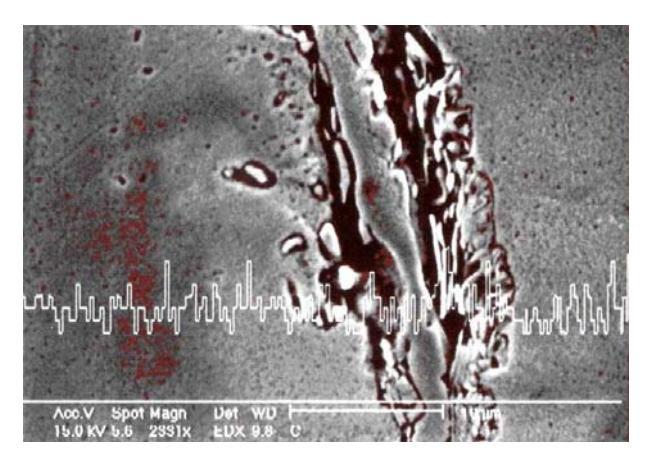
Figure 14. Carbon line-scan taken across a lamellar structure (possibly eutectoid).

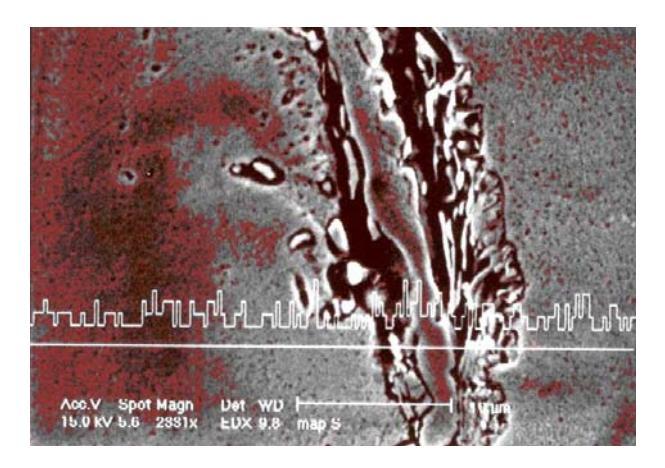
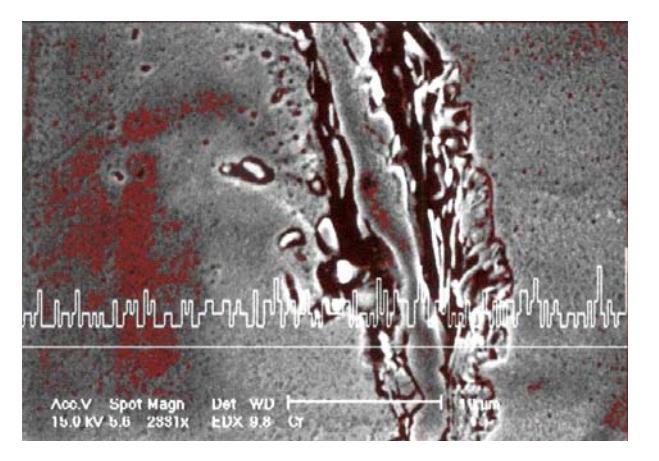
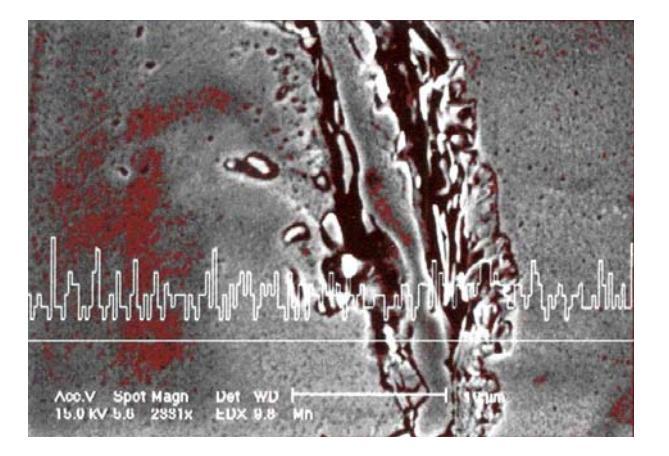
Figures 15-17 also show similar topographical analyses for sulfur, chromium and manganese concentrations, respectively. The line-scans across the eutectoid substructure for various elements indicate lower elemental contents in the eutectoid lamellar substructure than elsewhere. This finding confirms the eutectoid nature of the lamellar substructure. The depletion of alloying elements from the grains and other phases such as eutectoids and their diffusion toward the boundaries to form various inclusions within the grain boundaries result in the formation of an ideal path through which a crack can grow across the wall thickness of the shield.

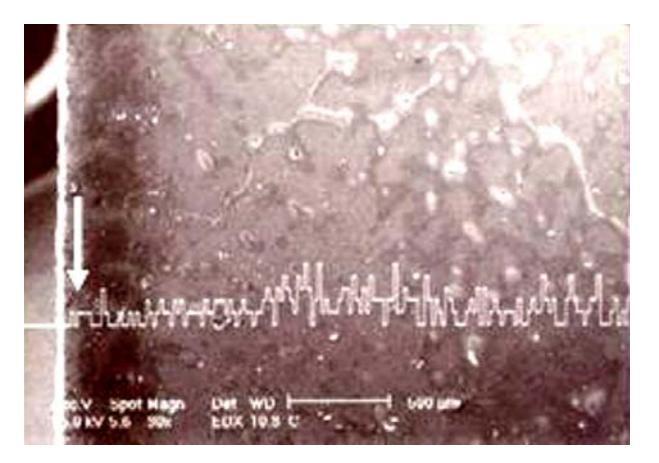
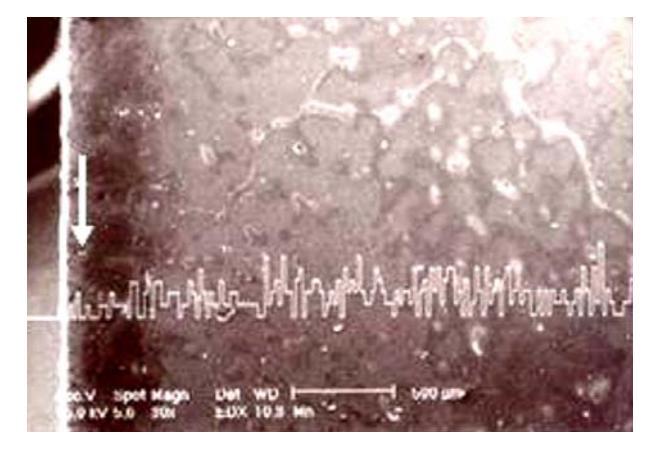
further For investigation of possible decarburization and demagnetizations of the inner surface of the shield, line-scans were employed again for carbon and manganese variations from the internal surface up to 500 µm depth below the surface of the shield. Figures 18 and 19 show the results of these analyses for carbon and manganese, respectively. The distributions of these two elements can be seen to be lower near the inner surface and gradually increase through the core up to a level, after which they remain almost constant.

By comparing these figures, it can be deduced that the Mn variations from the surface through the metal is more pronounced than that of C variations along the same line.

Therefore, it is true to say that demagnetizations is a prevailing structural defect as compared to the decarburization phenomenon in these shields. This is in keeping with other investigator's findings, i.e. the ratio of Mn/C < 10 results in demagnetizations and hence failure of Hadfield steel cone crushers [8]. Hence, the propagating crack initiated from the internal surface (Figure 12), can be primarily related to the demagnetizations phenomenon.
