Reconnaissance Report on Building Damage Due to Bam Earthquake of 26 December 2003

Yasushi Sanada¹, Masaki Maeda², Ali Niousha³, and M. Reza Ghayamghamian⁴

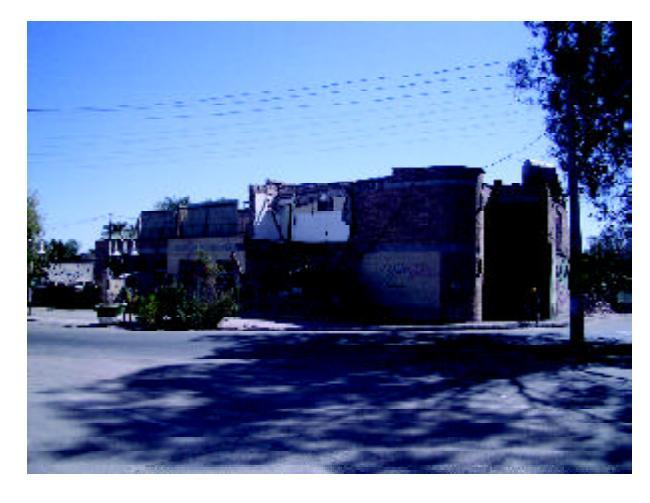
Governor's Building is a two-story *SM* building with reinforced concrete horizontal ties, as shown in Photo (1). This building has an irregular plan. The wall arrangement is illustrated in Figure (9). The damage level, classified by *EMS*-98, was Grade 4 due to the partially collapses of *NW*- and *SW*-sections as shown in Photo (2). The location of the seismograph is also illustrated in Figure (9), which shows that the seismograph was placed far from both collapsed areas. The wall ratios (= the sum of the first floor wall sectional area / the first floor area) were 6.4% to 6.8% in the *NS* direction and 5.8% to 6.7% in the *EW* direction considering the unknown collapsed area.

Photo 1. North view of Governor's building.

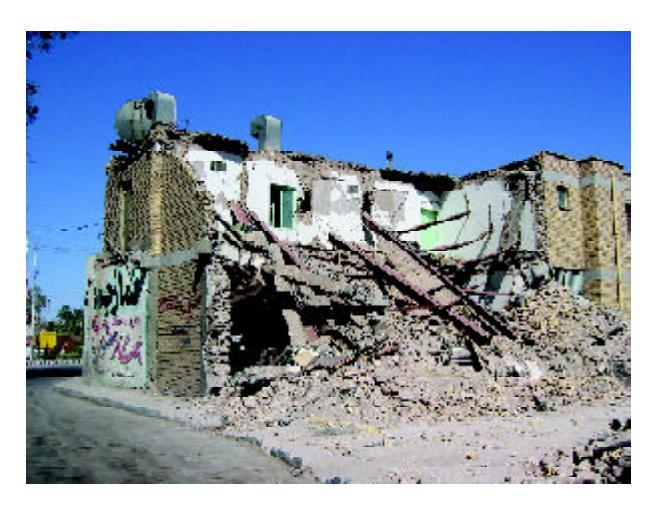
Photo 2. Collapse at the south west section.

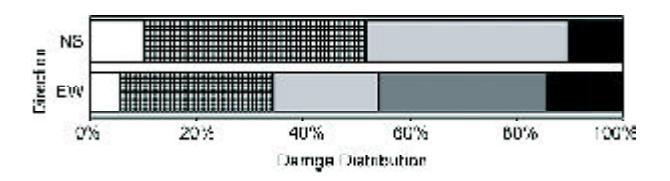
Figure 10. Distribution of the wall damage level in Governor's building.

distribution of the wall damage level in each direction was shown in Figure (10). The average damage level of all walls in the *EW* direction of 2.3, which is calculated as the mean value of damage levels of walls in Figure (10), is larger that in the *NS* direction of 1.7, which means the recurvity of the input motions, estimated by the wall ratios (*NS*⁻*EW*) and damage levels (*NS*<*EV*), corresponds to that of the actually recorded data (*'S*<*EW*).

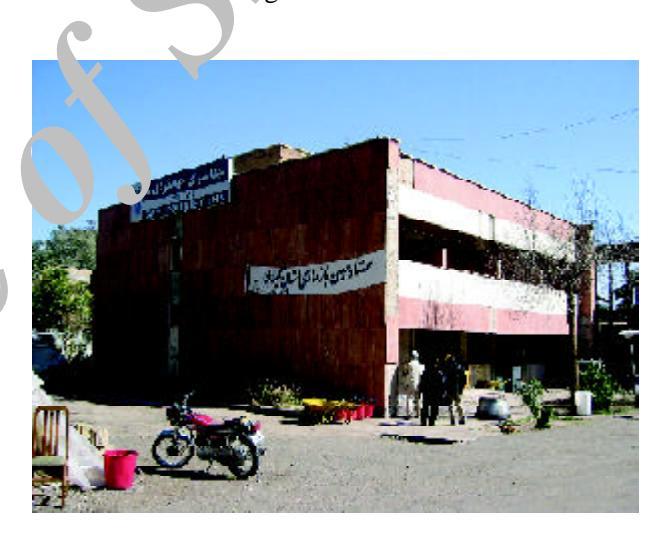
Bam Tourist Inn, us d as hotel and restaurant, is a two-story SM building as shown in Photo (3). The plan of this building is relatively regular, see Figure (11). The damage level, classified by *EMS*-98, was as low as Grade 2 as estimated from Photo (3),

Photo 3. South west view of Bam Tourist Inn.

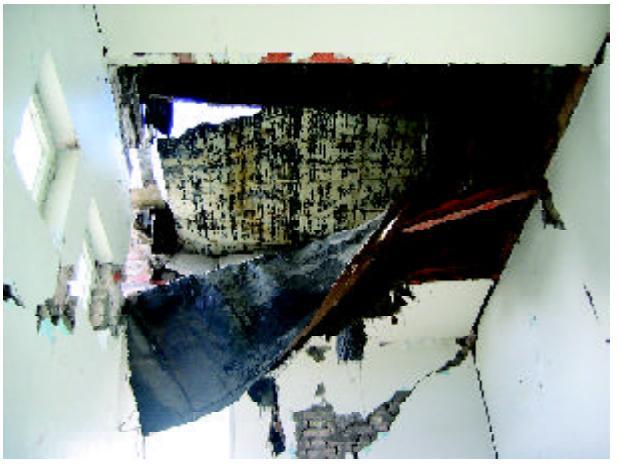
however, the roof of the penthouse fell down as shown in Photo (4). The wall ratio in the *NS* direction was 9.4%, which was much larger than those of Governor's Building, and that in the *EW* direction was 5.5%. The damage levels of the walls, which were evaluated based on the definition in Table (2), were illustrated in Figure (11). Figure (12) shows the distribution of the wall damage level in each direction. The averaged damage level of walls in the *NS* direction of 1.3 was a little smaller than that in the *EW* direction of 2.3, which roughly corresponds to the damage level of Governor's Building except the collapsed area.

Photo 4. Falling down of the roof of penthouse.

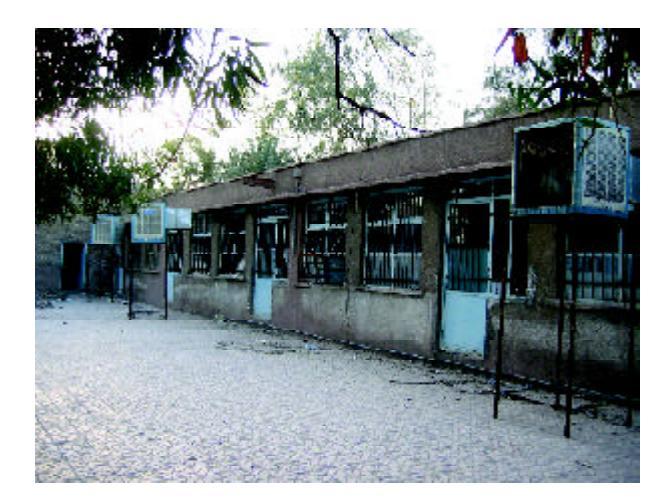
17 Shariwar High-School is located a few hundreds meter west of Governor's Building and consists of three SM buildings. The two single-story buildings escaped severe damage, as shown in Photo (5), although minor cracks were found on brick walls. On the other hand, the two-story building was partially collapsed, see Photo (6). This building consists of intermediate steel frame and exterior brick walls. The floor slab system is a jack arch type, mentioned earlier. The floor plan of the collapsed part is shown

Photo 5. Single-story school building (slight damage).

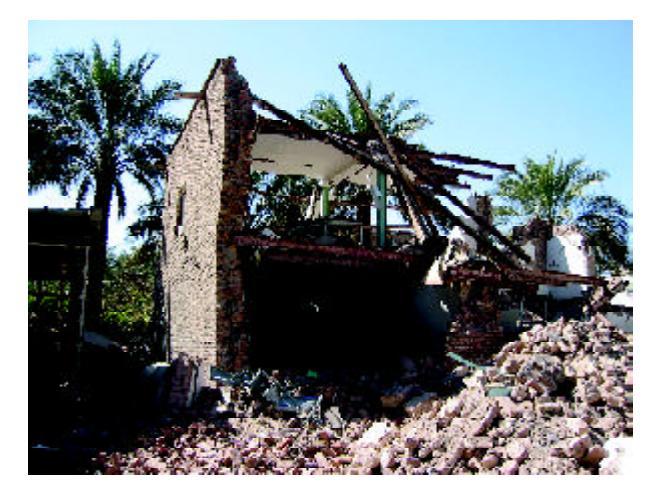
Photo 6. Collapsed two-story school building.

in Figure (14). The roof and floor slab fell off due to the collapse of an east exterior brick wall.

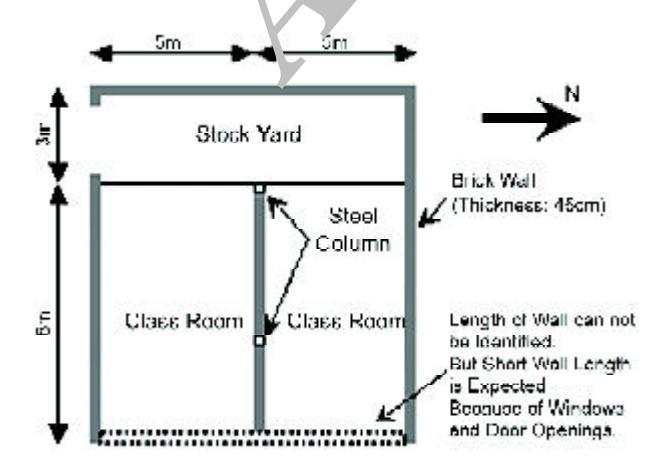
Figure 14. Floor plan of collapsed part of two-story school building.

The wall area ratio in the first story is obtained as 4.1% in *NS* direction and 11.0% in *EW* direction. Note that the value in *NS* was calculated assuming that the area of collapsed east exterior wall is 0, not only because thickness and length of the collapsed wall could not be identified but also very short wall length may be expected due to existence of the windows and doors. The wall area ratio in *NS* direction of 4.1%, in which severer damage occurred, is less than values of the two buildings mentioned before.

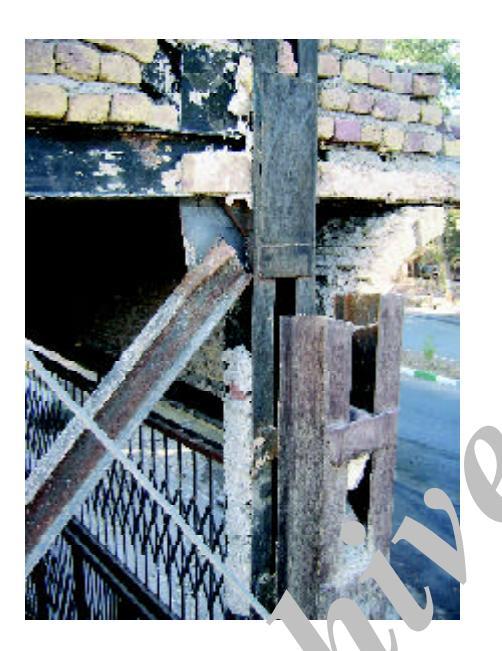
In the first story, fractures of welding joint and buckling of steel brace were observed, see Photos (8) and (9), and as a result, the brick walls were collapsed. Damage to the brick wall in the second story, see Photo (10) was also observed. No remarkable structural damage to the steel columns in *NS* direction was found, although bricks fell off the facade of the building.

Photo 8. Fracture of welded jo. of teel brace.

and (4) floor a h is $1.7m \times 16m = 91.2m^2$. These assumption, five a use shear coefficient, C, of 0.33. This base shear coefficient is relatively lower than the proving ed values for both Governor's Building and Ram Tourist Inn. This may be one reason why this bailding suffered severe damage. Other a sons may be poor quality of welding, see Figures (8) hd (9), and unconfined brick walls.

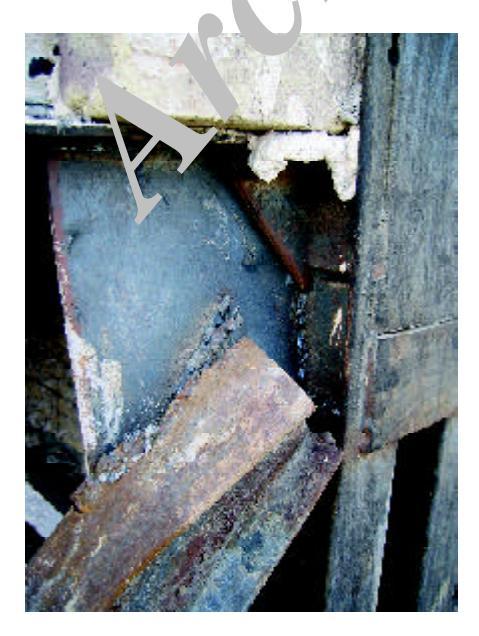
Photo 9. Close-up of Figure (8).

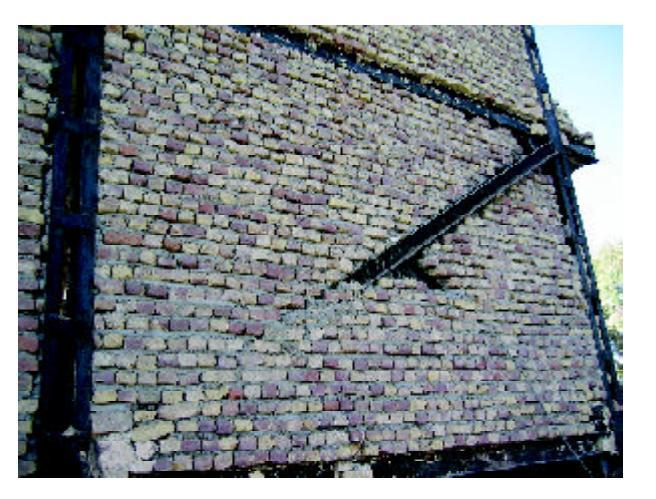
Photo 10: Buckling of steel brace and damage to brick wall.
