On the Nonstructural Elements and Their Behavior in the Bam Earthquake of 26 December 2003

Mahmood Hosseini

Structural Engineering Research Center, International Institute of Earthquake Engineering and Seismology (IIEES), Tehran, Iran, email: hosseini@iiees.ac.ir

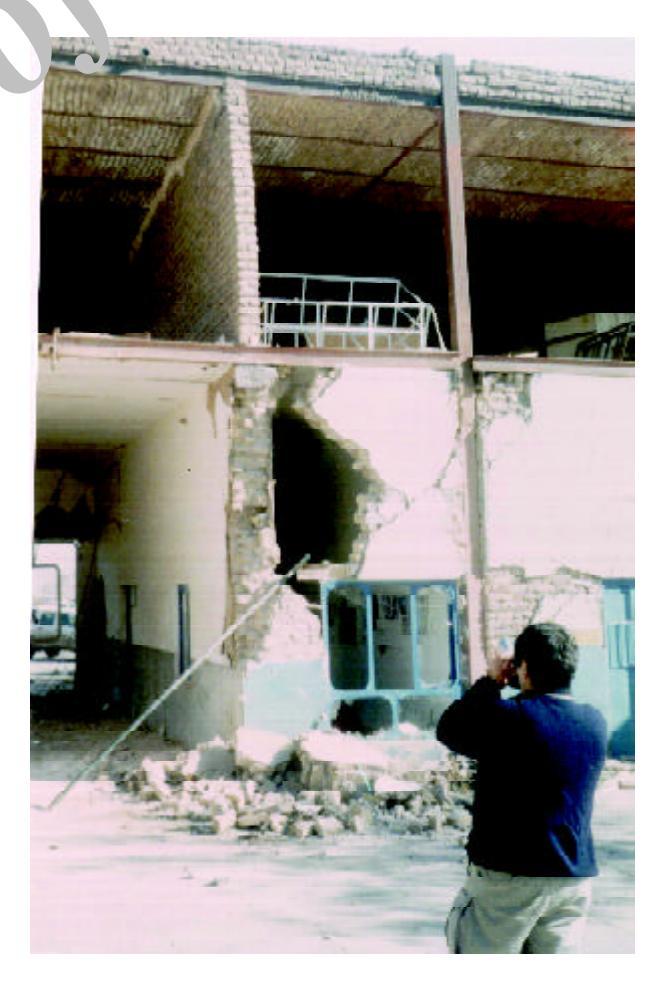
Several cases of damage to external wall masonry were observed, of which some samples are shown in Figures (1) to (4). It is seen in Figure (1), which is related to the recently constructed Emdad Khodro building located by ide the Kerman-Zahedan road, that the external walls is the second story and a part of it in the first story of the building have fallen out. This building have serve case of pounding as it is shown in the lext patterns. The broken glasses of the wind win the first story are also visible in the picture. Note that the e is no sign of the interlocking between the remained wall in the second floor with the one prmerly perpendicular to that, which is now fallen

Figure 1. Collapse of the external walls made of brick masonry in Emdad Khodro building (Photo by M. Hosseini).

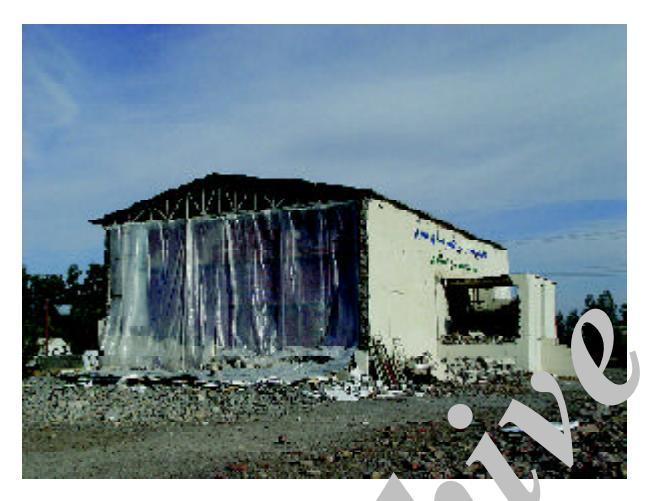
Another case of damage to the external walls is shown in Figure (2), which is related to Khormaye Shargh (East Date) export company. The complete collapse of the end wall of the refrigerating hall is seen in the figure. It is also seen that one wall of the motor house beside the hall has collapsed. A close up of this fallen wall is shown in Figure (3). Examination of the building showed that there was not any internal stabilizing column or external buttress in that end wall. In the case of the motor house wall just its inherent weakness and little integrity with other walls can be

Figure 2. Complete collapse of the free, t wall of the refrigeration saloon of Khormay Shaigh (east date) export company made if concile block masonry (Photo by M. Hosseini).

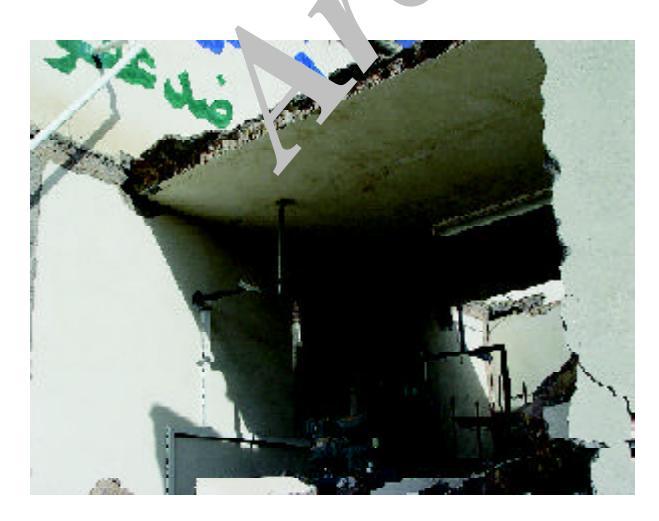
Figure 3. Complete failure of the external wall with partial collapse of the ceiling in the motor house of Khormaye Shargh export company (Photo by M. Hosseini).

the main cause of collapse.

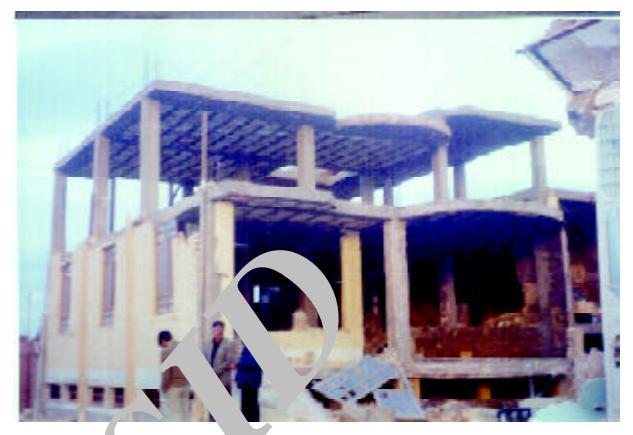
Other samples of the external walls failure are shown in Figures (4) and (5). The little integrity of these walls and their weak connections with the structures are believed to be the main causes of failure in these cases.

Figure 4. Comapse of external walls in an under construction R/C build ng, whose skeleton remained i ntact after the q_ake - Note to the fallen out window as well (Photo by M. Hosseini).

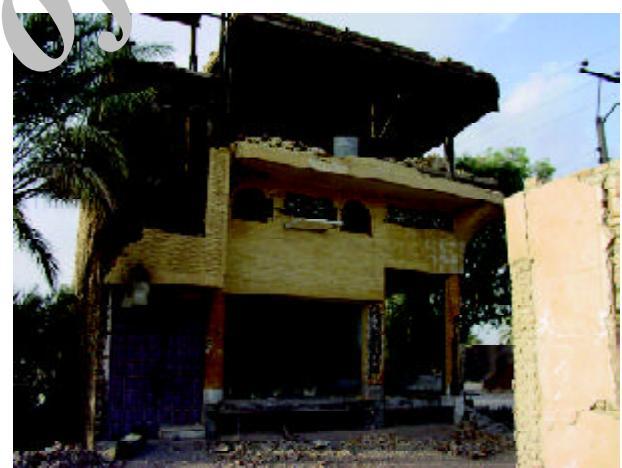
Figure 5. Collapse of the external wall masonry in the second and third stories of a 3 story steel structure building the roof parapet has fallen as well (Photo by M. Hosseini).

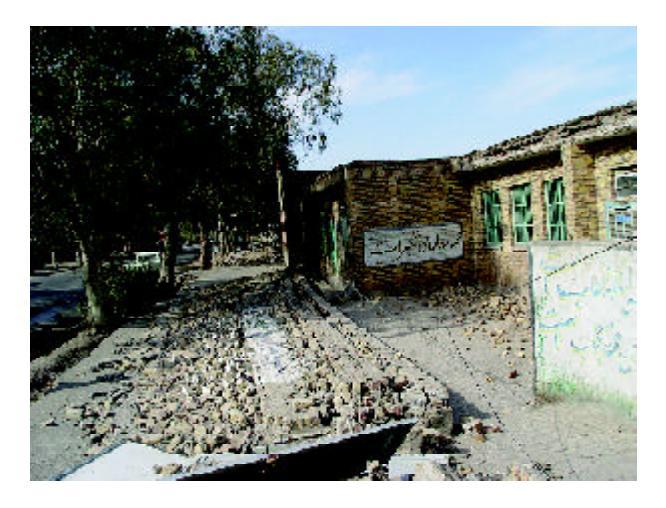
The main reason behind the collapse of these yard walls, as it can be seen in Figures 6 and 7, is in addition to their inherent weakness, the lack of, or the long distance between buttresses [loghaaz-haa].

Figure 6. Toppled brick wall - Note to the fallen parapets as well (Photo by M. Hosseini).

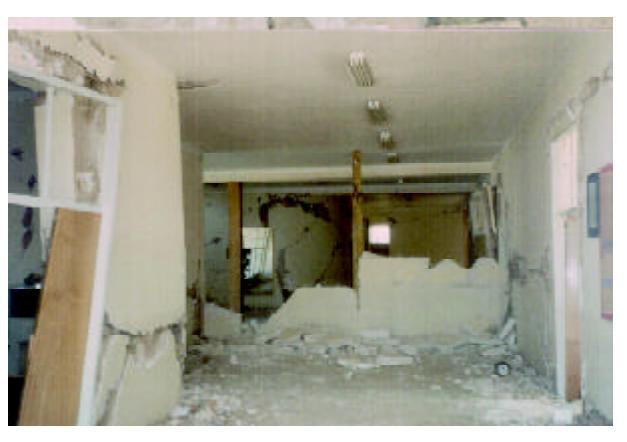
Figure 8. Severely damaged interior wall made of gypsum panels (Photo by M. Hosseini).

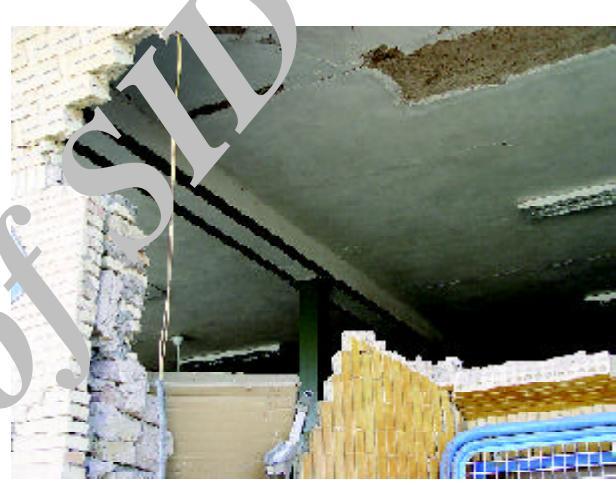
Figure 9. Severely damaged interior partition (Photo by M. Hosseini).

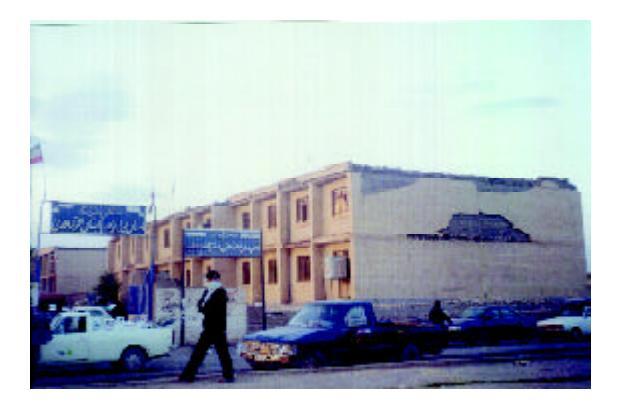
Figure 10. Damage to the so called 3cm brick facade in the second story of the Hijab girls' mid school (Photo by M. Hosseini)

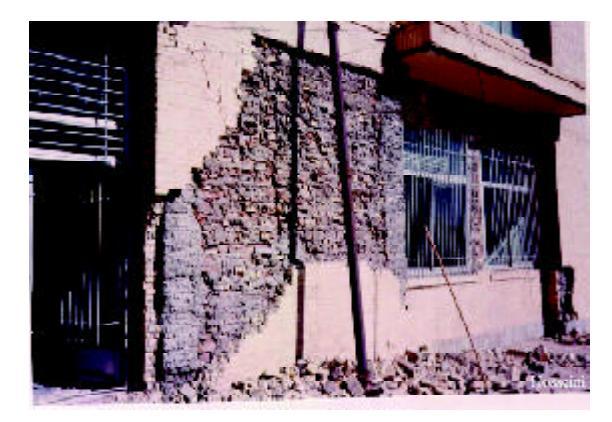
It is noticeable in Figures (11) and (12) that the window glasses have remained intact while the brick facades have gotten severely damaged. It is also notable that the parapet of the logistic building of (formerly) Azadi Hotel (presently Iran Parsian Hotel) has not fallen, which can be because of its little height. It should be noted as well that the Iran Parsian Hotel is located far from the causative fault of the earthquake comparing with the Hijab intermediate school or the city electric substation. However, this building suffered extensive nonstructural damages.

Figure 11. Damage to the so called 3-cm brick facade in the first story of the office building of the city electric substation (Photo by M. Hosseini).

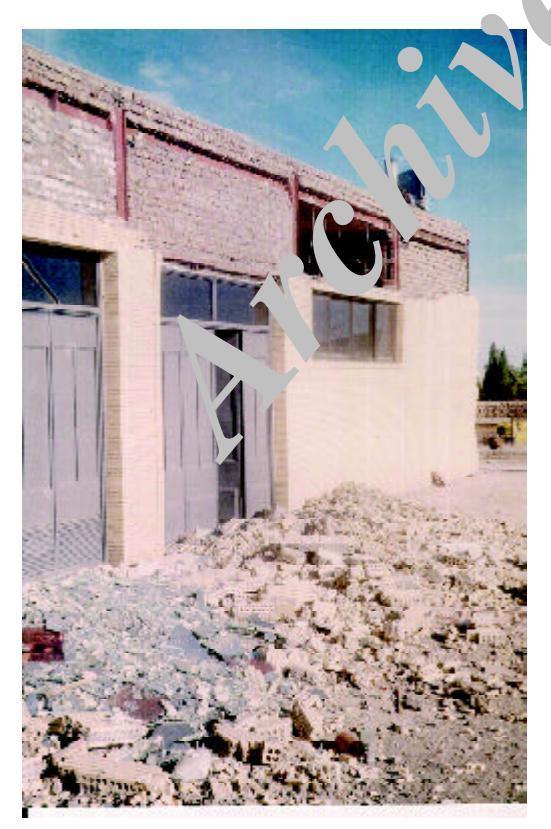
Figure 12. Damage to the brick facade in the top part of the walls in the logistic building of Azadi Hotel (Photo by M. Hosseini).

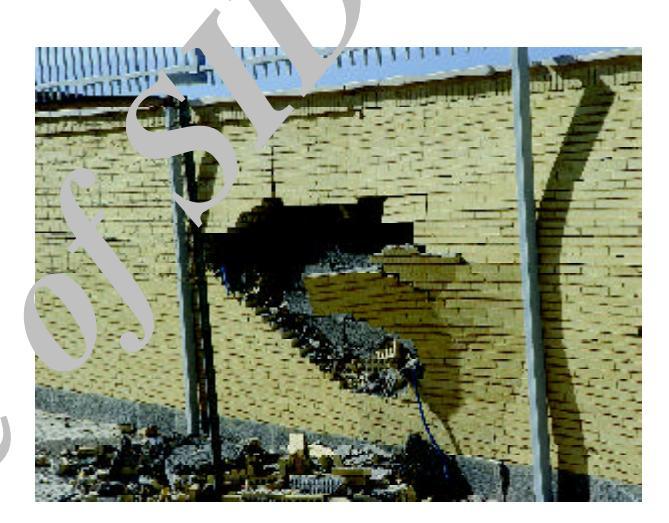
An interesting point, which is visible in Figure (13), is the lack of cohesion between the main wall masonry and the brick façade. The very clean surface of the concrete block masonry of the wall in this figure shows clearly this lack of cohesion. In the special case shown in this figure it seems the vertical box profiles of the top fence have prevented the façade form the complete collapse. Other interesting point is the detachment of the group of bricks with the used mortar behind them, which are stuck together and made a big piece of debris. It is obvious that falling of such a big piece from a high elevation can be very harmful to the subjected people. Nevertheless, this type of integrity between the bricks and the mortar can help their retrofit as described. section 5 of this paper.

Figure 13. Damage to the brick facade in a yard wall (Photo by Mahmood Hosseini).

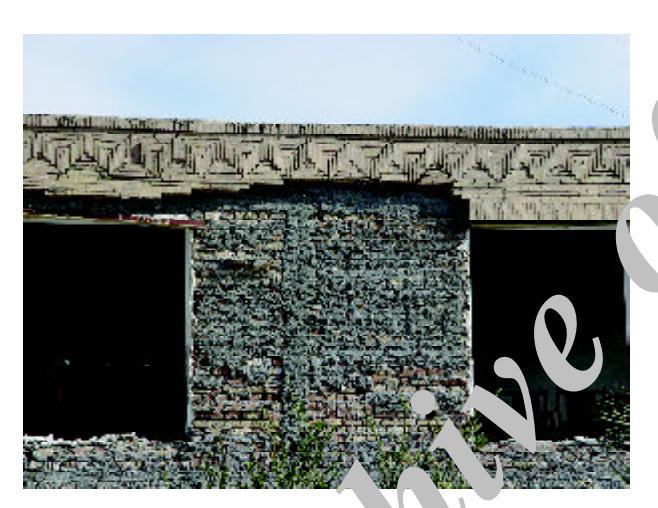
Figure 14. Failure of the brick facade the external wall of a residential building - ic.e to to popped out windows as well (Photo by M. Hossoini).

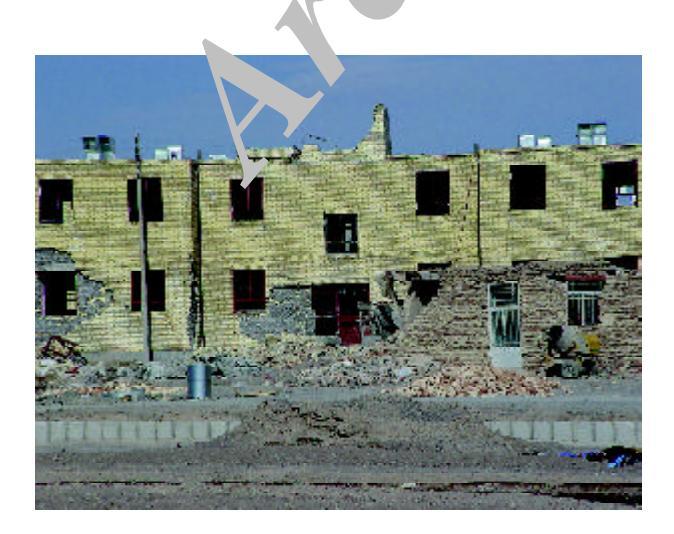
Figure 15. Damage to the brick facade in lower part of the two story residential buildings - Note to the collapsed penthouse as well (Photo by M. Hosseini).

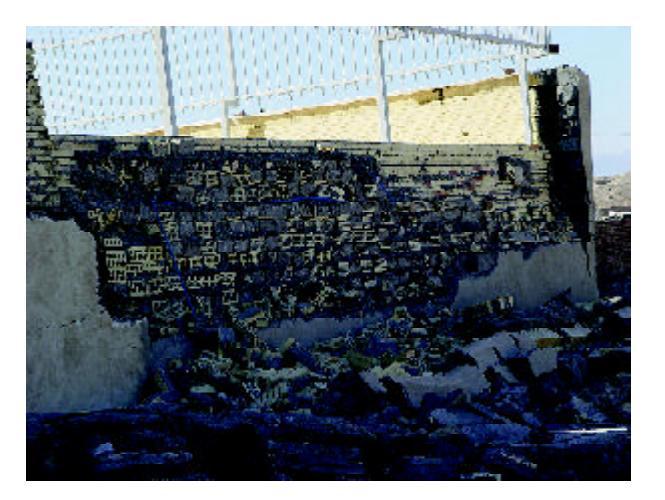
Figure 16. Damage to the plastered brick and block facade in a yard wall, a by M. Hosseini).

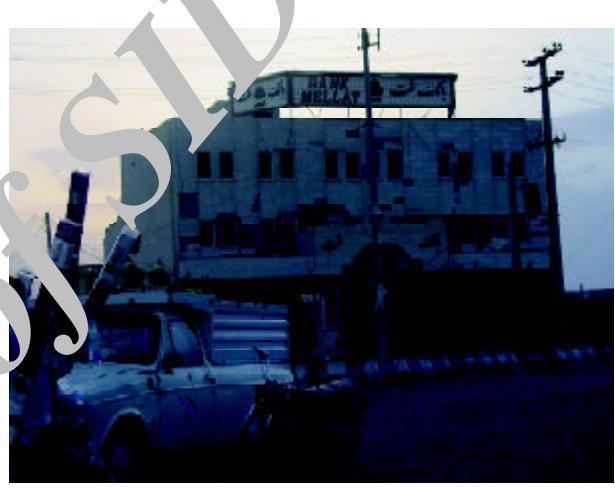
The sample of damaged stone façade is shown in Figure (17). The scattered locations of the detached tiles of the façade on the elevation of the building

Figure 17. Damage to the stone tiles facade in Ban k Mellat building (Photo by M. Hosseini).

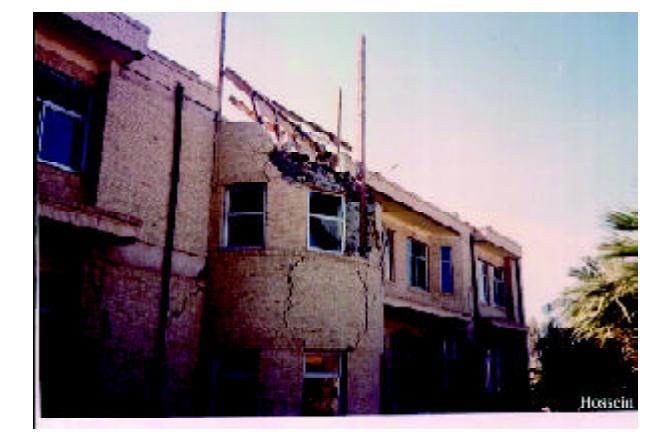
Figure 18. Severely damaged staircase roof in the office building of the city electric substation-Note to the broken glasses as well (Photo by M. Hosseini).

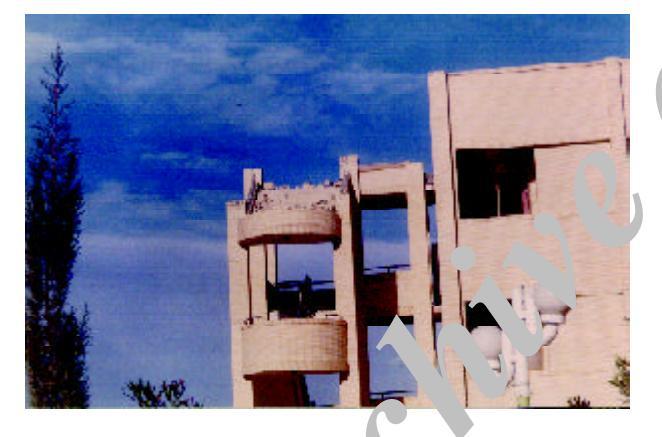
is visible in Figures (19) and (20). In a very recent study entitled "Post-Earthquake Quick Inspection of Damaged Buildings in Bam" (Moghadam and Eskandari, 2004) it is reported that in almost 75% of

Figure 19. Damage to the stainal roof in the three story building of Azadi Herter (Pr. Jy M. Hosseini).

the inspected buildings the main reason of collapse of the penthouses has been the lack of structural system or lack of structural integrity [31]. They also states that according to the inspection in more than 25% of cases both stairs and their sidewalls have been damaged, in more than 20% of cases just the sidewalls were damaged, while the stair itself was undamaged, and in less than 10% of cases, the stair has been damaged, while its sidewall was undamaged.

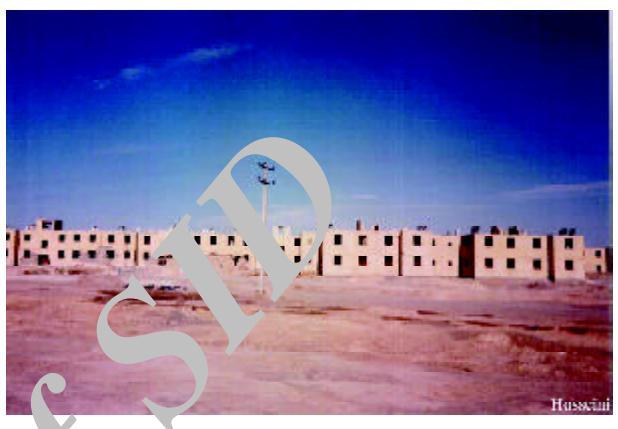
Figur **?1.** Severely damaged or totally collapse penthouses in the residential complex two story buildings (Photo by M. Hosseini).

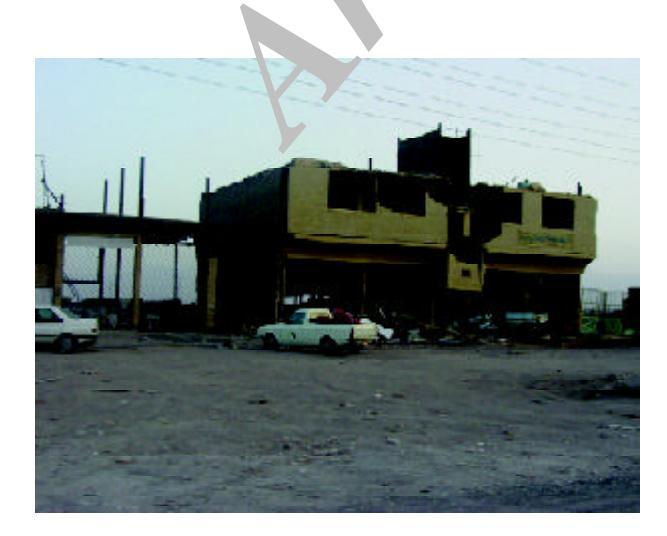
Figure 20. Severely damaged staircase in a commercial building (Photo by M. Hosseini).

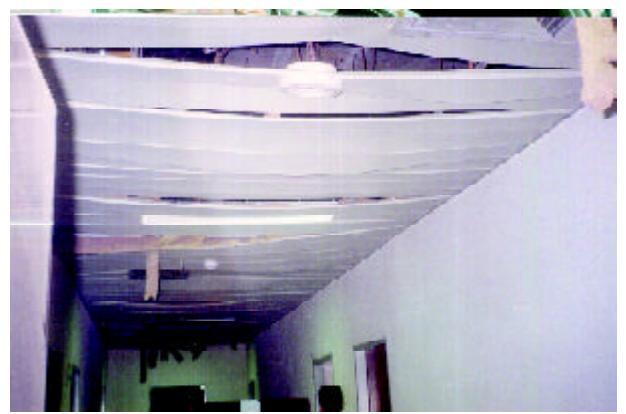
The most important building in which this kind of nonstructural damage was observed was the Bam Airport Terminal. It can be realized in Figures (22) and (23) that although the false ceiling parts seem not to be heavy, because of their high length, on the one hand, and the strong vertical component of the ground motion, on the other, they have suffered from a kind of buckling instability, resulted in their falling down.

Figure 22. The deformed parts of the false ceiling in the Bam Terminal Building (Photo by Mahmood Hosseini).

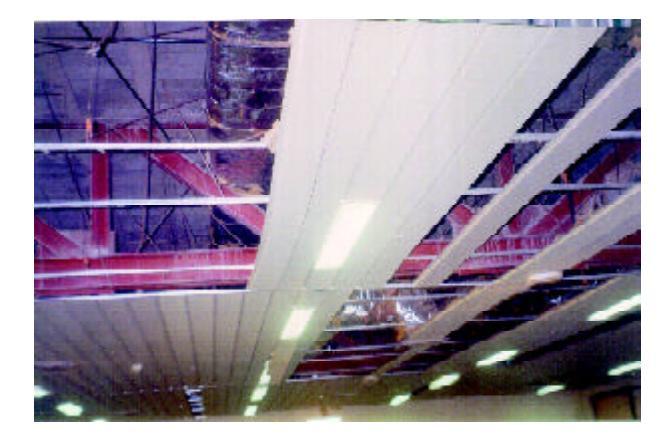
Figure 23. The false ceiling of the Bam Terminal Building, of which some part have fallen down because of instability (Photo by M. Hosseini)

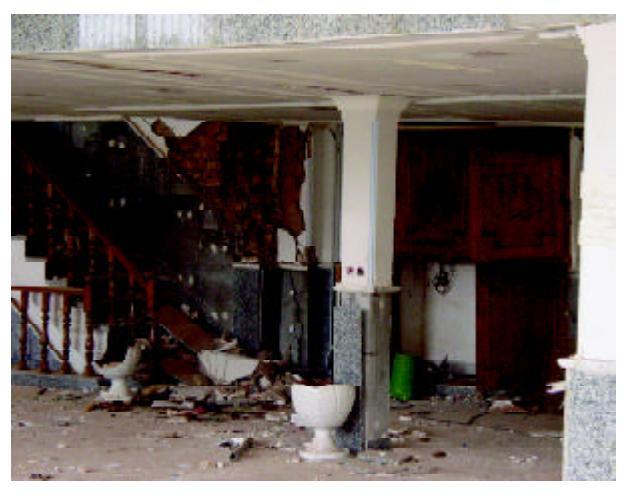
Figure 25. Severely imaged gypsum layer finishing of the interior wall one Bank Refah Karekaran building (Phr. v M. Huseini).

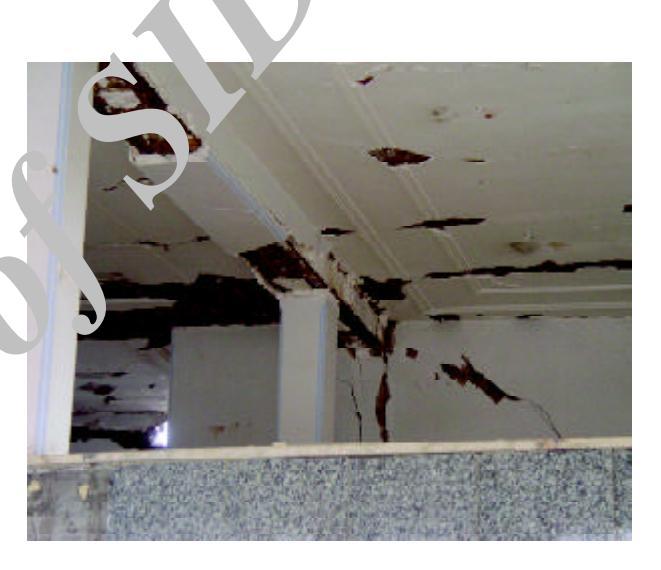
Figure 26. Severely damaged gypsum layer finishing of the ceiling of the Bank Refah Karekaran building (Photo by M. Hosseini).

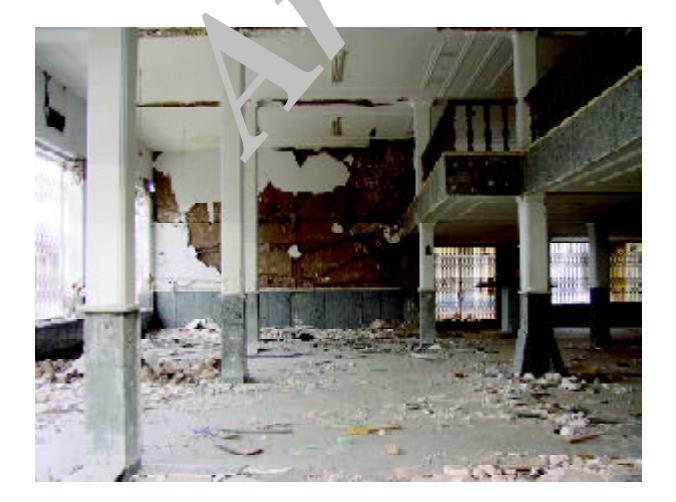
Figure 24. Severely damaged gypsum layer finishing of the interior wall of the Bank Refah Karekaran building (Photo by M. Hosseini).

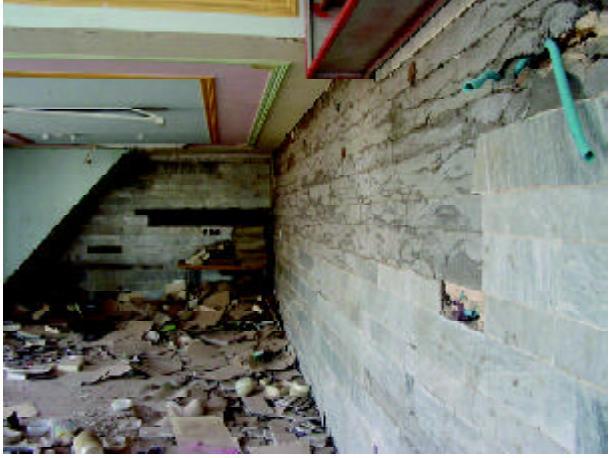
Figure 27. Severely damaged stone tile finishing of the interior wall of the Bank Refah Karekaran building (Photo by M. Hosseini).

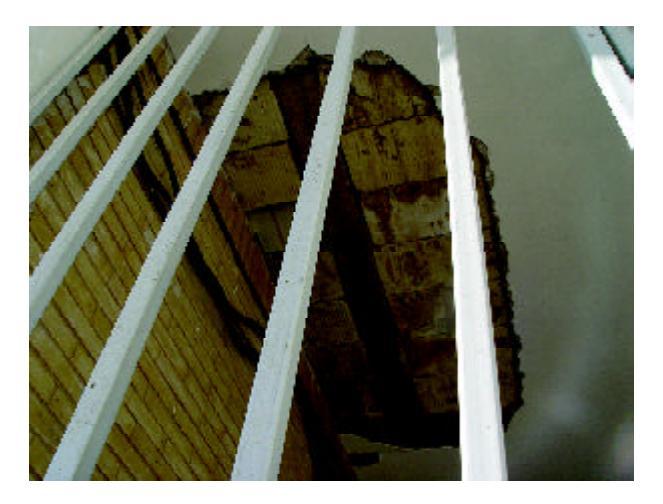
Figure 28. A big part of gypsum veneer of the ceiling has separated and fallen (Photo by M. Hosseini).

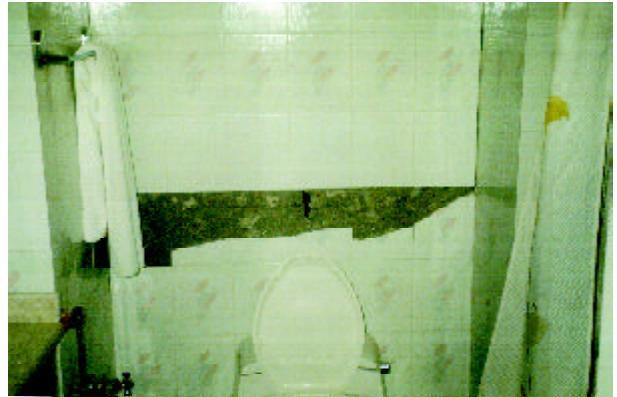
Figures (29) and (30) show the damages to the interior veneers in the Azadi (Iran Parsian) bote'. The veneers of the upper part of almost all of cold ns in the lobby were damaged as shown in F ure (29). There were also some damages \rightarrow the ceramic tile veneers in the bathrooms of the h el as shown in Figure (30). An interesting point is that just a small part of the column veneer is the part which is covered

Figure 30. A sample damages to the ceramic tile interior veneers in the bath rooms of Azadi (Iran Parsian) hotel (Photo by M. Hosseini).

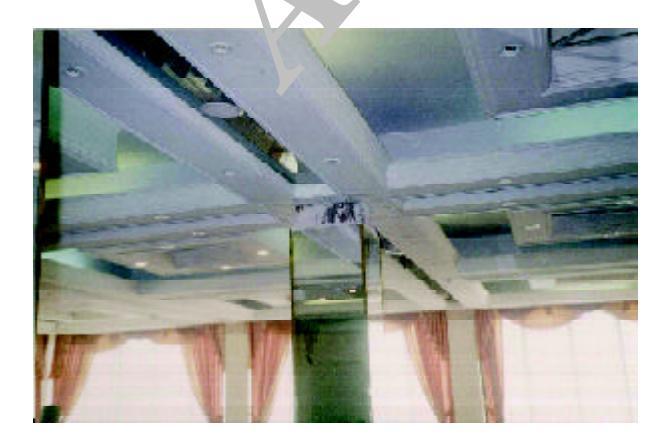
Figure 29. A sample of damages to the veneers of the columns tops in Azadi (Iran Parsian) hotel (Photo by M. Hosseini)

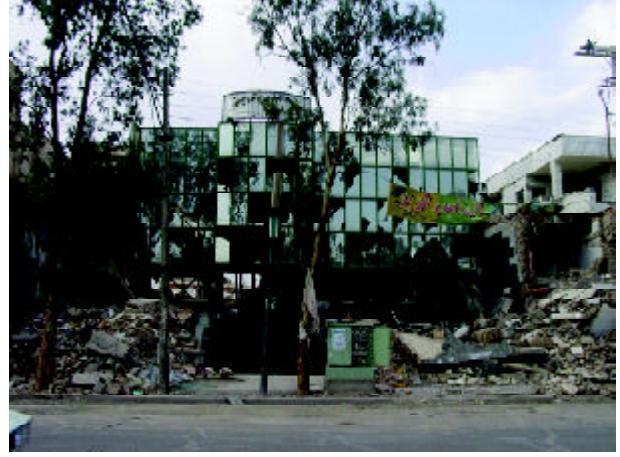
Figure 31. Damage to the glass facade of trade and tourism building (Photo by M. Hosseini).

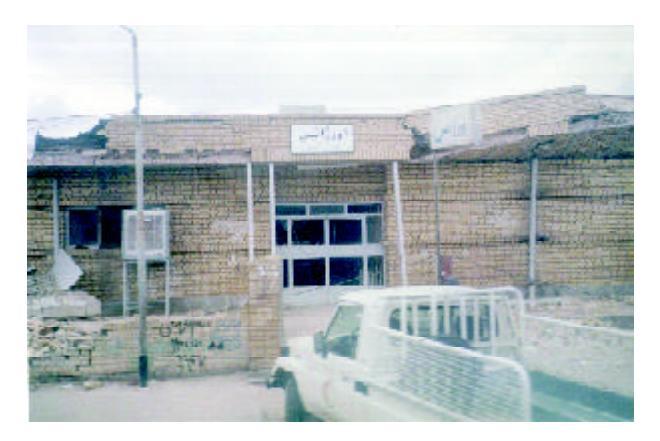
Figure 32. Damage to the glasses of widows in the Emergency Section of the city hospital (Photo by M. Hosseini).

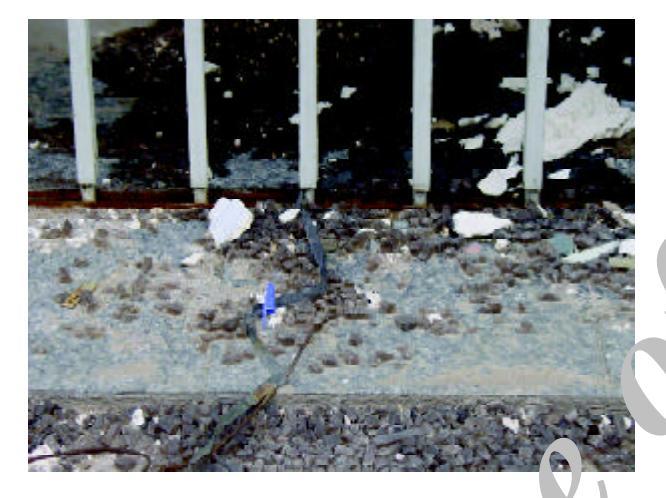
Figure 33. Splashed Parts of the broken thick sate of of Bank Refah Karekaran buildin Photo N. Hosseini).

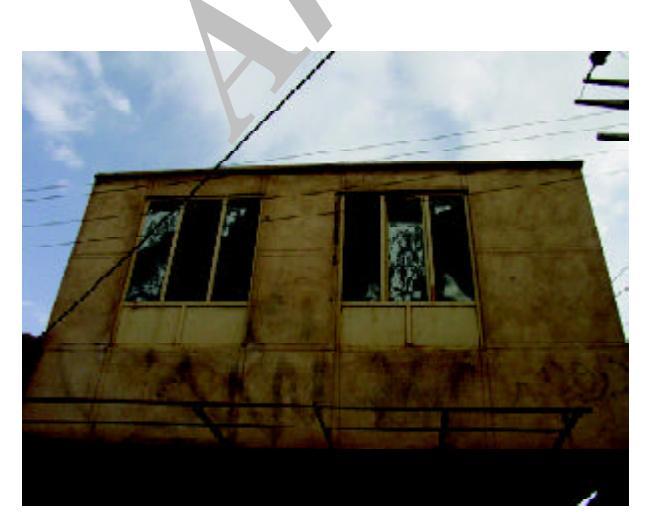
Figure (34) shows the brown and glasses of a building, while no crack can be enabled the veneer of the walls. The same case is seen. Figures (35) and (36). This shows that the window glass is more vulnerable than the basele facades. Nevertheless, in

Figure 34. Damage to the glasses of widows in the second story of a residential building (Photo by M. Hosseini).

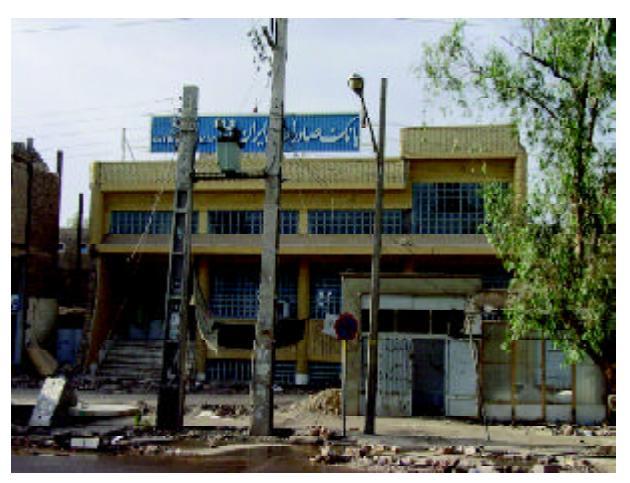
Figure 35. Damage to the glasses of widows in Bank Saderat Iran building (Iran Import Bank) (Photo by M. Hosseini).

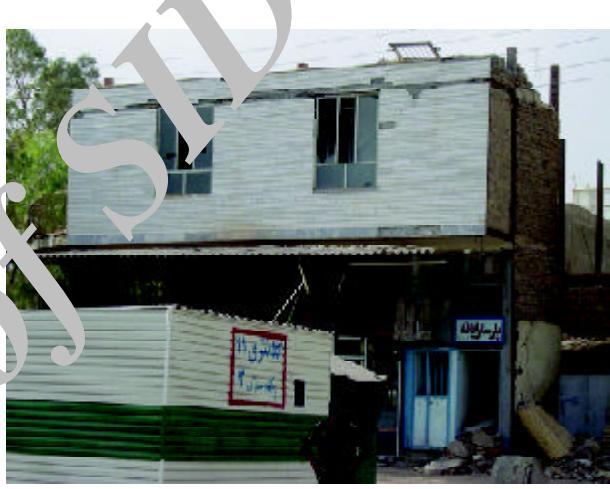
Figure 36. Damage to the glasses of widows in the second story of a residential building - Note to that horizontal damage line in the façade at the level of roof (Photo by M. Hosseini).

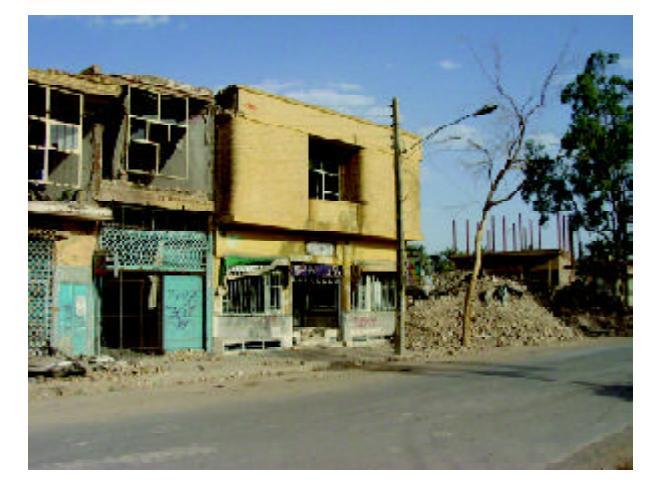
Figure 37. Damage to the glasses of widows in the second story of a residential building (Photo by M. Hosseini).

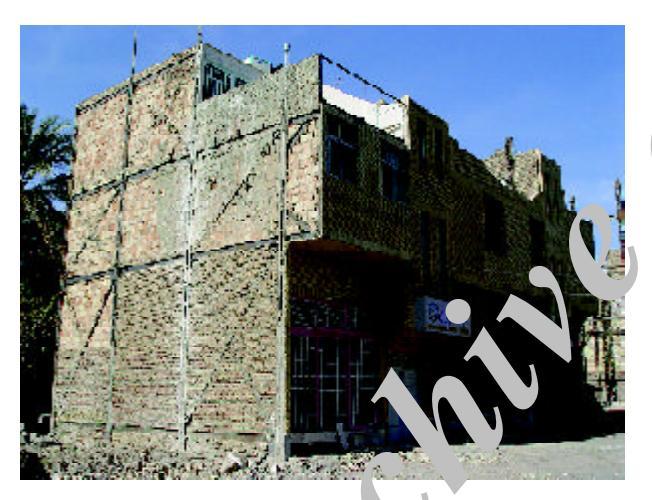
Figure 38. Collapse of parapets ti Irar Insurance Company building (Photo by 'Hoss...i).

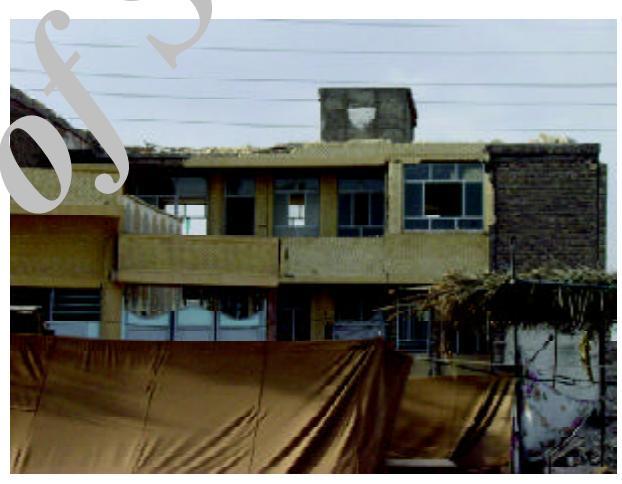
Figure 40. Complete collapse of parapets in a two story building (Photo by M. Hosseini).

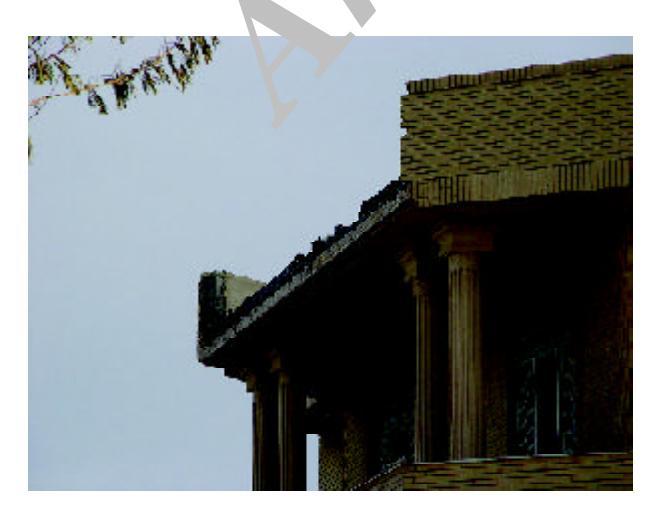
Figure 39. Partial collapse of parapets in a two story building (Photo by M. Hosseini).

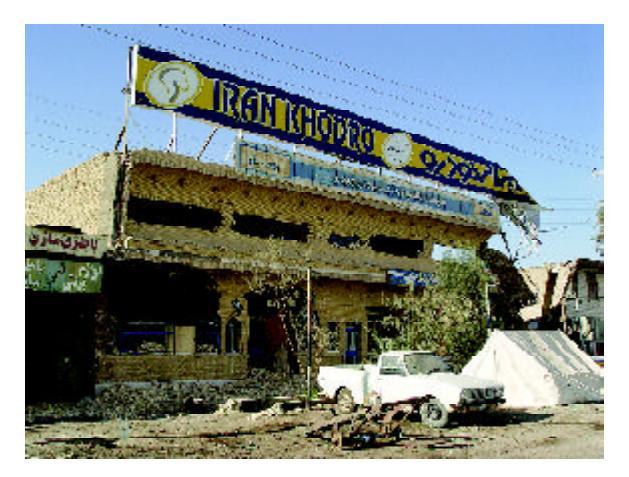
An almost newly observed phenomenon in this earthquake was the popping out of the windows and some door frames. Some samples of these cases are shown in Figures (42) to (44). This phenomenon can

Figure 42. The windows in Iran Khodro building popped out of walls (Photo by Mahmood Hosseini).

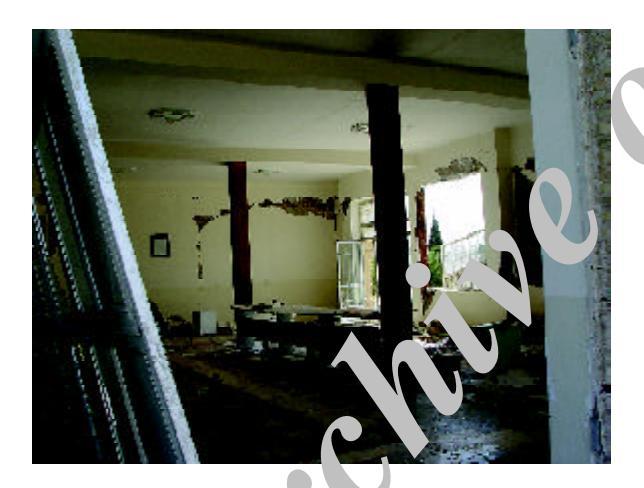
Figure 43. A popped ou kindov. ... the electric substation office building (K to by M. Hosseini).

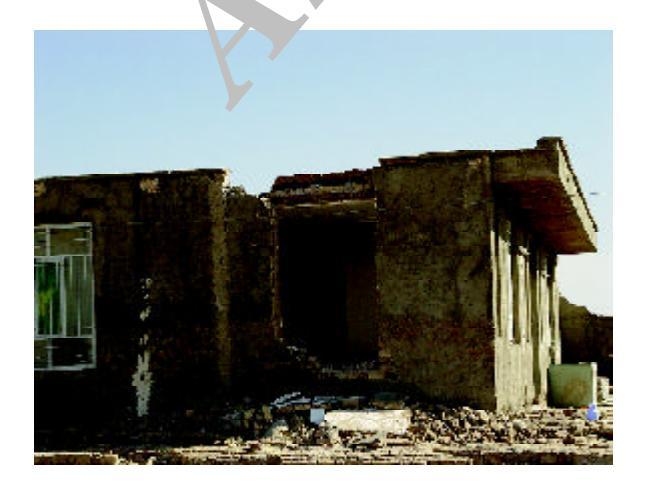
Figure 44. A popped out window in a one story residential building (Photo by M. Hosseini).

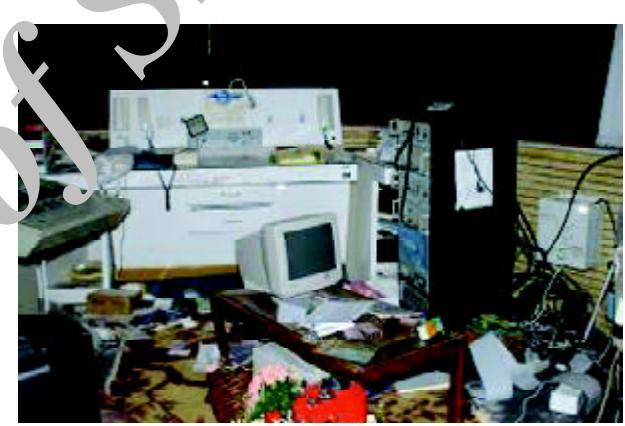
The cases of damage to mechanical and electrical facilities of building were not observed so much in this earthquake. Nevertheless, the observed cases had very adverse conservences. For example, the failure of these facilities in a Bam Airport Terminal and particularly its control to wer resulted in the interruption of the about corracion for several hours. It could be understood for some sigure (45) that some of electrical

Figure 45. The failure of mechanical and electrical facilities and interior equipment of the Bam airport control tower (Photo Source: http://www.irna.ir/melli/bam/photo_ index6.htm)

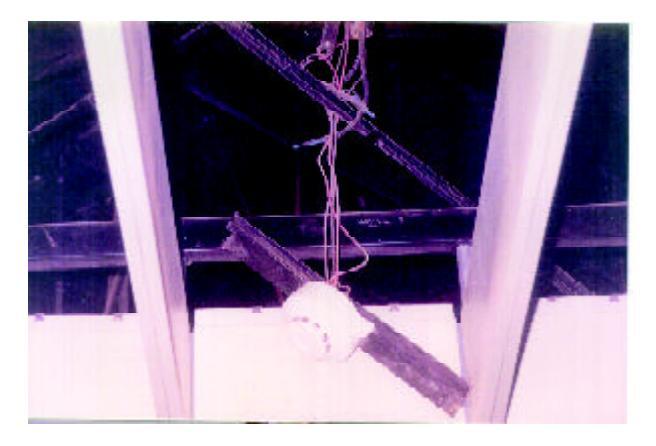
Figure 46. The failed smoke detector of the Bam airport (Photo by M. Hosseini).

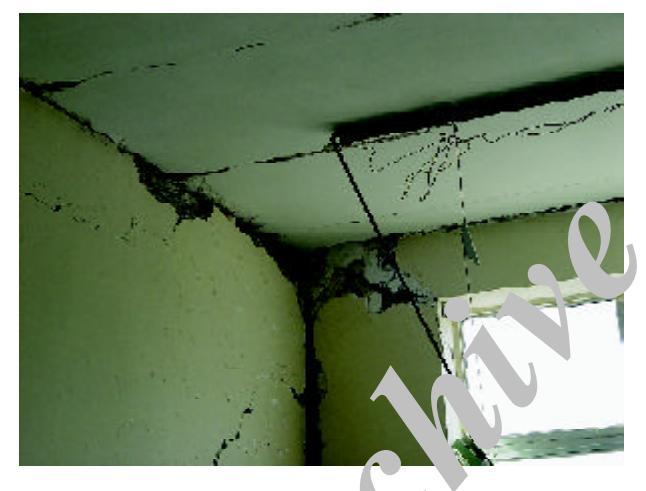
Figures(47) and (48) show some samples of damage to the electrical facilities. Figure (47) shows the failed light fixtures in the office building of the city electric power substation. The main reason behind this failure is the weakness of connections. Other case of damage to electrical system is shown in Figure 48, which depicts the pull out of the protective tubes of electric wires in the office building of the city electric power substation. The main reason behind this kind of failure seems to be the potential weak lines in the finishing due to the presence of the wire protection tubes, which are in fact some mainly hollow spaces. The partial failure of the ceiling in Figure (48) is also notable. This has been in fact an

Figure 47. The failed light fixtures the office building of the city electric power to stat. Photo by M. Hosseini).

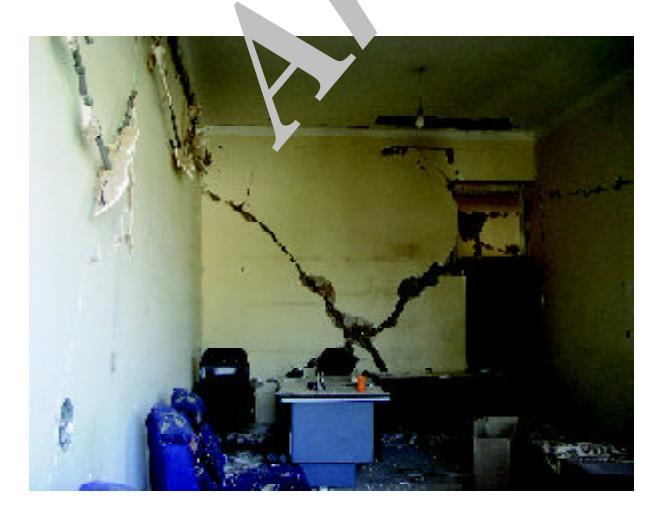
Figure 48. The pulled out protective tubes of electric wires in the office building of the city electric power substation (Photo by M. Hosseini).

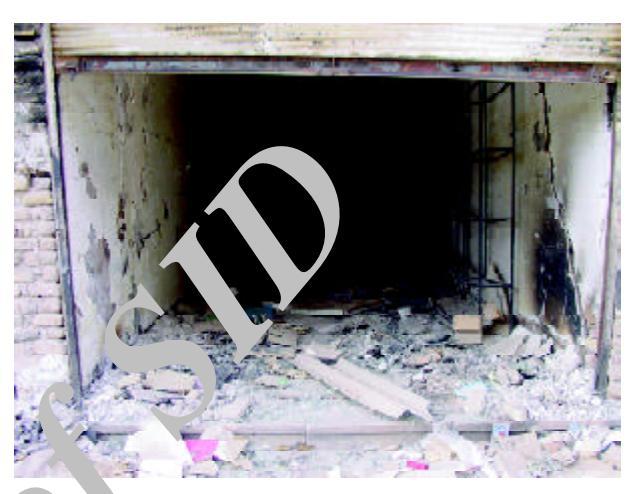
As in many of the past earthquake this event had also some cases of post earthquake fires, which were mainly due to the damage to the electrical facilities. Figure (49) shows a partially burnt shop, which caught fire because the failure of its electrical facilities. The fire caused of the deformation of the broken glass pieces as shown in Figure (50).

Fig e 4s A partially burnt shop which got in fire because the iailure of its electrical facilities (Photo by M. Hosseini).

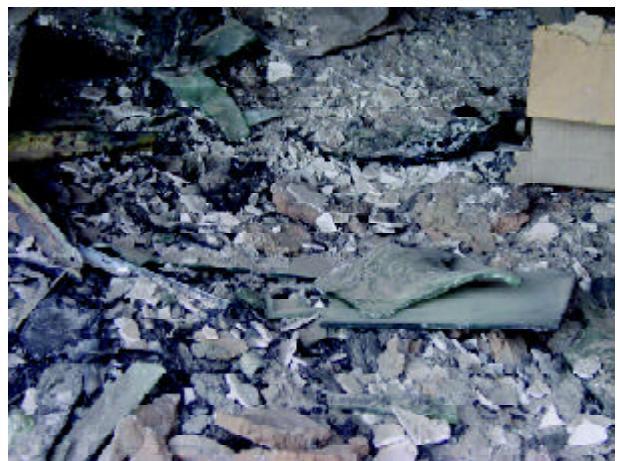
Figure 50. The deformed pieces of glass due to the fire occurred in the shop shown in Figure (49) (Photo by M. Hosseini)

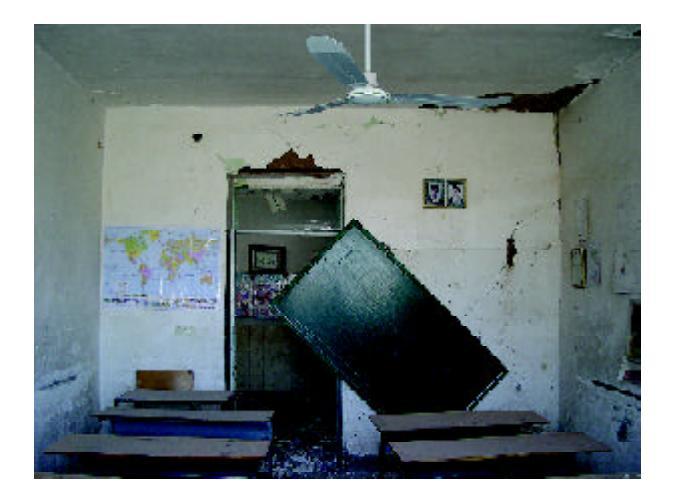
Figure 51. The semi-fallen blackboard due to the weak connection (Photo by M. Hosseini).

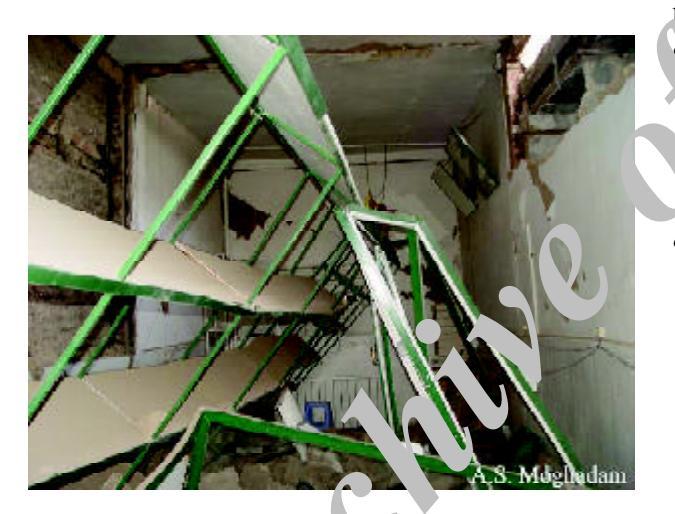
Figure 52. The toppled she is 'a shop board due to their weak connection (Pho. y A.S. Moghadam).

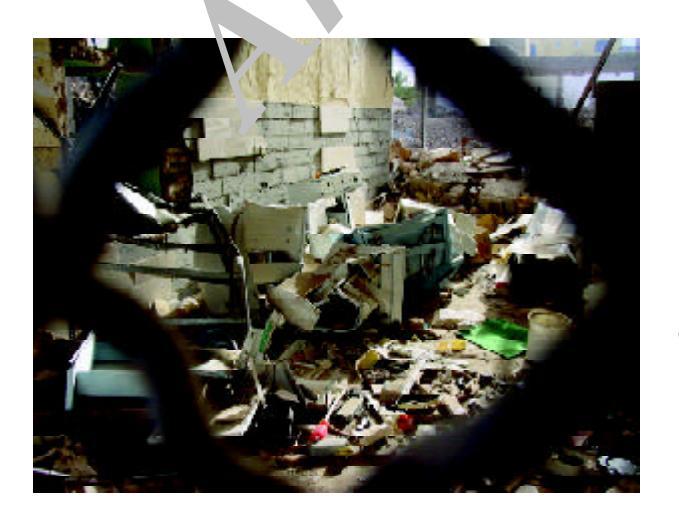
Figure 53. The entirely messed interior equipments of a shop (Photo by M. Hosseini)
