## VULNERABILITY ANALYSIS OF THE HISTORICAL BUILDINGS IN SEISMIC AREA BY A MULTILEVEL APPROACH

L. Binda<sup>\*1</sup>, G. Cardani<sup>1</sup>, A. Saisi<sup>1</sup> and M.R. Valluzzi<sup>2</sup>

<sup>1</sup>Department of Structural Engineering, Politecnico of Milan, Italy

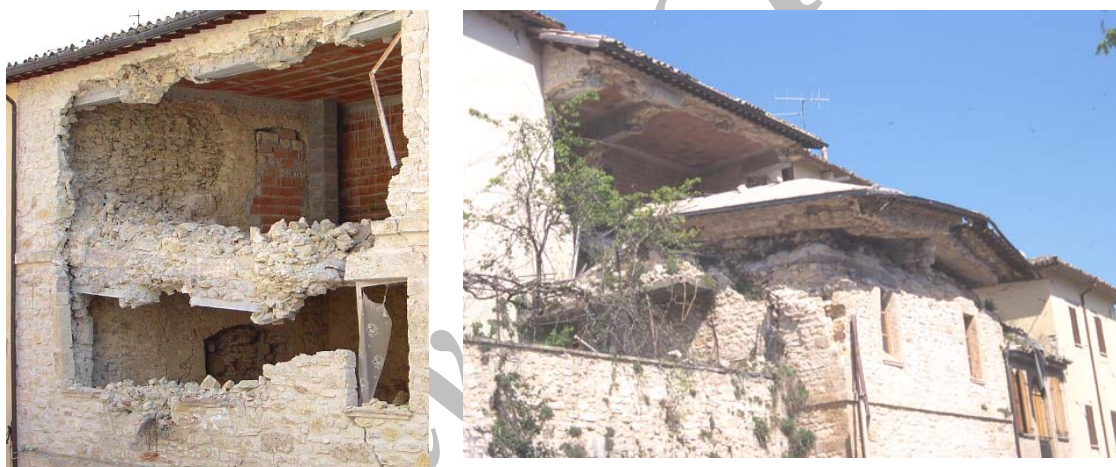
Figure 1. Example of a) Out-of-plane collapse of a wall with r.c. tie beams, b) roof hammering the masonry walls

regions, motivated the study. The damages showed as most retrofitting carried out after the previous 1979 earthquake, mainly performed with upgrading interventions (substitutions of timber floors and roofs with r.c., jacketing, etc.), caused unforeseen and serious out-of-plane effects (large collapses, local expulsions) (Figure 1), due to the “hybrid” behaviour activated from the new and the old structures [1], [2]. That effect was not clearly predictable by the existing assessment methods also suggested by the Italian as well as other seismic codes. The proposed analytical procedures were in fact based on hypotheses often not easy to be satisfied in old historic stone masonry buildings, as the effective strong connection among the structural components and the presence of stiff floors, both characterising the favourable “box” behaviour of buildings under seismic actions. It was also clear that the main cause of inappropriate choice for the intervention techniques was due to the lack of knowledge on the existing materials and on the structural behaviour due to the peculiar type of construction techniques used in the past centuries for the historic buildings.

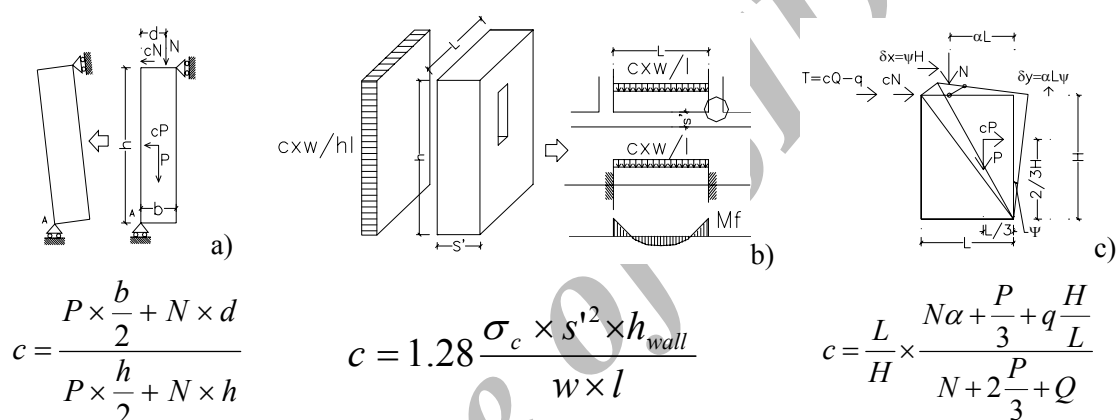
Figure 11. Examples of simple kinematics models for out-of-plane (a: overturning of a solid wall) (b: crushing of the masonry) and in-plane mechanisms (c: effect of in-plane overturning actions)[8].

shear resistance and out-of-plane collapse mechanisms, respectively. It is able to combine different mechanisms for global vulnerability analyses of buildings with sufficient regularity (both in plane and in elevation) and limited height (three storeys or less), and take into account the type of connection among the structural elements. The significant parameter describing the kinematics models is the collapse coefficient  $c=a/g$ , which corresponds to the seismic masses multiplier characterizing the limit of the equilibrium conditions for the considered element. Preliminarily, if the seismic degree of the zone is given, it is possible to execute safety assessments of the buildings in seismic conditions according to the current standards prescriptions (e.g.  $c_{min}=0.28$  for the Umbria region). Some examples of kinematics models and related  $c$  coefficients are given in Figure 11.

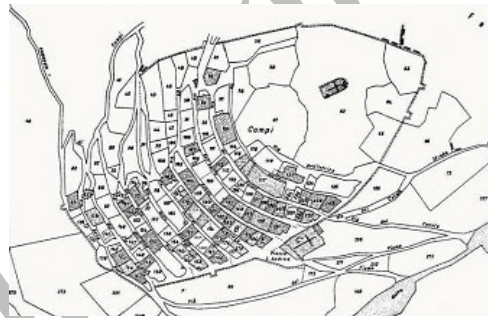
Figure 12. View and plan of Campi

Campi di Norcia (Figure 12) was a late medioeval castle perched on a slope surrounded by walls, and whose buildings are arranged in concentric terraces and narrow streets connected by short radial flights [8]. The only type of building observed in the area is the single family house with two or more floors, built with a simple technique in stonework and timber roof and floor. More complex buildings are derived only by different aggregations of this typology (Figure 13): isolated buildings, row buildings simple or double, block buildings. Due to the ground slope (more than 100 meters from the base to the top of the village), buildings develop following a row typology generally with three floors: the first one with an entrance at the lower street (for stables or deposits), one in the middle and the last with the entrance at the upper street (for living places). The lowest floor is partially excavated in the natural rock. The rooms are covered by barrel vaults, that, despite the several seismic events, are still well preserved even in the collapsed buildings. A detail observed in almost all buildings is that the vaults are backward from the facade of about 1 meter (Figure 13): the reason of that is still unknown. The numerous past seismic events deeply marked this historic centre together with the lack of maintenance throughout the last decades after the second world war.

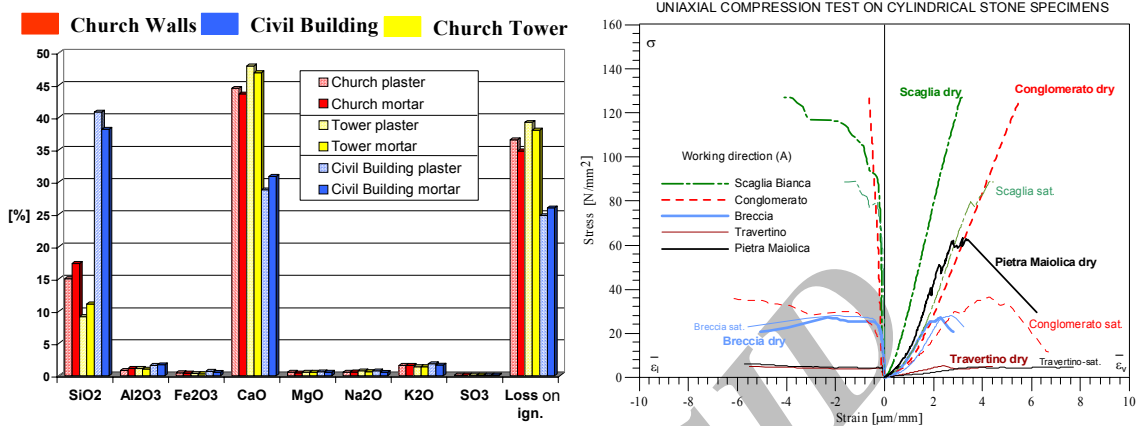
Figure 14. Some results on mortars and stones specimens sampled from Campi [8].

In Figure 14 some results of compression tests carried out on four types of stones sampled on site are shown (white and pink calcareous stone, sandstone and travertine). From the plot it is very clear the difference between the *scaglia* (limestone) strength and the *travertine* strength. This explains the higher use of the *scaglia* in the walls and the use of travertine only for lintels and vaults. Nevertheless in a more recent past when the “rules of art” were lost, the *travertine* was more and more used also in the wall construction both as irregularly or regularly cut elements.

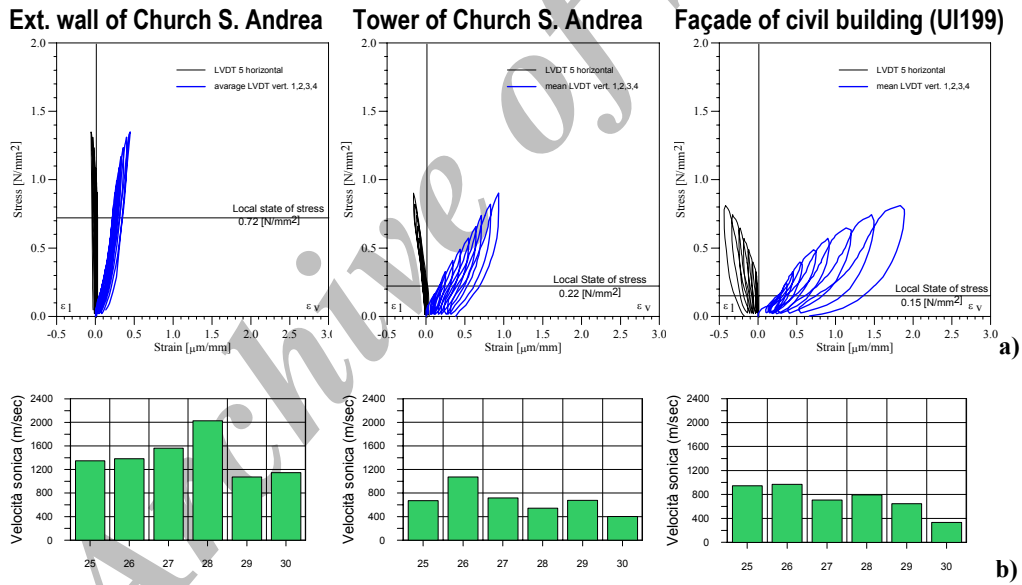
Figure 15. Results obtained with single and double flat-jack tests (a) and the corresponding results of the diagonal surface sonic measurements (b) on: the external wall of a church (left), of a bell tower (middle) and of a civil building (right).

In Figure 15 the results of the tests with simple and double flat jack carried out on some sample buildings of Campi are reported. The results allow to see the different behaviour between the masonry of the important buildings or of complex structures (church or the bell tower) and the private or poor buildings. At the same time it is possible to compare the sonic velocity values (Figure 15(b)) measured in the same areas where the flat jack test has been carried out. As an example it is possible to see that the dwelling masonry is the weakest one (UI199) both for flat jack and sonic test.

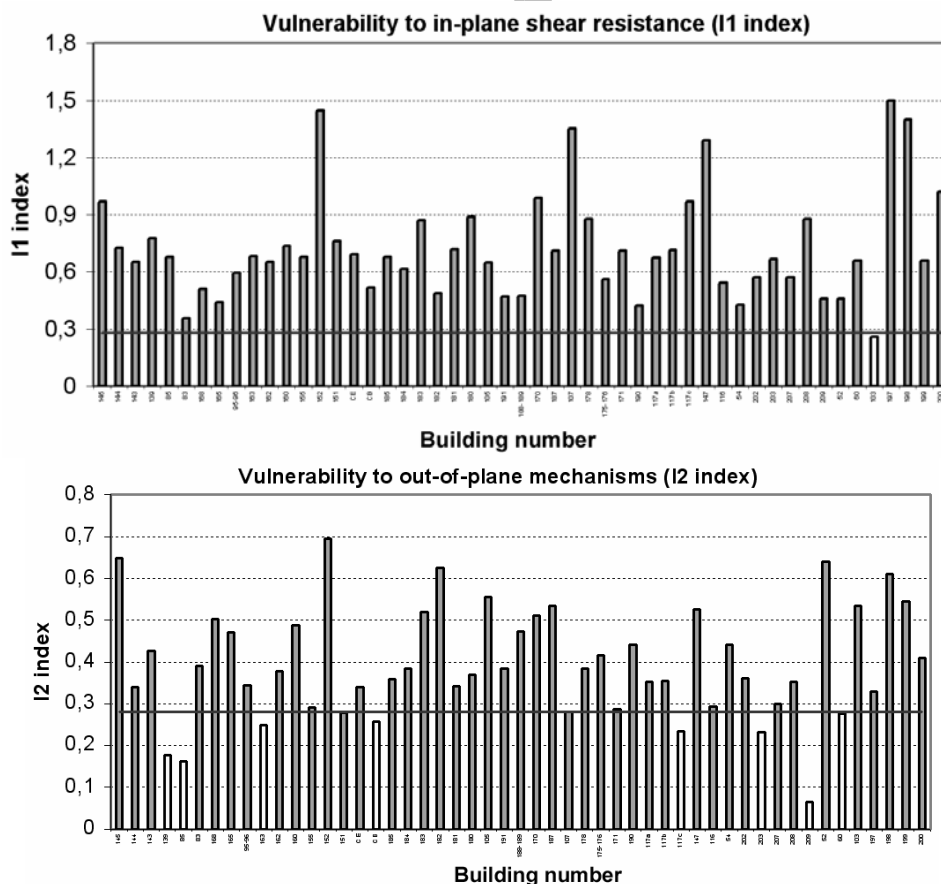
Figure 16. Results obtained by “Vulnus” for the whole centre of Campi: seismic vulnerability

assessment expressed by I1 and I2 indexes. The limit imposed by the Italian seismic standard is 0.28.

Results of the application of Vulnus on the whole center of Campi are depicted in Figure 16. As expected, for all the buildings (except one) the safety is not affected by the shear resistance of masonry panels, whereas main problems are related to out-of-plane mechanisms. About the 25% of buildings present an I2 index lower or very close to the limit imposed by the standards (0.28). The weakest mechanisms are related to the global overturning of façades and overturning of corners.
