Histomorphometric and ultrasonographic evaluations of the rumen in sheep

Mohammad Movahedi Zade^a, Ahmad Reza Raji^a, Ali Mirshahi^b

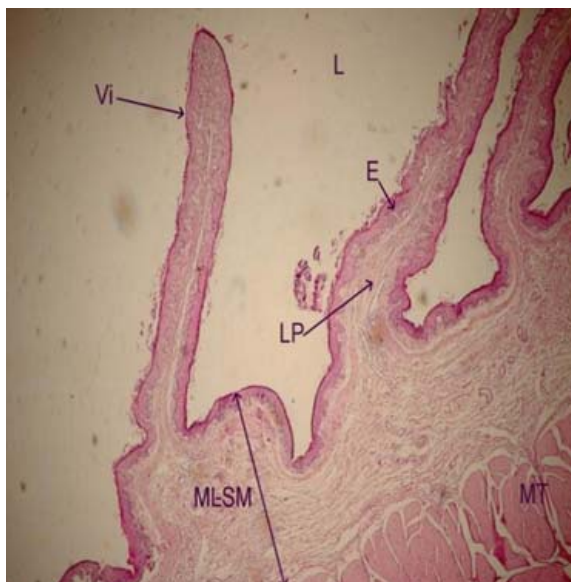
Figure 1
Histological structure of dorsal blind sac. Lumen (L), Epithelium (E), Villi (Vi), Lamina propria (LP), mucosal and submucosal layer (ML- SM), Muscular Tunica (MT), H&E, ×40.

In the histological images of the rumen, the different layers were determined such as, epithelium, lamina propria, tunica mucosa and submucosa, tunica muscularis and serosa (Figures 1, 2, and 3). We concluded that highest average diameter of the mucosa and submucosa was seen in the ventral blind sac of rumen, the highest average diameter of muscle and serous in pillar, and maximum diameter of the walls in pillar (Table 1).

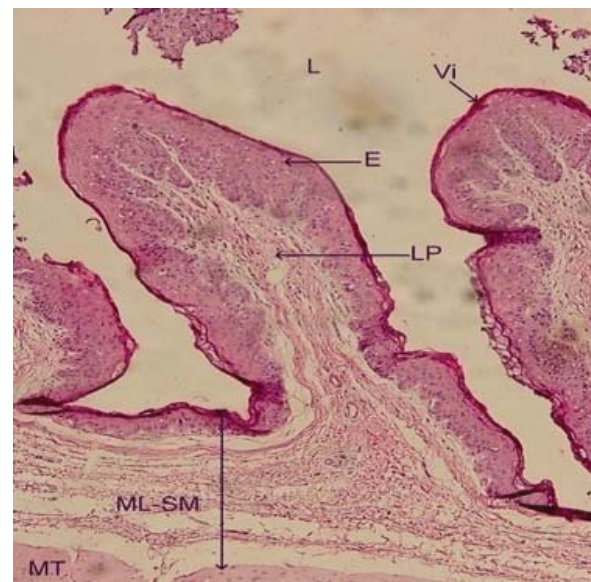
Figure 2
Histological structure of ventral blind. Lumen (L), Epithelium (E), Villi (Vi), Lamina propria (LP), mucosal and submucosal layer (ML- SM), Muscular Tunica (MT), H&E, ×100.

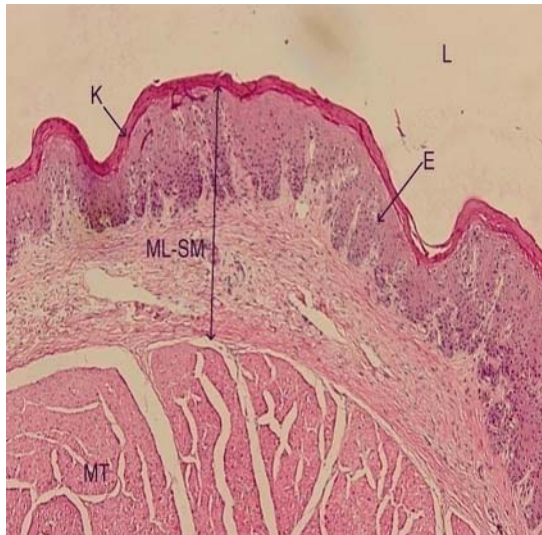
Figure 3
Histological structure of pillar. Lumen (L), Epithelium (E), Kerapreparationtine (K), mucosal and sub mucosal layers (ML- SM), Muscular Tunica (MT), H&E, ×40.

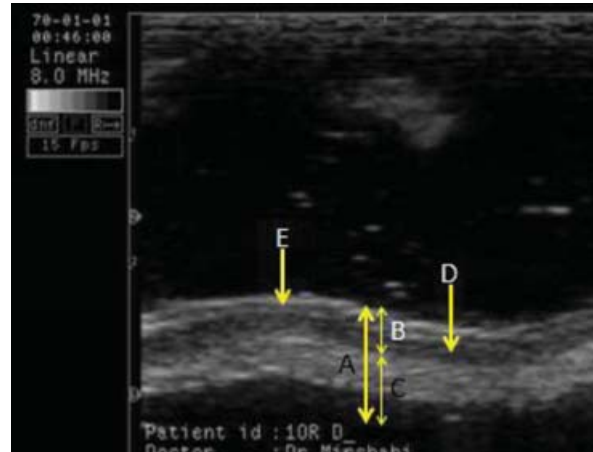
Figure 4
Ultrasonogram of dorsal blind sac. Wall thickness (A), thickness of muscularis and serosal layers (B), thickness of mucosal and submucosal layers (C), muscularis layer (D), serosal layer (E).

In the ultrasonography, the mucosal and submucosal layers of the rumen were hyperechoic than muscular layer; the serosal layer was isochoic to mucosal and submucosal layer. Muscular layer was observed hypoechoic in the wall of the rumen (Figures 4, 5, 6). According to the ultrasonographic measurements of the rumen wall in its different areas, the diameter of rumen had the highest average in pillars, dorsal blind sac and ventral blind sac. The average diameter of the mucosa and submucosa layers was the highest in the ventral blind sac, dorsal blind sac and pillars and the average di-

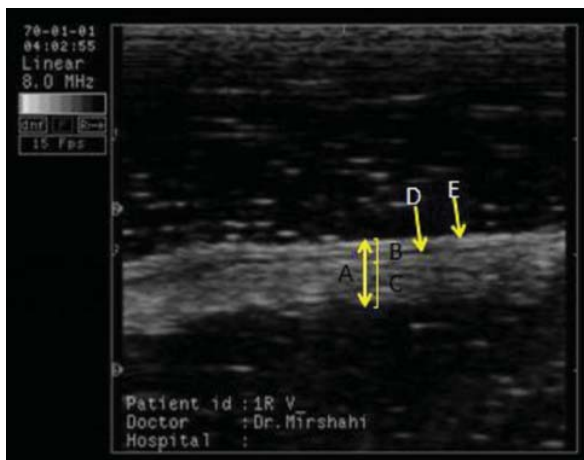
Figure 5
Ultrasonogram of ventral blind sac. Wall thickness (A), thickness of muscularis and serosal layers (B), thickness of mucosal and submucosal layers (C), muscularis layer (D), serosal layer (E).

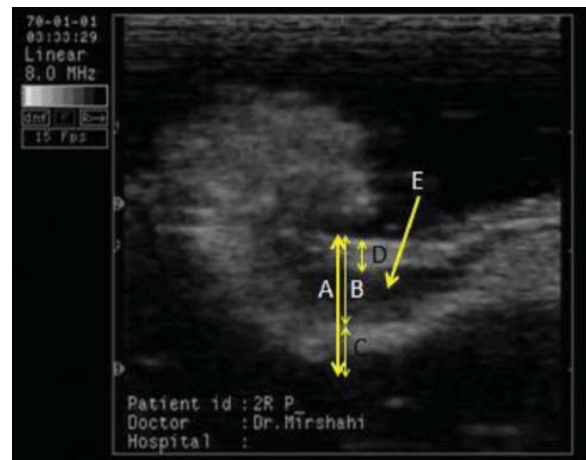
Figure 6
Ultrasonogram of pillar. Wall thickness (A), thickness of muscularis and serosal layers (B), thickness of mucosal and sub mucosal layers (C), muscularis layer (E), serosal layer (D).
