The Effect of Preparation Design on the Fracture Resistance of Zirconia Crown Copings (Computer Associated Design/Computer Associated Machine, CAD/CAM System)

Journal of Dentistry, Tehran University of Medical Sciences, Tehran, Iran (2011; Vol. 8, No.3)

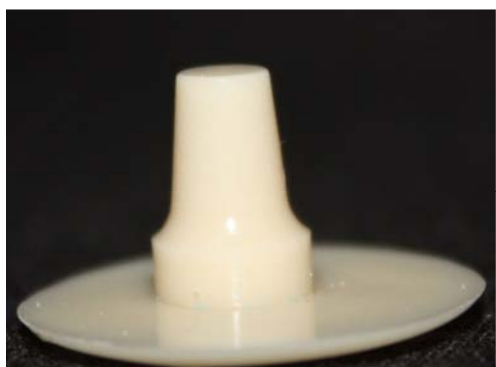
Fig (c1): Epoxy resin dies with chamfer

(figure a1, b1).10 poly vinyl siloxane impressions(PVC, Elite H-D+, Zhermach, Germany) were made and ten epoxy resin dyes

(CW2215, Hunstman-Germany) were created from these Impressions (Fig c1).

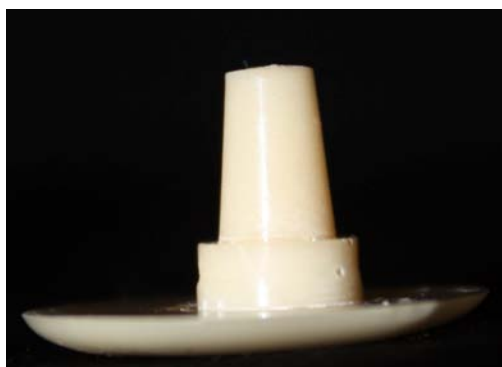
Fig (c2): Shoulder margin

Again 10 PVC impressions were made and ten epoxy resin dyes were created from these impressions (Figure c2) [7,9]. (20 copings were made of a partially sintered ZrO_2 ceramic material by using CAD/CAM technology (Cercon Smart Ceramics, Degu Dent, Hanau, Germany). The copings with 0.4mm thickness and [15,16] 35 μ m cement space[7]. milled out from the presintered ZrO_2 by cercon milling (Cercon, Brain, Dego Dent, Hanau, Germany) and Cercon Heat (Degu Dent, Hanau, Germany) heated.

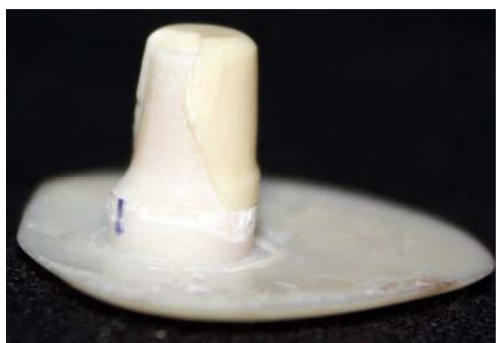
Fig (d1): Fracture area in chamfer

After cementation, excess luting agent was removed and fitness was considered accomplished when two or more investigators determined-by visual inspection-that no marginal gap was visible [7]. Ten samples were stored in a saline solution at room temperature for 24 hours. Mechanical tests were carried out using a universal testing machine (GOTECH AI-700LAC, Arsona, USA). The compressive static load was applied at the center of the occlusal surface along the long axis of dye with a crosshead speed of 0.5 mm/min according to previous studies [7] that starts from 0N and increased until fracture occurred [19]. The fracture load data were automatically recorded using by vista software, which also completed stress-strain diagram and recorded the breaking load. Samples were investigated from the point of view of the origin of the failure (Fig. d1, 2).

The mean \pm SD of fracture resistance were 788.90 ± 99.56 N for the shoulder and 991.75 ± 112.00 N for chamfer margin (Graph 1). Both of minimum and maximum fracture resistance of the two groups were more than intra oral loads. The student's t-test revealed a statistically significant difference between two groups ($p=0.001$). This research carried out with 95% confidence, Kaplan Meir graph showed the design of fracture, that chamfer margin bears more cracks till fracture than shoulder margin (Graph 2). Figure d 1,2 showed that the origin of failure of cores with chamfer margin was axial wall and in shoulder margin, the 90° sharp internal angle was the point of failure (Table 1).

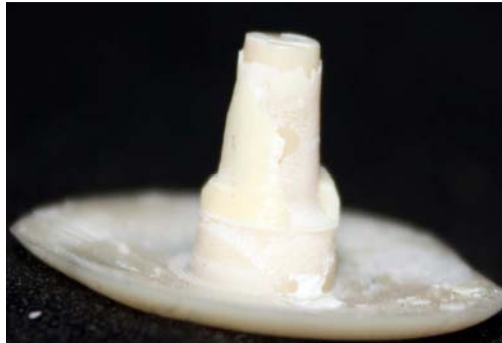
Fig (d2): Shoulder margin

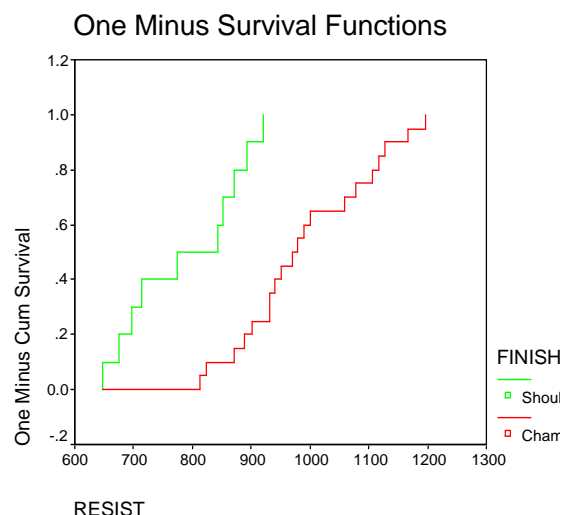
Graph 2. Kaplan-Meier graph shows the cumulative distribution of fracture /load in the chamfer and shoulder finishing lines.
