The Effect of Preparation Design on the Fracture Resistance of Zirconia Crown Copings (Computer Associated Design/Computer Associated Machine, CAD/CAM System)

Journal of Dentistry, Tehran University of Medical Sciences, Tehran, Iran (2011; Vol. 8, No.3)

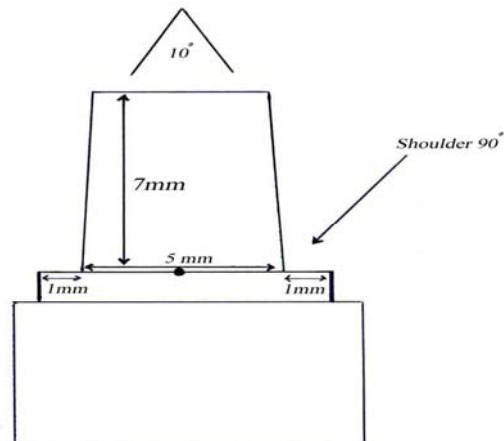
Fig (a2): Shoulder preparation

Afterwards. The standard dye was converted into shoulder with 1 mm depth [15,16]. (Fig a2, b2).

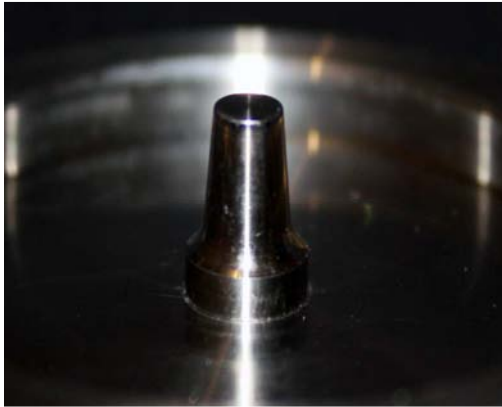
Fig (b1): Standard dies of Chamfer

the dye was prepared with 50° chamfer finish line (0.8 mm depth) [15,16].

(figure a1, b1). 10 poly vinyl siloxane impressions (PVC, Elite H-D+, Zhermach, Germany) were made and ten epoxy resin dyes

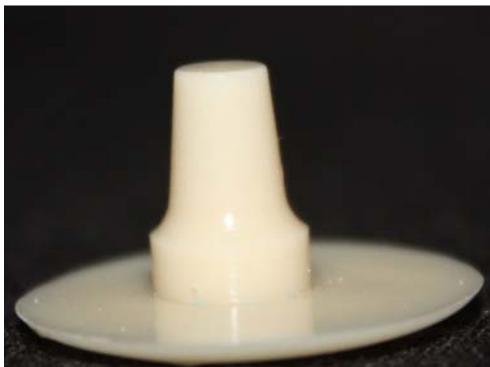
Fig (c1): Epoxy resin dies with chamfer

(CW2215, Hunstman-Germany) were created from these Impressions (Fig c1).

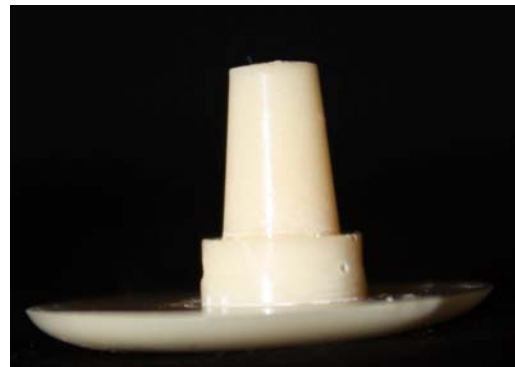
Fig (c2): Shoulder margin

Again 10 PVC impressions were made and ten epoxy resin dyes were created from these impressions (Figure c2) [7,9]. (20 copings were made of a partially sintered ZrO₂ ceramic material by using CAD/CAM technology (Cercon Smart Ceramics, Degu Dent, Hanau, Germany). The copings with 0.4mm thickness and [15,16] 35µm cement space[7]. milled out from the presintered ZrO₂ by cercon milling (Cercon, Brain, Dego Dent, Hanau, Germany) and Cercon Heat (Degu Dent, Hanau, Germany) heated.

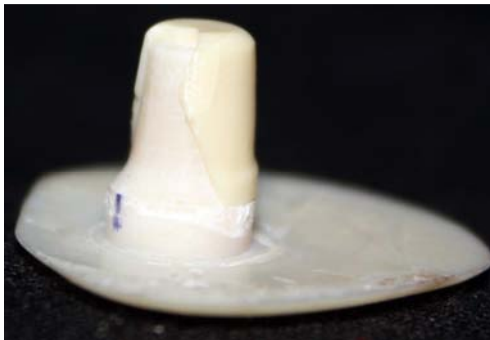
Fig (d1): Fracture area in chamfer

After cementation, excess luting agent was removed and fitness was considered accomplished when two or more investigators determined-by visual inspection-that no marginal gap was visible [7]. Ten samples were stored in a saline solution at room temperature for 24 hours. Mechanical tests were carried out using a universal testing machine (GOTECH AI-700LAC, Arsona, USA). The compressive static load was applied at the center of the occlusal surface along the long axis of dye with a crosshead speed of 0.5 mm/min according to previous studies [7] that starts from 0N and increased until fracture occurred [19]. The fracture load data were automatically recorded using by vista software, which also completed stress-strain diagram and recorded the breaking load. Samples were investigated from the point of view of the origin of the failure (Fig. d1, 2).

The mean \pm SD of fracture resistance were 788.90 ± 99.56 N for the shoulder and 991.75 ± 112.00 N for chamfer margin (Graph 1). Both of minimum and maximum fracture resistance of the two groups were more than intra oral loads. The student's t-test revealed a statistically significant difference between two groups ($p=0.001$). This research carried out with 95% confidence, Kaplan Meir graph showed the design of fracture, that chamfer margin bears more cracks till fracture than shoulder margin (Graph 2). Figure d 1,2 showed that the origin of failure of cores with chamfer margin was axial wall and in shoulder margin, the 90° sharp internal angle was the point of failure (Table 1).

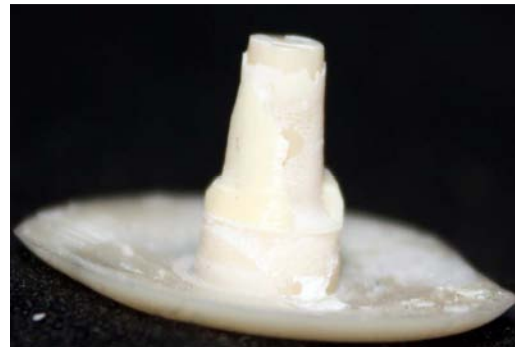
Fig (d2): Shoulder margin
