Cavitation Process and the Performance of Some Ferrous and Non-Ferrous Alloys

*M. Farzam**

Faculty of Petroleum Engineering, Petroleum University of Technology, Ahwaz, Iran

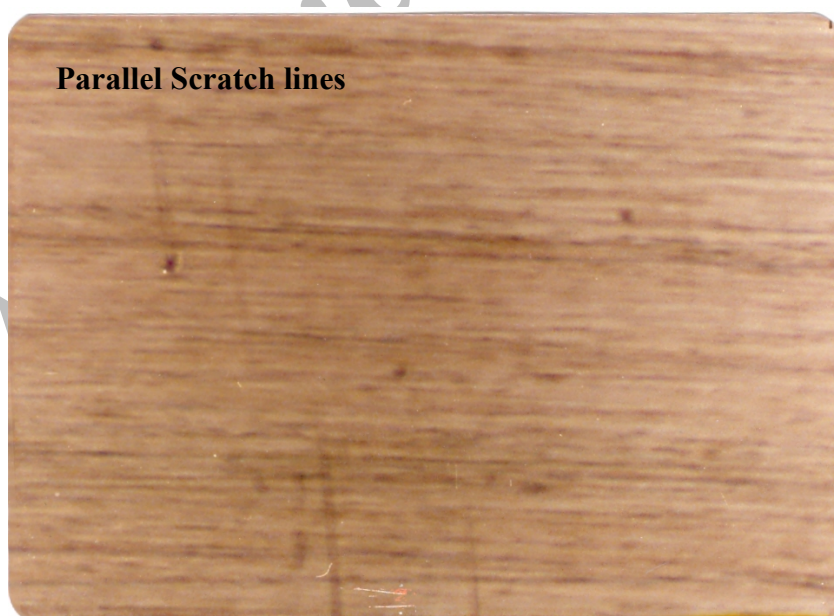
All the metal pieces were ground in the workshop before being polished with a SiC paper grade 600 (Fig. 4); notice the polishing

Figure 4. Original alloy surface finish before being cavitiated, alloy AISI 304 Mag. x 100

place, and mass loss due to erosion happens. Figure 4 shows the original stainless steel (AISI 304) in its polished state, notice the 600 grade polishing paper's parallel lines. This conditioning was the same for all the test alloys before their insertion (the fixture held all the 7 alloys at the same time) into the cavitating venturie. All the alloys were micro-photographed before insertion, the

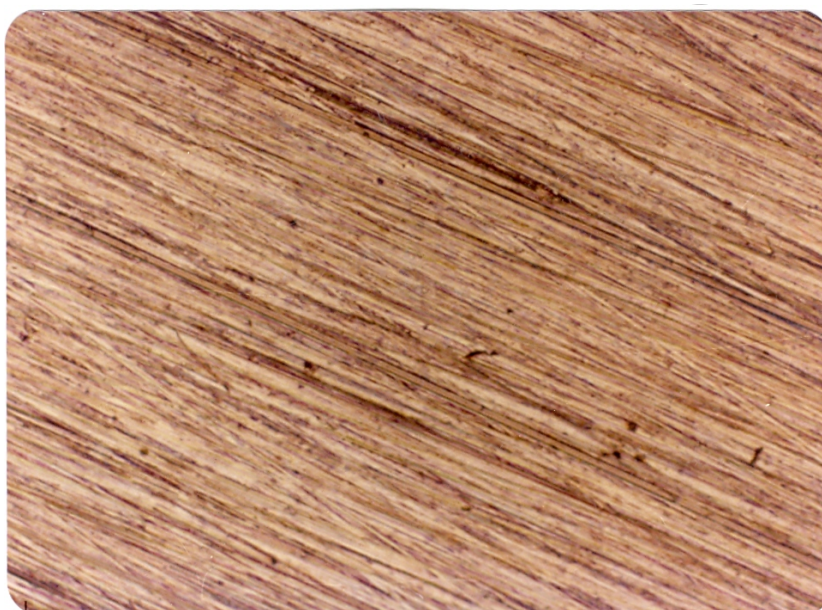
Figure 6. Carbon steel (AISI 1020) polished with 600 SiC paper Mag. x 80.

only difference noticed visually was their color. Figure 6 and 7 show alloys carbon steel (AISI 1020) and stainless steel (AISI 304) in their original state.

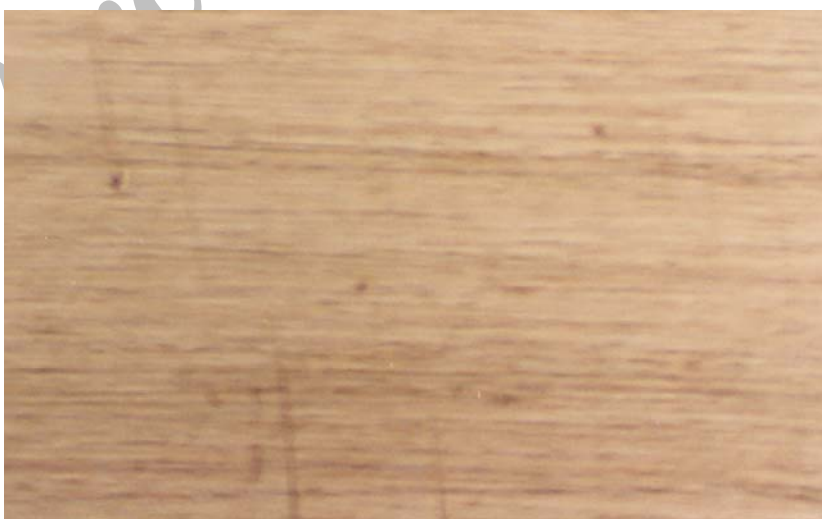
Figure 7. Stainless steel (AISI 304) polished with SiC paper Mag. x 200

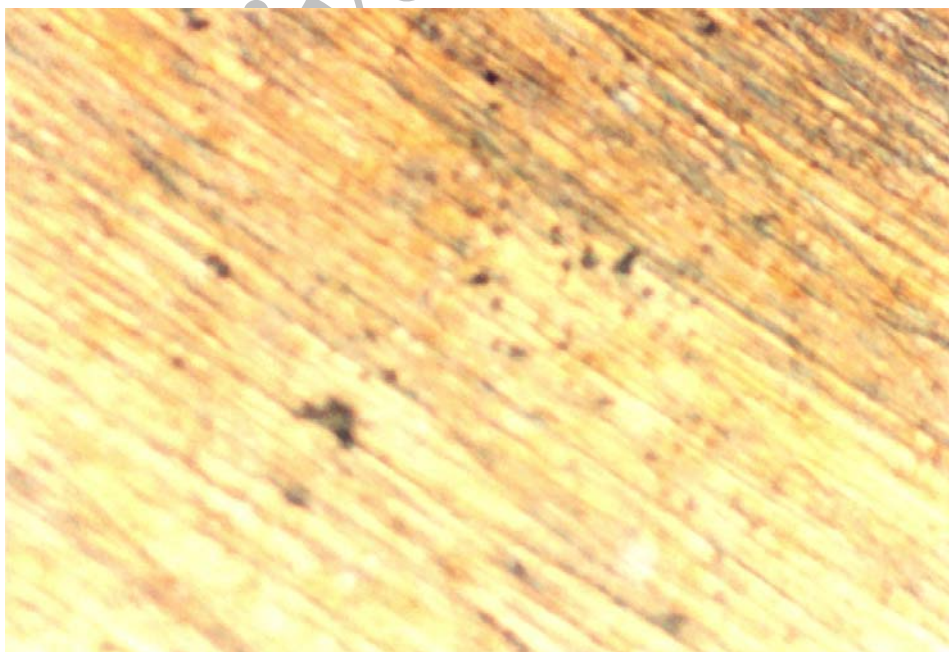
Figure 9. Al-Bronze (C60800) after 60 min exposure is little damaged Mag x 200

After 60 min exposure to the cavitation cloud it was noticed that carbon steel (AISI 1020) was the most damaged alloy (Fig. 8), while the aluminum bronze (C60800) the least (Fig. 9).

While Al-Bronze showed the least damage (Fig. 9), it fits the previous postulation about mechanical properties as this alloy had the highest tensile strength (759 MPa) and hardness (95). This finding fits the data presented in figure 15, where the relative cavitation resistance of Al-Bronze is taken as 1, and stellite (Ni-Ti) alloy is shown to have the highest cavitation resistance of all the alloys available. Richman et al [16] found, experimentally, that stellite was extremely resistant to cavitation erosion. Gen He et al's [19] findings about the low cavitation erosion resistance of C-Steel fitted the data generated in this work. Other researchers [9,10] have also conducted cavitation erosion tests on the resistance of stainless steel and cast iron Cr-Mo-Cu alloy, their findings were also in agreement with this research.

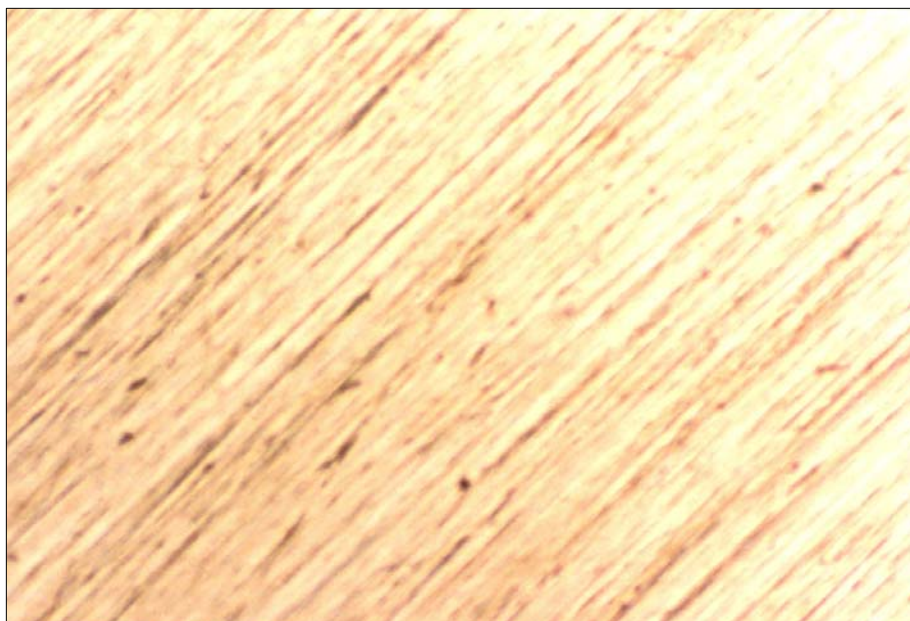
Figure 12. Stainless steel AISI 304 was lightly attacked (pitted) Mag. x 100

Light microscopy examination showed that stainless steels 304 and 316 were only mildly attacked, and in the worst places the surface only exhibited shallow pits (Fig. 12, 13).

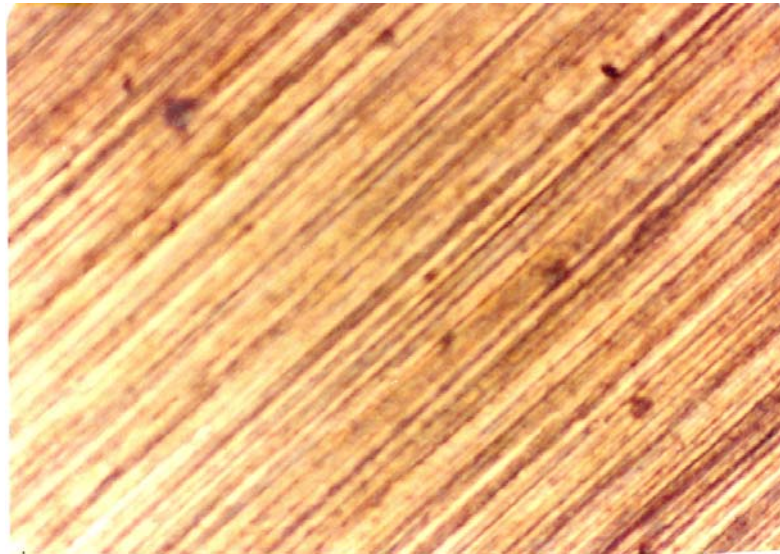
Figure 14. P-Bronze (C51000) after 60 min exposure showed slight pitting Mag. x 100

Phosphor bronze behaved better than the previously discussed alloys, with very few pits, (Fig. 14). The cavitation (erosion) pits nature and the time it took for them to be revealed are in accordance with other workers research [3,25]. This alloy had a relatively high hardness of 86, but a low tensile strength of 455 MPa. One may suggest that the best material ranking is obtained using a resilience number[20] (Fig.15). The American Society of Metals [24] also pays detailed attention to material selection for such applications.

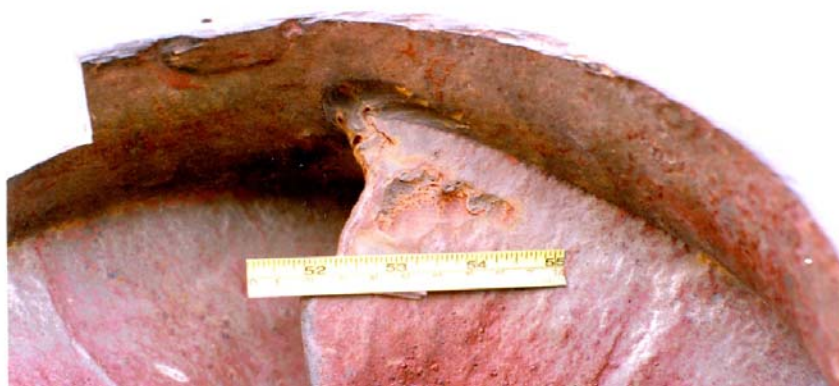
Figure 16. Cavitation erosion-corrosion of a centrifugal pump's impeller

In an another extensive field study on the centrifugal pumps of the Iranian sugar cane industry [15], it was concluded that if the hydraulics hydro-dynamic conditions of such pumps were not met, cavitation erosion-corrosion could damage the pumps parts (Fig. 16).

As it was noticed after only a few months of service, the cast iron impellers and the casings were attacked. As a result, the integrity of the pump design was degraded; the pump efficiency was reduced [15]. The circulating fluid was brine water containing sand particles extracted from the artificial water flooding of Khozestan farms which were being rehabilitated for sugar cane farming. Figure 17 shows the microstructure of the impeller's gray cast iron in its polished and etched state. The fluid approaches the impeller blade with larger and larger angles of incidence altering the velocity and pressure fields inside the impeller. Suction recirculation [22], stall and separation of the fluid leads to reversal flow in the pump. For

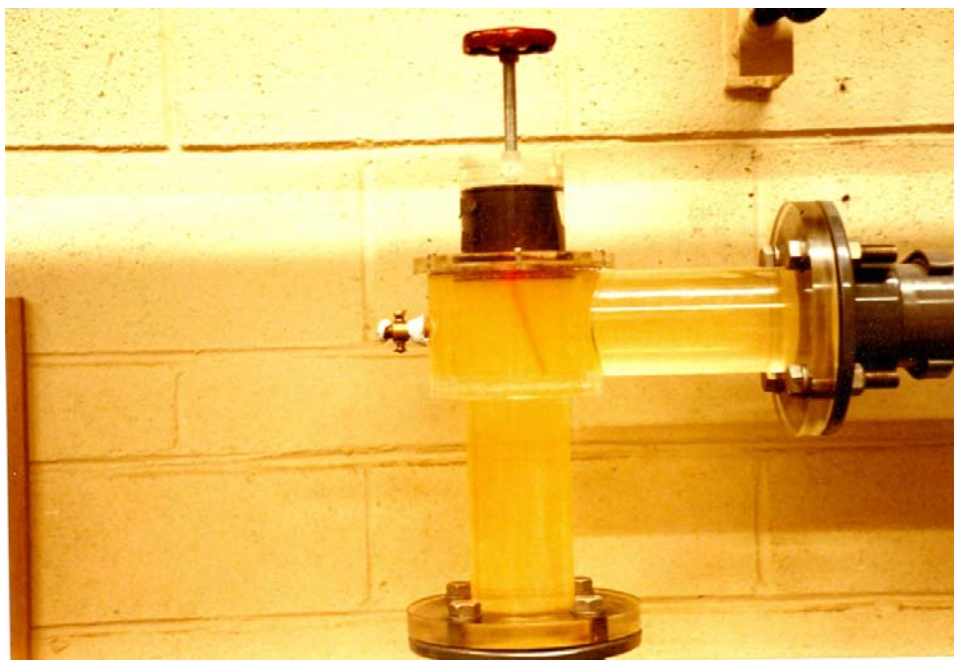
Figure 18. the constructed choke valve

conditions of a petroleum industry's well head choke valve was conducted (Fig. 18). I also tried to apply the laser beam via-a-vis a computer program to statically number the cavitation population.

When the piston; the actuator, (Fig. 18,19) was fully out, flow rate was at its maximum with the highest static and dynamic pressure drop. With the rig's flow condition described in the experimental section, a cavitation cloud developed in the choke valve. As the piston was traversed forward, the flow rate decreased, cavitation bubble production emerged with noise and vibration continued. As was gathered through the above results and discussion, to protect against cavitation erosion-corrosion, design (cavitation number and N.P.S.H.) and material selection [24] are the two main important factors to be considered. Decreasing the flow rate, increasing the piping diameter, reducing sharp section changes and controlling the cavitation number and net positive suction head are the main design factors to be met. Hard surface laser treatment coating has been [11], surface roughening and dampening may also be applied. Mathias et al [17] suggested that the cavitation process is similar to shot peening, thus by introducing surface compressive stresses one may harden the material against cavitation damage. Proper selection of the material; Stellite, Al-Bronze, etc is also suggested, or resistance coatings may be applied [26]. Eliminating the suspended particles and or controlling the fluid electrochemistry may also be used to reduce cavitation erosion-corrosion.
