## ON THREE-STAGE MITIGATION OF LIQUEFACTION-INDUCED HAZARDS

### ABSTRACT

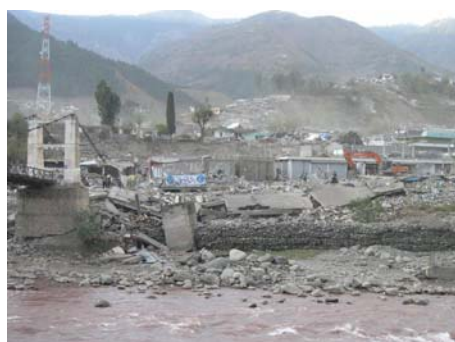
Figure 1. Balakot town of Pakistan which was totally destroyed by earthquake in 2005

Firstly, the section compares the conventional kind of earthquake damage. Figures 1 and 2 illustrate the consequence of earthquake in 2005 which hit Kashmir region, northern Pakistan. It can be seen that shaking completely destroyed the shape and function of structures. Most traditional structures, inclusive of natural slopes, have brittle nature which induces total failure once yielding occurs. Restoration requires removal of debris and re-construction which require long time and cost.

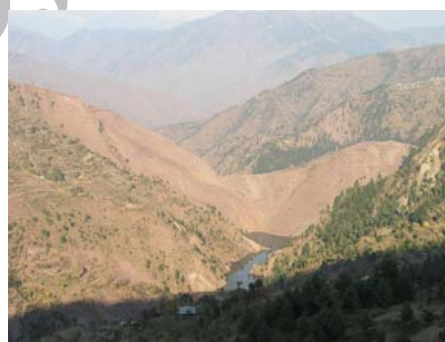
Figure 2. Slope failure and natural dam near Chakar in Pakistan during the Kashmir earthquake in 2005

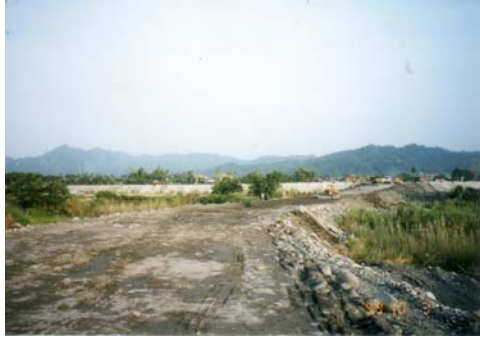
Figure 3. Quick construction of detour road after 1999 ChiChi earthquake in Taiwan

There is, however, a situation in which geotechnical structure has an advantage over other kinds of structure. Figure 3 illustrates a quick construction of emergency road after the 1999 ChiChi earthquake in Taiwan. In this earthquake, fault movement destroyed many bridges, and, in the site of this figure, emergency transportation was made possible by constructing this detour road. Thus, earth structure has this advantage of quick construction / restoration. Figure 4 demonstrates a collapse of road embankment. Although the previous section proposed an idea of network for cost-efficient principle, the 2004 Niigata-Chuetsu earthquake destroyed all the roads in the epicentral area, and the idea of network did not work properly. This adverse situation made extremely difficult and delayed the restoration

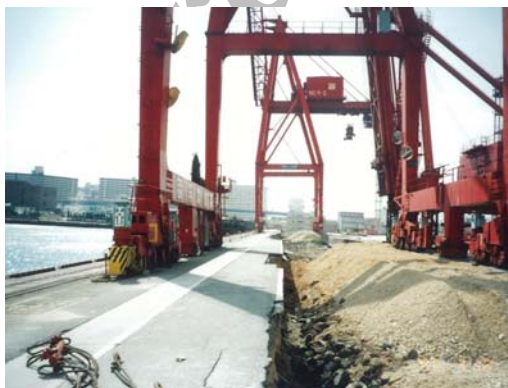
Figure 5. Heavy distortion of quay wall in

Kobe Harbor in 1995

Figure 5 illustrates the significant distortion of a gravity quay wall in Kobe Harbor which was induced by a combined effect of strong shaking (inertial force) and development of pore water pressure in the foundation as well as in the backfill. The significant displacement (several meters) and tilting of the wall made the crane get derailed and backfill surface subside. This situation stopped the function of the harbor for many months. Since the idea of quick restoration did not work, the harbor client went to other harbors and hardly came back. Another example of unacceptable deformation due to liquefaction is shown in Figure 6 in which a manhole of sewage system floated. Thus, service to local sanitary environment was intervened by liquefaction.

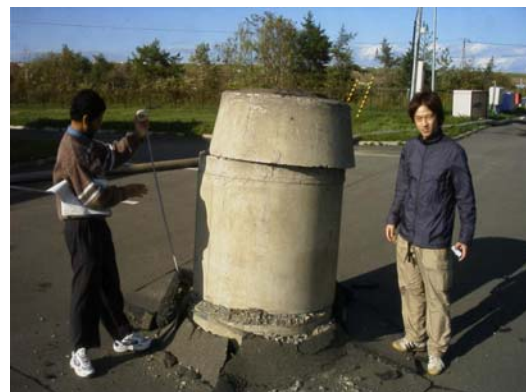
Figure 6. Significant floating of sewage

manhole at 2004 Tokachi-oki earthquake

The last example of an underground wall concerns floating of an embedded structure. In addition to floating of sewage manhole (Figure 6), a bigger water treatment tank floated during the 1964 Niigata earthquake and also in 2004 Niigata-Chuetsu earthquake. In this regard, the author carried out 1-G shaking model tests on mitigation of a bigger structure such as underground parking lot, shopping mall, subway, and highway. Figure 34 illustrates the configuration of the model. The configuration after shaking (Figure 34b) clearly indicates that the floating was accompanied by the inward movement of liquefied subsoil under the structure and that the structure was pushed upwards by this sand movement. It is therefore inferred that floating may be mitigated by preventing soil movement by installation of underground walls beside the structure.

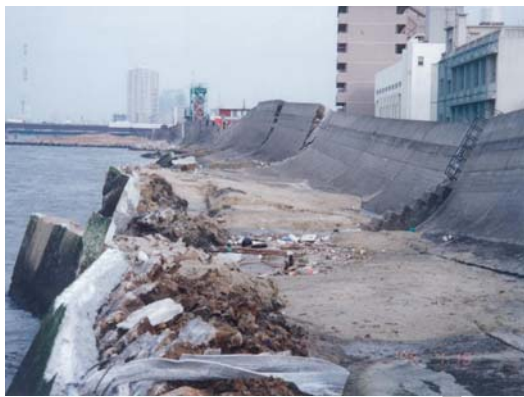
Figure 7. Significant subsidence of Yodo River dike in 1995 (Ministry of Construction)

Figure 7 illustrates another example of unallowable deformation. The subsidence and slope failure of Yodo River dike in Osaka City made flooding of the back area very likely. Since the main function of river dikes is to prevent flooding, significant subsidence may be fatal, while minor subsidence is not serious and can be restored within a reasonably short time (Figure 8). Thus, the essence of liquefaction-induced damage lies in the extent of residual deformation/displacement and its significance is evaluated in terms of impacts on social and economic issues. Note that liquefaction has hardly killed people except the collapse of tailing dam at El Cobre of Chile in 1960s.

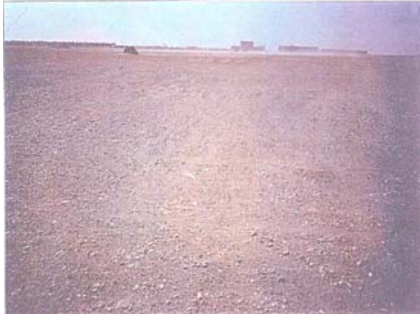
No liquefaction because of densification

Figure 9. Effects of dynamic compaction in Lu-Kang of Taiwan during 1999 ChiChi earthquake

While the main aim of liquefaction-mitigation measure is to reduce the residual deformation to an allowable extent, the conventional approach has been more effective. Compaction of sand or installation of drains aimed at preventing onset of liquefaction under design earthquake motion. Past earthquakes verified the reliability of those measures. For example, the central part of Kobe Port Island did not develop liquefaction due to a variety of soil densification measures (Yasuda et al., 1996). For economical densification, dynamic consolidation in terms of free fall of heavy weight was proved useful in Lu-Kang site of Taiwan in 1999 (Figure 9). Gravel drains prevented liquefaction and heavy subsidence in Kushiro Harbor in 1993 (Figure 10).

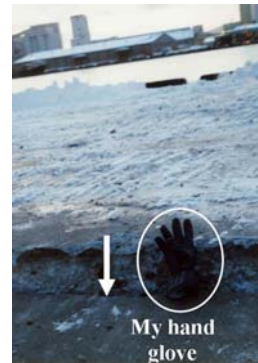
Figure 10. Minor subsidence in Kushiro Harbor in 1993 in spite of heavy seismic shaking

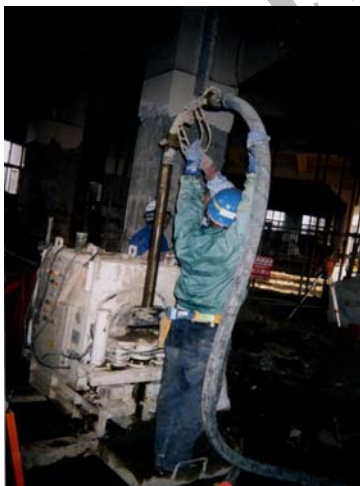
Figure 11. Compaction grouting in basement of existing building

More difficult aim has emerged in the recent times in which liquefaction-induced damage has to be mitigated in “existing” structures. Although these structures were designed to resist previous design earthquakes, the increased intensity of design earthquake in the recent times requires reinforcement of those structures. Since the ground surface is occupied by existing structures, it is practically impossible to bring in big tamping machines or to cause ground vibration for densification. Figure 11 illustrates ongoing densification of soil under an existing building. This work was carried out by compaction grouting from a basement of the building. Figure 12 shows injection of silicate grout close to an existing harbor structure immediately behind a quay wall.

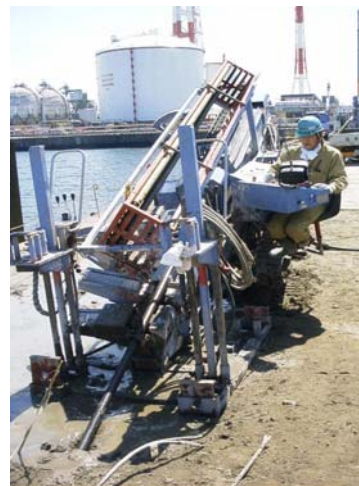
Figure 12. Soil improvement by means of silicate grout under existing structure in the vicinity of quay wall

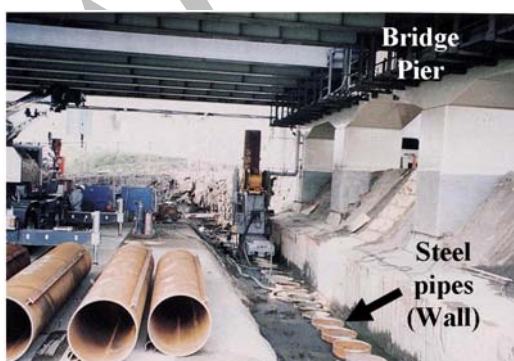
Figure 13. Sheet pile wall as mitigation

Figure 13 illustrates an example of steel pipe installation in front of an existing bridge pier. The steel pipe wall prevents lateral displacement of soils around the pier and protects it from the significant earth pressure induced by soil movement. Note that the use of steel pipe wall does not try to prevent liquefaction in the surrounding subsoil. It is attempted therein to reduce the ground displacement by installing a rigid wall. The effect of underground wall is supported by the good performance of Yodo River dike in Takami site (Figure 14) which is located to the upstream direction of the heavily damaged dike in Figure 7. To understand the reasons for different seismic performances of dikes in these two areas, Figure 15 illustrates the subsoil conditions as well as the depth of sheet pile walls. Note that the sheet pile walls under the dike were installed not to prevent liquefaction problems but to reduce seepage flow under the dike. The situations in the Takami site are characterized by three features; different soil conditions (deltaic alluvial soil which is different from younger reclaimed soil in Torishima site), the length of sheet pile wall, and the existence of fill on the river side of the dike. Since more aged soil has less possibility of liquefaction, the soil condition may be the cause of different dike performance. Moreover, the thickness of alluvial sand (deltaic deposit) which is prone to liquefaction is approximately 10 meters along the river channel. Thus, the sheet pile in the Takami site reached the bottom of this sandy layer, and was probably able to prevent the lateral displacement of the foundation sand towards the river channel. The mitigative mechanism of underground walls is illustrated in Figure 16 in which the subsidence of the overlying dike is associated with the subsoil movement in the lateral direction. Installation of walls can reduce the lateral soil movement and consequently the subsidence of the overlying embankment.

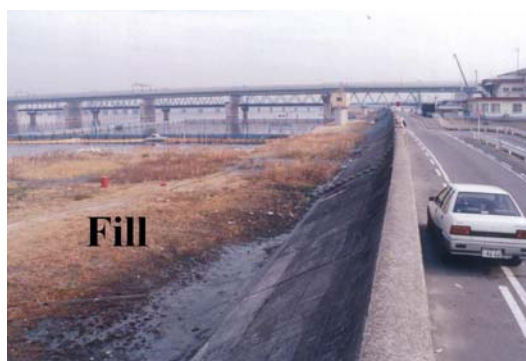
Figure 14. Minor distortion of Yodo River in

dike of lateral soil movement (Photo by Prof. S. Yasuda). Takami site of Osaka City (in contrast with damage in Torishima site in Figure 7).

Another reason for different behaviors is the existence of fill on the river side of the dike. Since the Takami site (Figure 14) had a fill which measured 50 m in width, its weight reduced the potential of lateral sliding. This is in good contrast with the dike in Figure 7 that had no such a fill. Figure 17 shows another evidence of wall effects. The foundation of the building on the left side was surrounded by a wall which was constructed upon excavation of the basement. Since this wall existed when the building was shaken by the 1995 Kobe earthquake, the building was not affected by the soil movement caused by a nearby quay wall deformation.

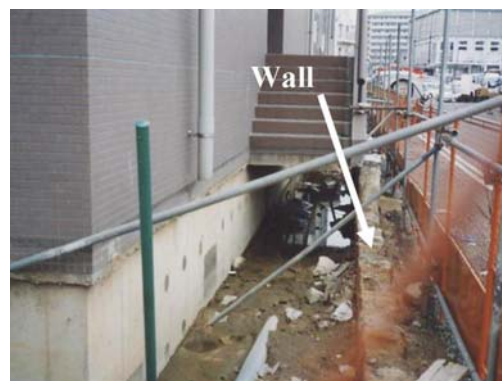
Figure 17. Protected building near quay wall in Kobe Harbor (Photo by Prof. J.Koseki)

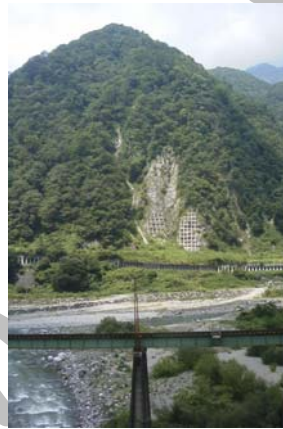
Figure 18. Slope reinforcement to prevent its failure and production of debris (mitigation at source)

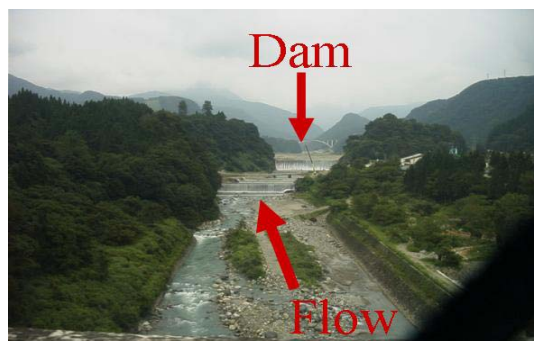
Figure 19. Erosion control dam to stop migration of debris to downstream area (mitigation on path).

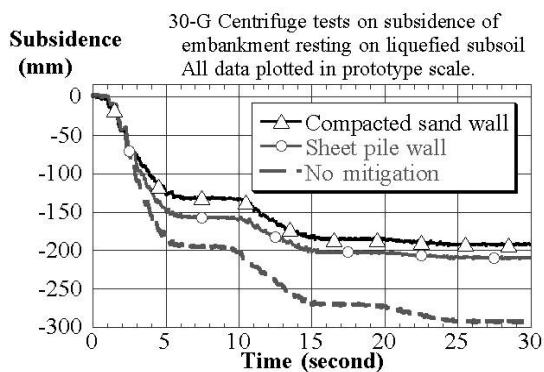
Figure 24. Time history of subsidence at bottom of surface embankment.

Figure 23 illustrates the time history of base shaking in the test on embankment. Excitation took place three times with decreasing the amplitude in order to reproduce the effects of aftershocks in reality and also to study the effects of continued shaking on deformation of liquefied sandy ground. Accordingly, the time history of subsidence in Figure 24 consists of three stages of development. Deformation of subsoil thus occurred only when shaking was ongoing. While two kinds of underground walls were employed in the present tests (sheet pile wall and compacted sand wall), both measures were able to reduce the subsidence.

By comparing Figures 24, 30, and 36 it is detected that mitigation of floating is more effective than that of subsidence of tank and embankment. The reason for this is illustrated in Figure 38. When liquefied soil tries to come in towards the underground structure, sheet pile walls are pushed inward as well. While bending stiffness is the source of resistance of walls against soil movement, the stiffness of walls is further increased by the rigidity of the underground structure. In case of subsidence, on the contrary, sheet pile walls are simply pushed outwards and there is no such additional stiffness. It seems thus promising to install walls around existing structures in order to reduce floating.

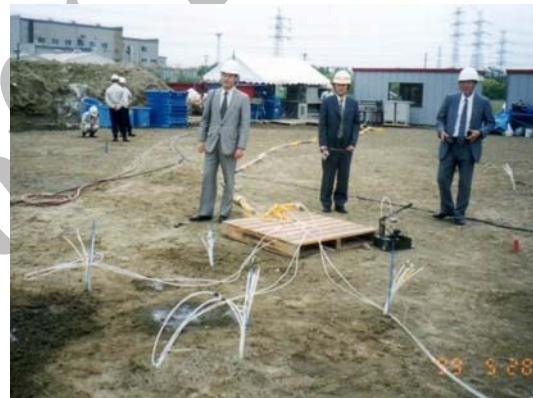
Figure 25. Seeping of silicate liquid into sandy ground

Grouting can construct an underground near an existing structure as well. Figure 25 shows the injection of silicate liquid slowly and uniformly into sandy ground. This procedure does not employ any big equipment and does not cause vibration. Figure 26 demonstrates an excavated shape of grouted sand. This effect of uniform seeping is permanent without weathering and is not poisonous to human health either.

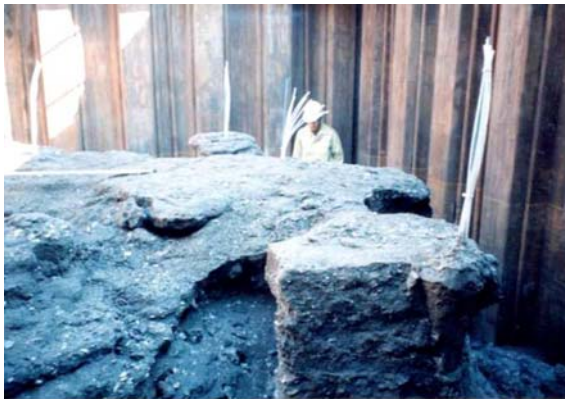
Figure 26. Excavation of subsoil grouted by seeping of silicate liquid.

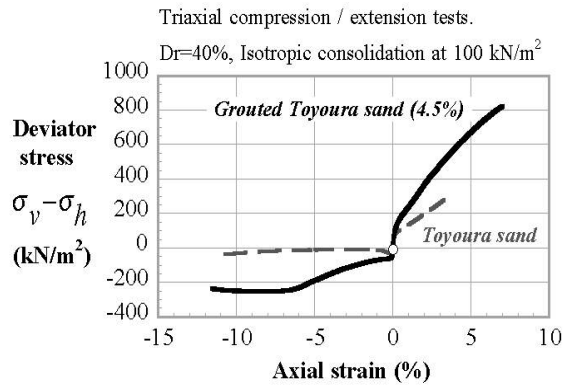
Figure 27. Stress-strain behavior of sand improved by seeping grout

Towhata and Kabashima (2001) conducted triaxial shear tests to examine the improved behaviour of grouted sand. Triaxial compression and extension tests in drained manner (Figure 27) revealed that rigidity of sand was improved by this grouting. Figure 28 further shows the increased liquefaction resistance of grouted sand. Although cost is high, this measure is able to improve sand under difficult situation where ground deformation or vibration is not allowed by existing structures. To examine the mitigation of subsidence by this grouting, 1-G model tests were conducted. Figure 29 illustrates a model of liquid storage tank with underground walls made by grouting. Base shaking with 500 Gal and 10 Hz with 20 cycles caused different extent of subsidence in accordance with the type of walls (Figure 30). Although grouting of entire subsoil exhibits the best performance, grouting with limited width achieved satisfactory results as well.

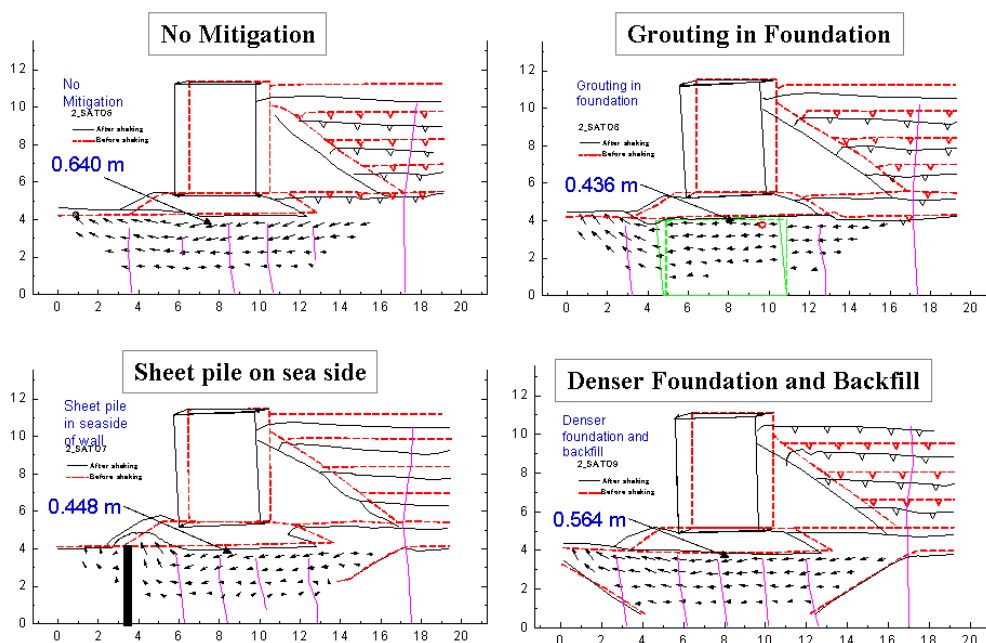
Figure 32. Deformation of foundation sand under gravity quay wall obtained by 30G centrifugal tests)

The consequent deformation in the foundation was observed by using marker locations

and was illustrated in Figure 32. It is indicated by the displacement numbers in the figure that all the three mitigative measures reduced the lateral displacement at the top of the foundation sand. This mitigative effect was particularly important in the case of sheet pile wall and grouting. The displacement at the top of the quay wall was, however, similar in all tests. This is because shear deformation in the rubble mound (see Figure 31) was greater and the tilting of the quay wall body was greater as well when foundation sand did not deform very much (Figure 33). Probably the stabilized foundation sand increased the inertial effects and dynamic earth pressure behind the wall.

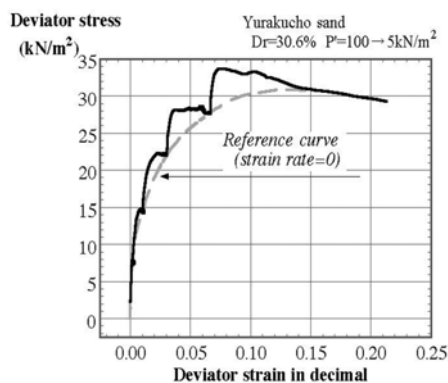
Figure 43. Triaxial compression test with in drained manner (Gallage et al., 2005)

In the test of Figure 43, a loose sandy specimen was consolidated under 100 kPa, and the effective stress was reduced to 5 kPa by introducing high back pressure (pore water pressure controlled externally) or running undrained cyclic loading. This procedure reproduces the process of liquefaction in reality. A drainage valve of a triaxial apparatus was then opened and triaxial compression was conducted while maintaining constant the pore water pressure and the lateral effective stress ( $\sigma'_3$ ). In the stress-strain diagram of Figure 43, the deviatoric stress,  $\sigma_1 - \sigma_3$ , was increased by steps followed by constant value. This way of loading was intended to measure creep deformation of sand and thereby to obtain the viscous parameters of sand. The reference curve in the figure was obtained by connecting the stress-strain state at the end of creep. Therefore, this curve indicates rate-independent and frictional nature of sand, and the difference between the measured and reference curves gives the rate-dependent nature.

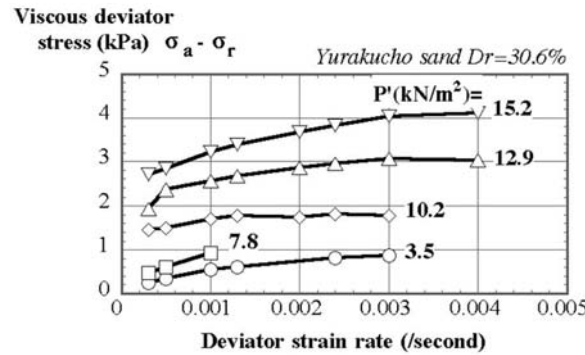
Figure 44. Bingham nature of liquefied sand under low effective stress.

Figure 44 depicts the viscous component of stress which changes with strain rate. Although there is no proportionality, a linear relationship is reasonable between strain rate

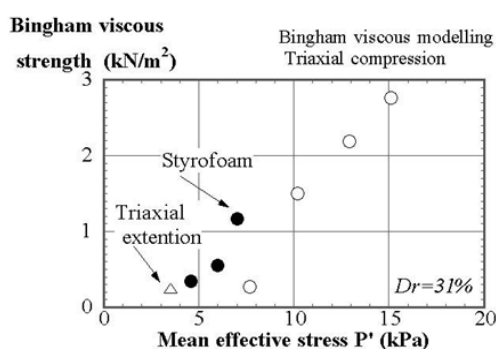
Figure 46. Bingham strength of liquefied sand under low effective stress.

and stress. Therefore, it was decided to model this behavior by Bingham viscous model which is expressed by strength and viscous coefficient (Figure 45). These Bingham viscosity parameters were read from experimental data and were plotted in Figures 46 and 47 against the mean effective stress. Since triaxial specimens could not maintain their shape and stability under zero effective stress, test results under low but still positive effective stress were collected, plotted, and were extrapolated towards zero stress in order to assess the nature of liquefied sand. It was found accordingly that the Bingham strength vanishes in completely liquefied state, changing sand to a Newtonian viscous liquid, and that the viscosity coefficient lies in the range of 30 to 100kPa.sec.

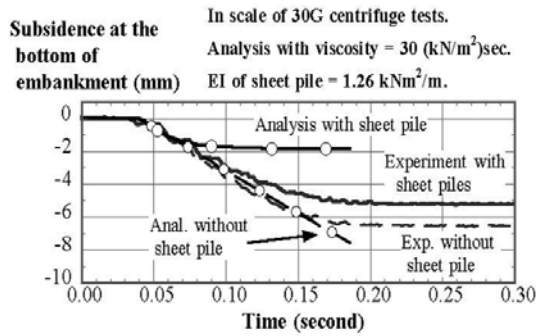
Figure 48. Viscous analysis on subsidence of embankment resting on liquefied subsoil

By using the obtained viscous parameters (Bingham strength=zero), a few calculation was conducted. For the analytical details, refer to Towhata et al. (1999). Firstly, the centrifugal test on subsidence of embankment resting on liquefied subsoil (Figure 20) was calculated in Figure 48. The mitigative effects of sheet pile walls are included here. The calculated time history of subsidence seems to be reasonable. Noteworthy is that this calculation requires only a limited number of data such as thickness of liquefiable soil layer and viscosity together with unit weight of soil. The second analysis concerned the floating of an underground structure (Figures 34 and 35). An analysis on the case without mitigation (Figure 34) was conducted by varying the viscosity and the best-fitting coefficient of viscosity was found to be 10kPa.sec (Figure 49) By using this, the case with sheet pile walls was analyzed in Figure 50. Although the agreement is not yet satisfactory, the mitigative effects were somehow reproduced by the analysis.

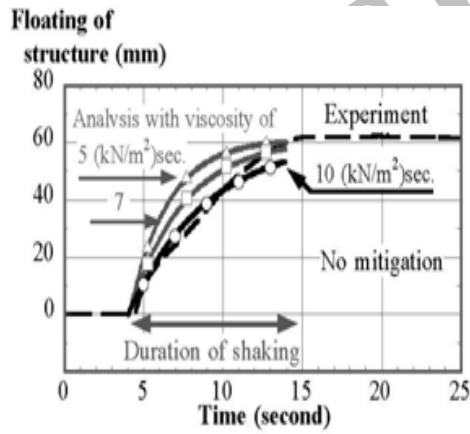
Figure 49. Viscous analysis on floating without sheet pile wall
