Original Article

## The Effect of Finish Line Design on the Fracture Strength of Zirconia Copings

**Cite this article as:** Hashemi Ardakani Z, Khorsandipour Sh, Mohaghegh M, Ghoreishian SA, Khaledi AAR. The Effect of Finish Line Design on the Fracture Strength of Zirconia Copings. J Dent Shiraz Univ Med Sci. December 2019; 20(4): 271-275.

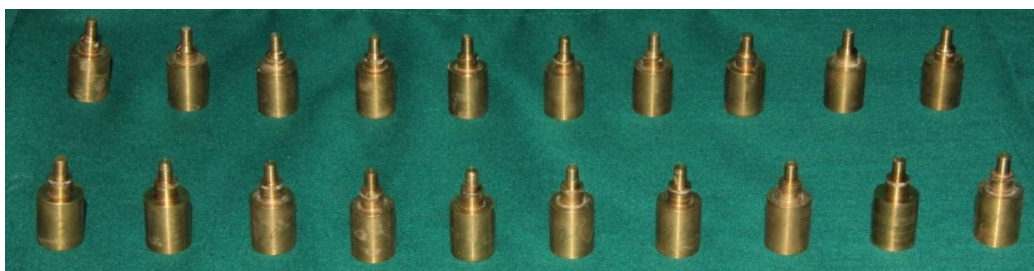
Figure 1: Master dies

In this *in vitro* study, 20 standard brass dies were designed and prepared by CNC milling machine (CNC 350; Arix Co. Tainan Hsin, Taiwan) (Figure 1). Preparation was standardized using a wide smooth continuous margin, free of any irregularities. Each die was made to provide 6° occlusal convergence angle, and axial occluso-gingival height of 6.4mm, 5.5mm base width and 1.2mm margin thickness; half of the samples had a 135° shoulder margin (Figure 2a) and the other half with a 90° shoulder margin (Figure 2b) (n=10). The brass dies were visually inspected for any possible irregularities by a single operator utilizing a binocular loupes (Heine HR-C 2.5\*; Heine, Herrsching, Germany).

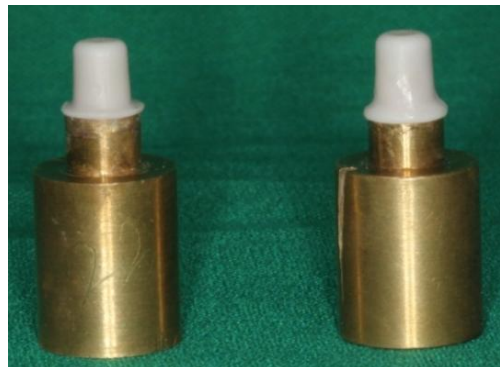
**Figure 3:** Zirconia copings placed on master dies

The copings were cemented with glass-ionomer luting cement (GC Corporation; Tokyo, Japan) which was mixed based on the manufacturer's instruction. It was inserted into the crown by use of an applicator and

the copings were mounted on brass dies (Figure 3). The excessive cement was removed by using a probe and the final samples were stored in normal saline at room temperature for 24 hours.
