Three-Dimensional Echocardiography for the Evaluation of the Left Ventricular Outflow Tract in a Patient with a History of Mitral Valve Replacement

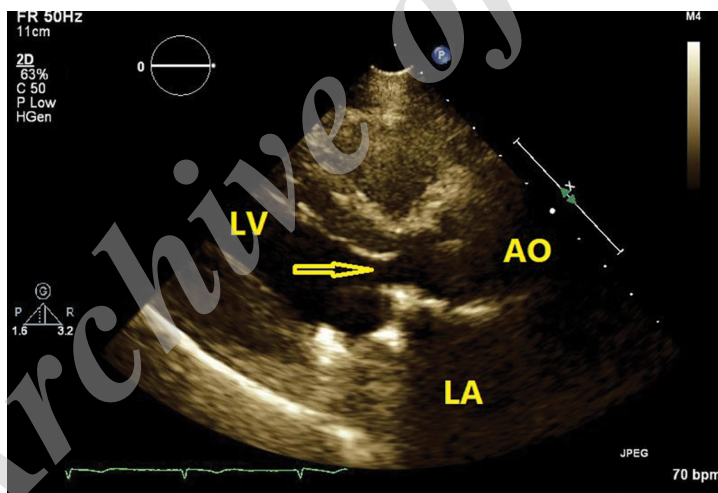
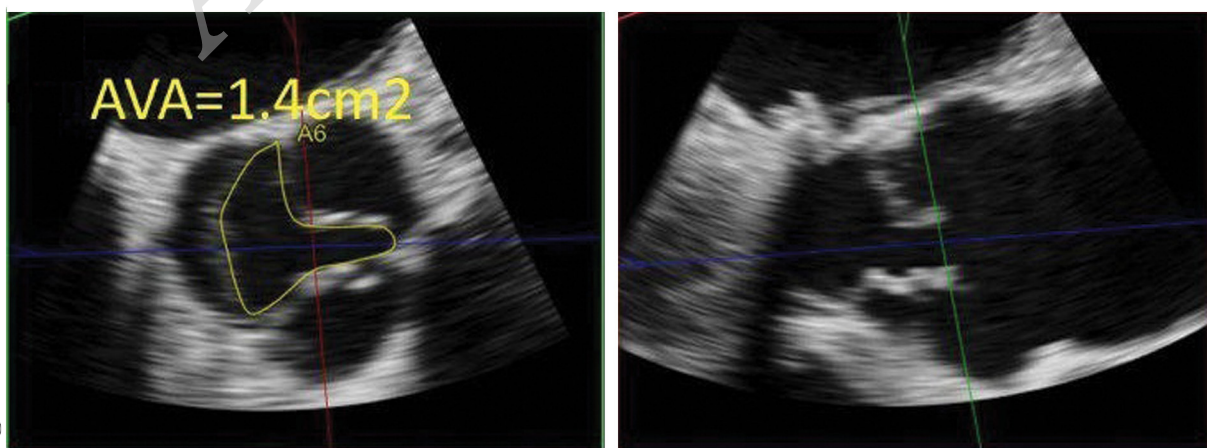
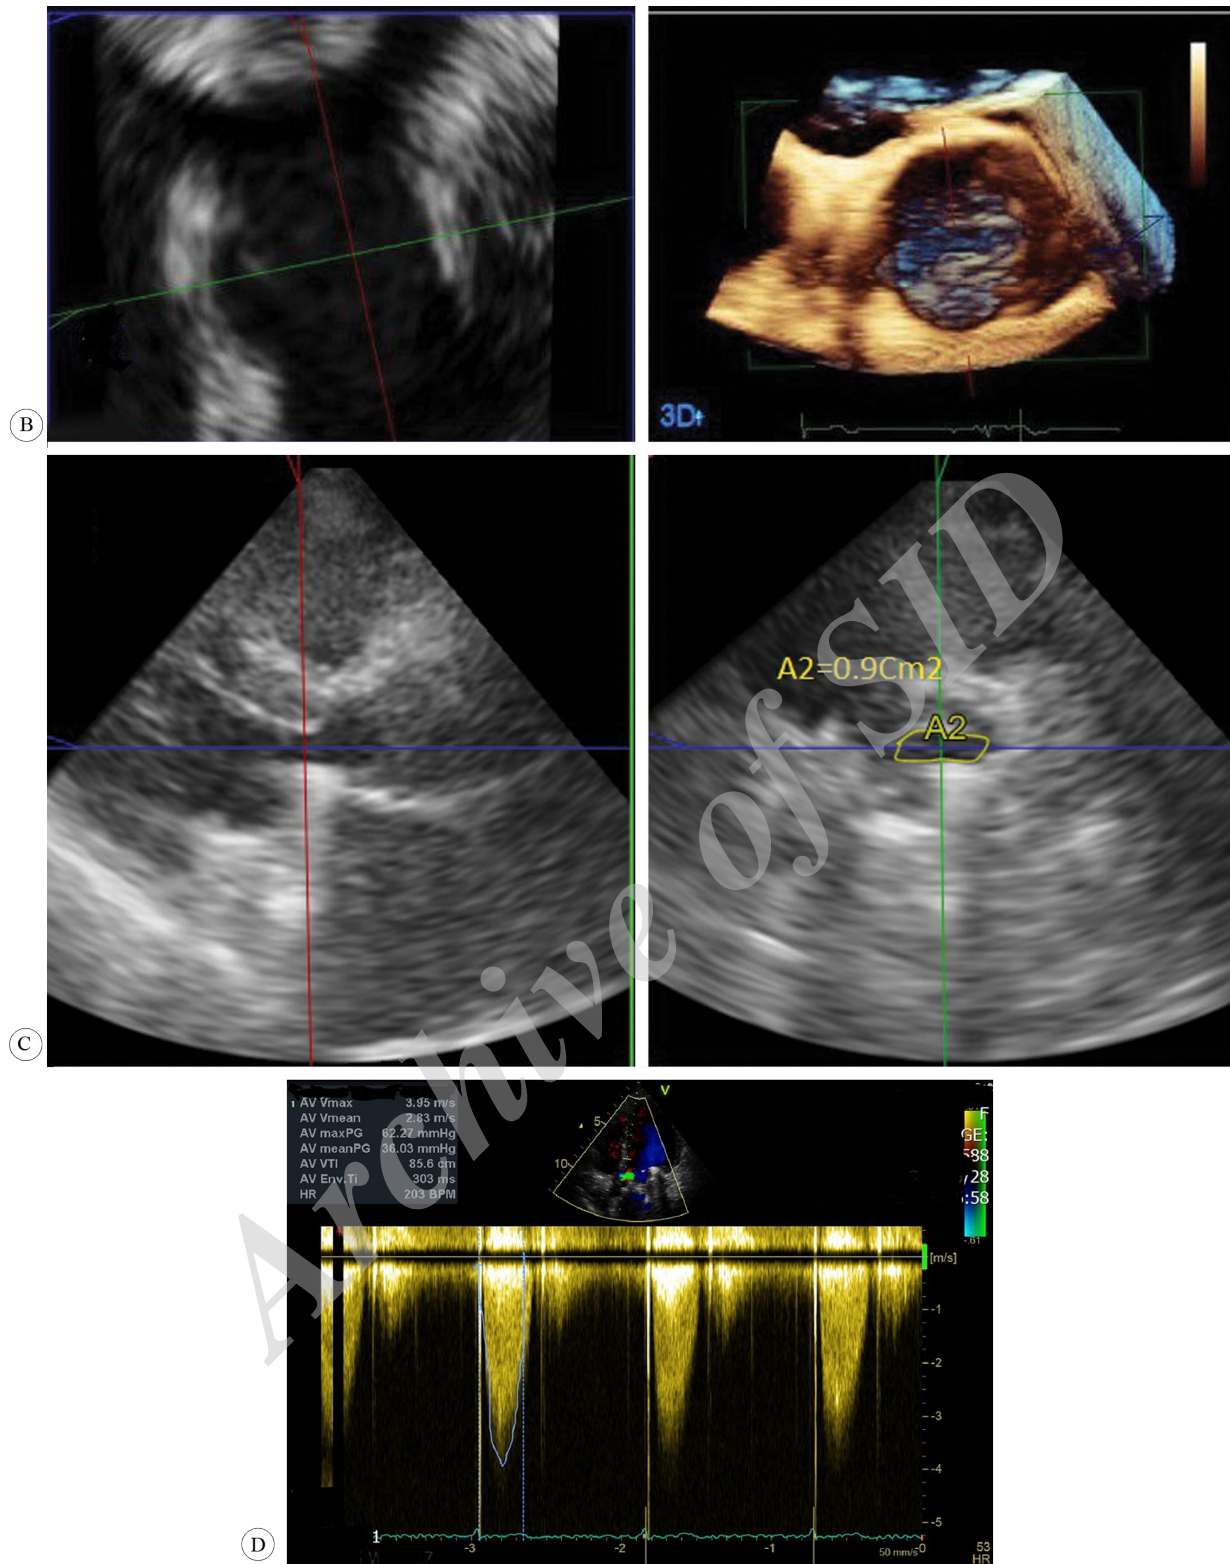
Figure 1. A) Anterior displacement of the mechanical prosthetic mitral valve, resulting in the left ventricular outflow tract (LVOT) narrowing (arrow) in the parasternal long-axis view in transthoracic echocardiography; B) Direct planimetry of the aortic valve in three-dimensional (3D) transesophageal echocardiography in the mid-esophageal short-axis of the aortic valve view; C) Direct planimetry of the LVOT using 3D transthoracic echocardiography in the parasternal long-axis view; and D) The LVOT pressure gradient in the 5-chamber view in transthoracic echocardiography evaluated by continuous wave AO, Ascending aorta; AVA, Aortic valve area; LA, Left atrium; LV, Left ventricle; LVOT, Left ventricular outflow tract

fluoroscopy was normal. Transthoracic and transesophageal echocardiographic examinations demonstrated a left ventricular ejection fraction of 50%, a mechanical prosthetic mitral valve with a normal leaflet motion and acceptable gradients, no visible paravalvular leakage, moderate tricuspid and aortic valve regurgitation, and no tricuspid stenosis. However, there was significant left ventricular outflow tract (LVOT) obstruction (peak pressure gradient=62 mmHg and mean pressure gradient=38 mmHg). For a further evaluation of the aortic valve and the LVOT region, we conducted three-dimensional (3D) echocardiography at the time of transthoracic and transesophageal echocardiography and found that the aortic valve area by direct planimetry was 1.4 cm² and the LVOT area was 0.9 cm² as a result of the anterior displacement of the mitral prosthesis (Figure 1). The reduced aortic valve area did not explain completely what we obtained in the continuous-wave study, so it seems that the main cause was the LVOT obstruction caused by the anterior displacement of the mechanical mitral leaflet, demonstrated by the direct planimetry of the LVOT in 3D echocardiography. The reviewing of the preoperative

transthoracic and transesophageal echocardiographic examinations revealed that there was no aortic valve and LVOT obstruction at that time. The reduced aortic valve area may have been due to a low-flow passing aortic valve because of a significant LVOT obstruction.

The LVOT obstruction after mechanical mitral valve replacement rarely occurs.¹⁻⁴ If the mechanical valve is not sutured to the mitral annulus exactly, the LVOT obstruction due to the anterior displacement of the sewing ring may occur. The correction of this malpositioning results in the elimination of the LVOT obstruction.² Our patient refused any invasive evaluation or intervention. We recommend that special attention be paid to the LVOT region in the evaluation of patients with mitral valve replacement and 3D echocardiography can be helpful in challenging cases.
