Effects of Different Irrigation Solutions and Protocols on Mineral Content and Ultrastructure of Root Canal Dentine

Original Article

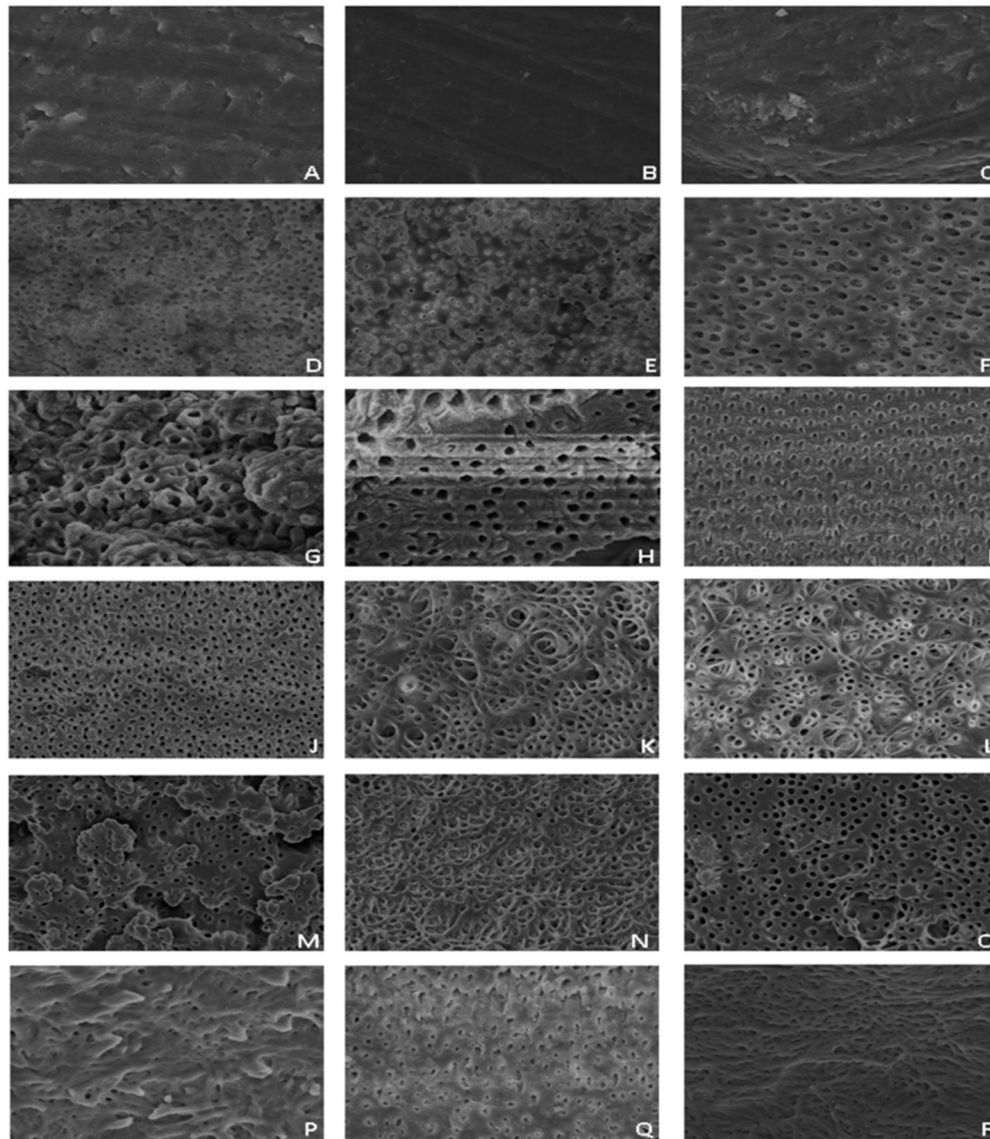
Figure 1. Photomicrographs of human root dentine from the cervical, middle and apical thirds of groups 1 (A, B and C), 2 (D, E and F) 3 (G, H and I), 4 (J, K, and L), 5 (M, N and O) and 6 (P, Q and R) (original magnification 1000 \times , 20 kV)

The images shown in [Figure 1](#) represent the most common aspect observed in the different thirds of the samples. G1 predominantly showed the presence of the smear layer covering the dentin wall, obliterating the dentinal tubules ([Figure 1A to C](#)).

In G2, the cervical and middle thirds had exposed dentinal tubules with preserved intertubular dentin. In the apical third, there were several areas of erosion of intertubular dentin and irregularly enlarged tubules, and, in some areas, excessive erosion led to the communication of dentinal tubules ([Figure 1D to F](#)). In

G3, there was irregular intertubular dentin with an uneven appearance and some debris near the entrances of the tubules ([Figure 1G to I](#)).

In the cervical third of G4, the presence of micro branches was noted. The entry of the tubules was irregular. In the middle and apical thirds, there was a greater opening of the tubules and erosion areas, leading to the union of two or more tubules. There was a reduction in the space occupied by the intertubular dentin ([Figure 1J to L](#)). In G5, the intertubular dentin was free of debris, and the tubules were clearly observed ([Figure 1M to O](#)). G6 showed the presence of a smear layer in the dentinal walls, particularly in the apical third, covering part of dentinal tubules. The intertubular dentin showed an irregular surface ([Figure 1P to R](#)).

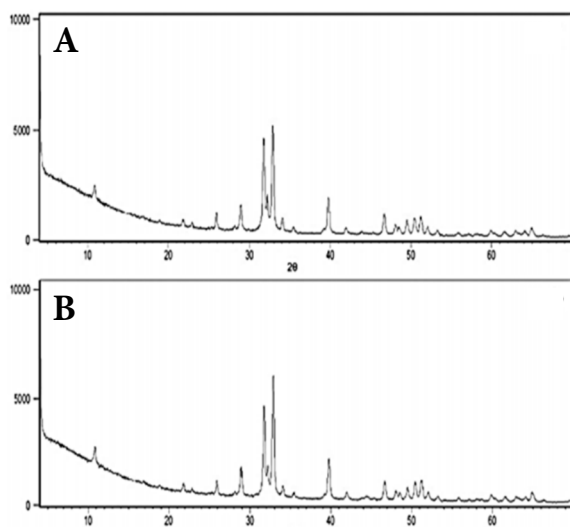
Figure 2. Representative XRD patterns of groups 1 to 4; A) hydroxyapatite peak corresponding to 5 and 6 and; B) the peak corresponding to fluorapatite

The diffractogram of groups 1 to 4 showed peak characteristics of hydroxyapatite crystals, while those of groups 5 and 6 showed fluorapatite. For the other peaks, no difference was observed when compared to the control group.
