Natural Disasters and Diagnosis of Man-made Factors, the Cases of Manjil and Bam

Mohsen Sartipi, Ph. D.

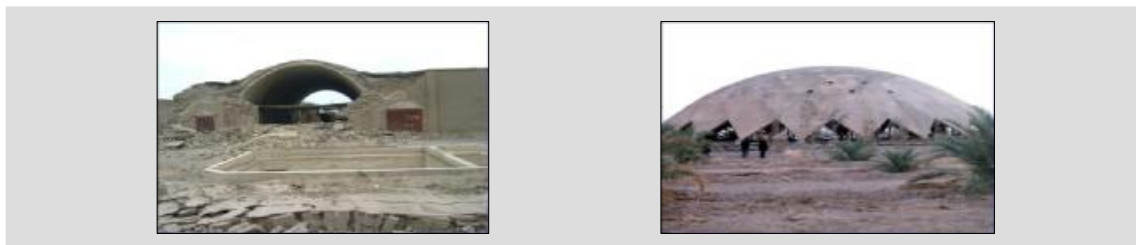
Figure 6- The effect of a geometrical form of the building on its stability, the right picture: a fair hall with the ceiling of space structure and a one-layer coating in newly repaired Arge Bam. The left picture: a mill building with annular barrel vault with a span of 10 meters.

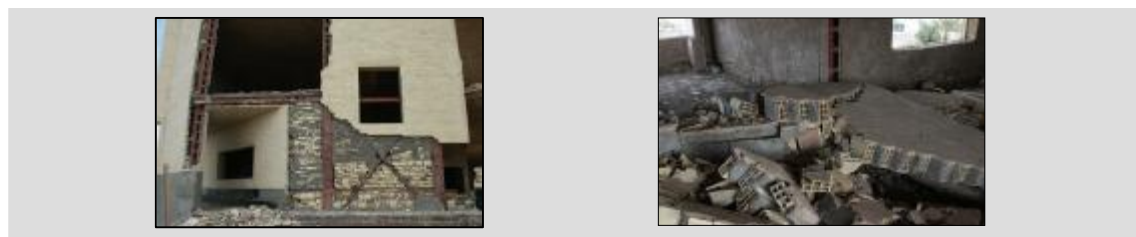
to disqualified attention to execution details especially in connecting the ceiling to the walls. The next important problem in nearly all buildings associated with the absence of connection between force carrying elements and dividing walls or other elements which did give way to increased rate of damage and destruction.

Figure 7- Following the earthquake, many housing and administrative buildings collapsed before the operation phase due to lack of connection between facades and dividing walls, and the structure.
