Study of ball bearings failure modes in an eddy current dynamometer

R. Rohani^{1*}, S. M. Jafari², M. Roozban³

ABSTRACT

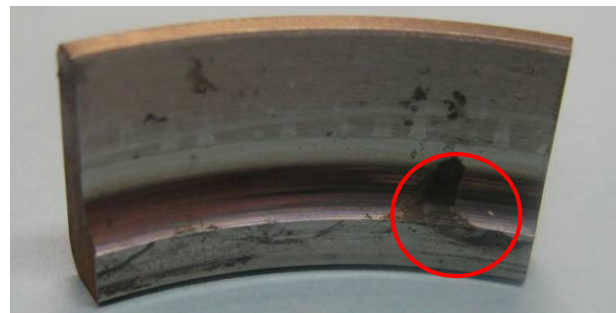
A dynamometer outer race with spalling damage is shown in figure 4. The single spall indicates that the defect is not only the result of Hertzian fatigue, but also arises from the pieces flaked out of the surface. Existence of contaminant foreign objects is also probable [11].

Figure 4: Fatigue damage on an angular contact ball bearing outer race

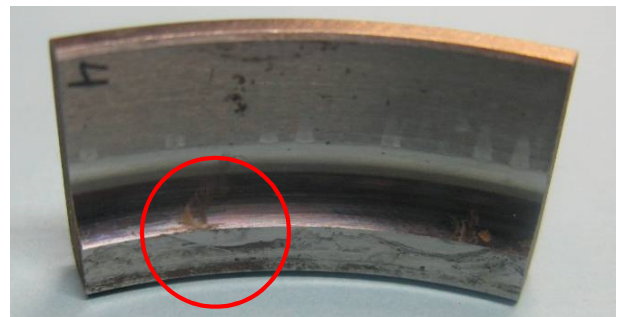
Because of coarseness of abrasive particles, the surfaces with this defect are dull and can be easily distinguished. Unpacking bearings just before mounting and using fresh, clean lubricants to some extent can prevent this damage [14]. An outer race with this defect is shown in figures 8 and 9. Pitting also exists in the area.

Figure 8: Abrasive wear in an angular contact ball bearing

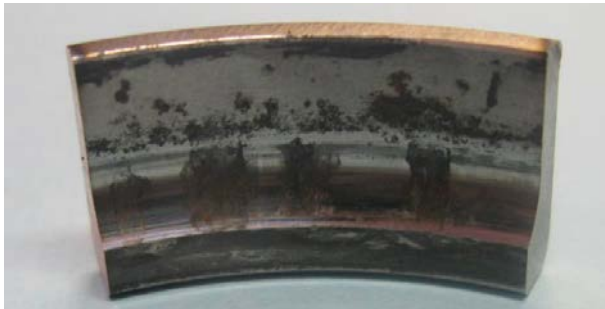
To decrease vibration and noise in dynamometers, dyno manufacturers utilize super precision bearings with fine surface finishes on the order of fraction of micron in the engine side of the shaft-rotor. Vibrations of environment influence the stationary dynamometers by producing micro-motions in the contact areas of bearing components. A dynamometer in the engine test bed never runs fulltime. The times consumed for New specimen (engine) installations, test cell software/hardware troubleshooting, and all in all when an engine test cell comes to a standstill can be the occasions in which the dynamometer bearings don't rotate but are subject to the vibrations raised

from other test cells or even the vibrations of facilities such as spot fans in the very engine test cell. The lack of lubricant film between balls and races leads to metal to metal contacts and the small relative movements as a result of vibration produce small broken particles and form depression in the raceways. The damage is called false brinelling with marks on the raceways surfaces at the ball pitch and parallel to the shaft axis. In most cases like what is shown in figures 10 and 11, oxidation of the detached particles produces red rust at the bottom of the depressions which is easily noticeable.

Figure 10: False brinelling in the outer race of an angular contact ball bearing

For stationary dynamometers, it is good practice to modify the engine test bed foundation and use air spring systems with required settings to absorb vibrations, and also to rotate the dynamometer shaft to prevent standstill of dynamometers as much as possible. Contriving oil pump beside dynamometers and using oil instead of grease as lubricant will decrease this damage in ball bearings.

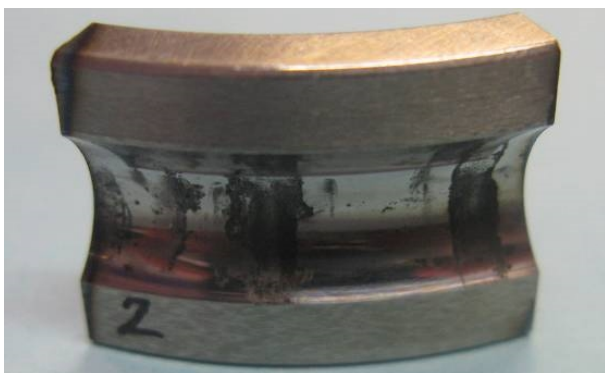
Figure 11: False brinelling in the inner race of an angular contact ball bearing

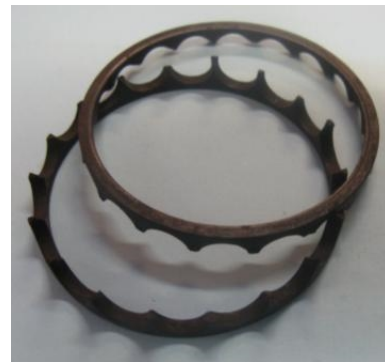
Among several dynamometer failed bearings chosen to study, just one case engaged cage damage which is shown in figure 17. In the angular contact ball bearing suffered from lubricant starvation and was exposed to excessive vibration, the cage is thought to fail due to blockage owing to wedged hard particles between the cage and a ball that prevented the latter from rotation around its axis.

Figure 17: Failure of an angular contact ball bearing cage
