# Experimental tests on existing RC beams strengthened in flexure and retrofitted for shear by C-FRP in presence of negative moments

## Abstract

**Keywords** Existing building · RC beams · FRP · Experimental test · Strengthening · End anchorage

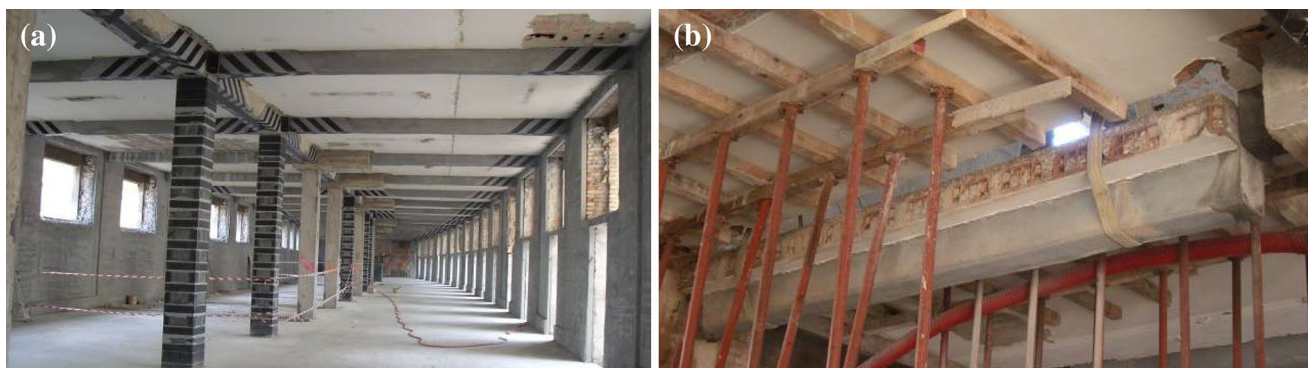
Fig. 1 Retrofitting of the RC building (a) and removal of the beams (b)

The retrofitting intervention on the RC structure involved the construction of new RC walls with consequent removal of two existing beams, as depicted in Fig. 1. These beams, labelled as TM1 and TM2, were carried to the PRiSMa Lab

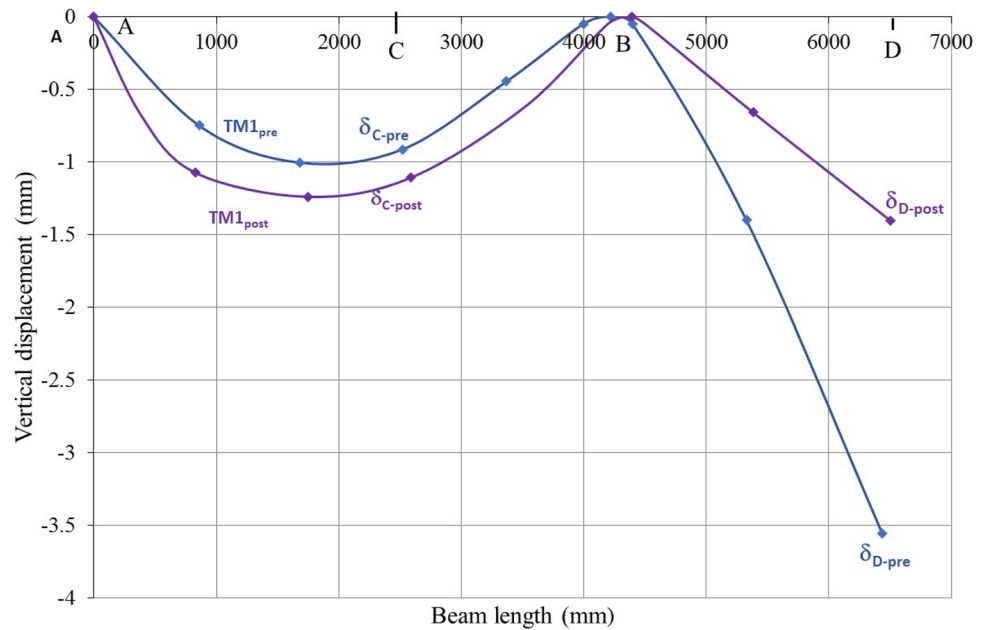
**Fig. 12** Deflections of the beam S-TM1-A for loads  $F_1 = 73\text{--}75\text{ kN}$  and  $F_2 = 27\text{ kN}$  before retrofitting (TM1pre) and after retrofitting (TM1post)

The behavior of the beam compared to that before retrofitting can be seen in Fig. 12 in terms of beam deflections. As already explained, the geometry of failure tests has light differences with respect to the elastic one. Therefore,

displacement comparison is not straightforward. The span of the retrofitted beam is larger, while the cantilever is shorter. Therefore, larger span and smaller cantilever displacements were expected.
