Research Article

Rockfall hazard analysis in the Ganjnameh tourist area, west of Iran

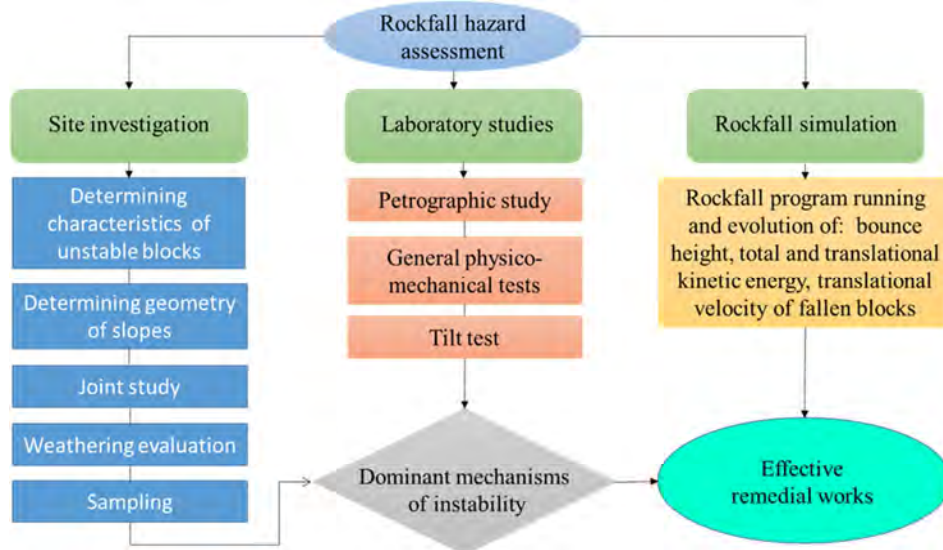
Fig. 4: Flow chart of this research process.

As discussed earlier, this study aims to assess rockfall hazard in the Ganjnameh tourist area. For this reason, a research program has been drawn based on three significant phases, including site investigation, laboratory studies, and rockfall simulation by computing software (Fig. 4). During the site investigation phase, comprehensive field surveying was done to determine the location of unstable blocks, their volumes and geometries, the key areas prone to the rockfall, geometry of slopes, sampling for laboratory works, weathering evaluation, and joint studies. Characterization of discontinuities in the study area was performed based on ISRM (1978) suggested methods. Laboratory investigation was done to determine some engineering geological properties, including petrographic, physical, and mechanical properties. Three thin sections have been prepared and studied using a petrological microscope to determine the mineralogical abundance and textural features of the rocks. Core samples were prepared and physico-mechanical properties have been determined following the standard test procedures suggested by the ISRM (2007). Six tilt-tests with four repetitions were also done on pairs of small slabs to estimate the basic friction angle. A rockfall program was performed and some indices such as total and translational kinetic energy, bounce height, and translational velocity of fallen blocks were determined. Finally, the mechanism of instability was determined and for protection purposes, some methods were suggested.

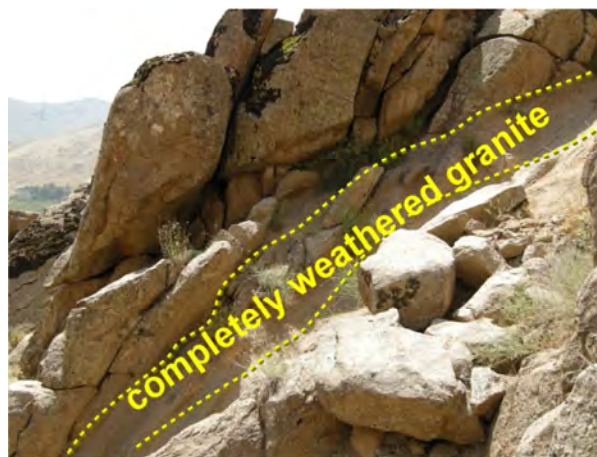
Fig. 5: Lying of instable blocks on completely weathered granite as basement.

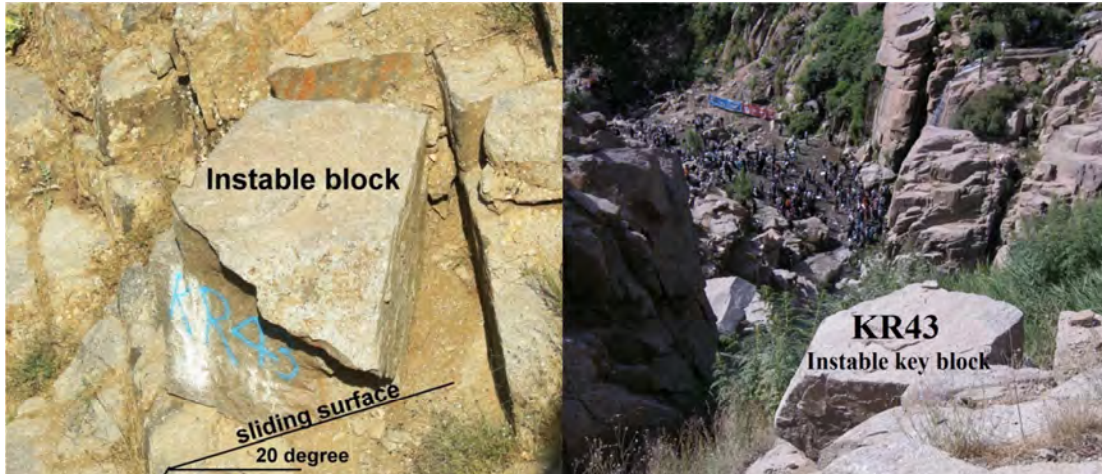
Fig. 6: A view of key block KR43 detaching due to Ice jacking action

needed as well. The external forces are associated with ice-jacking phenomena. Right side slopes will attract more sunshine and are subjected to high temperature variations over 24 hours. During a day, sunshine leads to the thawing of snow and the water will flow in cracks and joints. In the evening and night, the temperature will drop to below zero and the water will be frozen. The generated ice can produce two pressures.

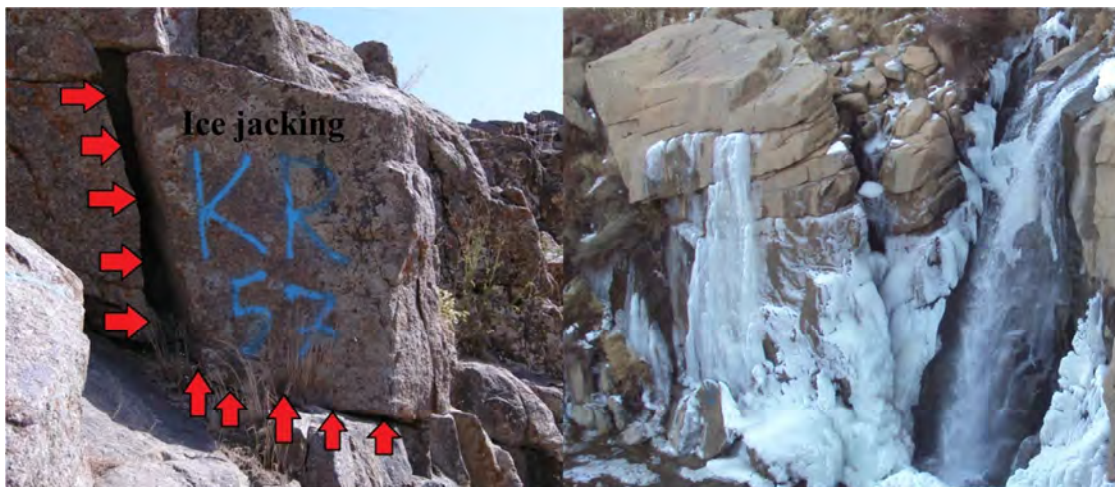
Fig. 7: A view of blocks detaching due to ice jacking action

As is shown in Fig. 7, the pressures are perpendicular to the cracks and one of them, which acts on the sliding surface, leads to a decreasing basic friction angle. The other one applies additional shear forces, and both of them are playing instability roles. Also, repetition of the freezing-thawing cycles will make weak the rock strength and reduce basic friction angle due to fatigue action.

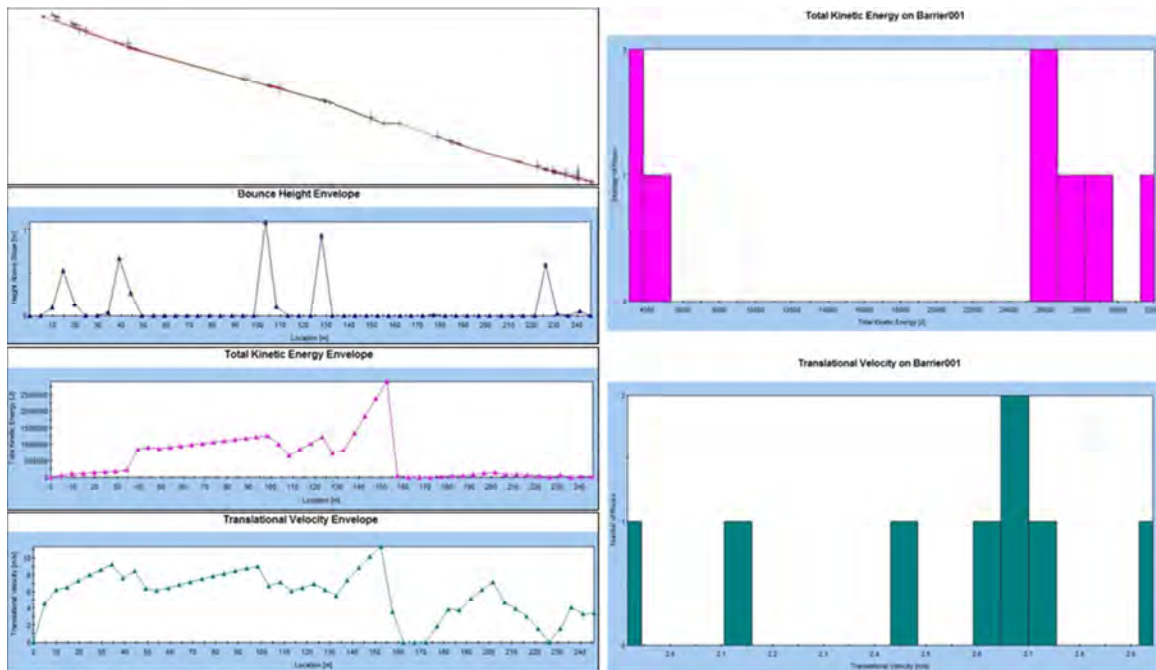
Fig. 9: Summary of rockfall analysis results on profile 2

A summary of the rockfall analysis results of profile 2 located in zone 3 is shown in Fig. 9. This simulation illustrates that the falling blocks were moving in a rolling state and just in 5 locations show a little bouncing less than 1 m. Total kinetic energy variation more or less shows gradually increasing up to 155 m of the route and after that dramatically decreased. A close inspection of translational velocity changes in this zone indicates that this parameter more or less is varied similar to total kinetic energy.

The velocity changes from 0-11 m/s, and a considerable decrease around 155 m of the route is highlighted. After crossing 220 m of the route, energy and velocity are sensibly decreased. On the other hand, the area is near the toe of the slope. So, the barrier location was considered at 228 m. assessment of falling blocks impact on the barrier indicates that just 8 blocks will reach the barrier.

The total kinetic energy of three blocks is less than 5 kJ, and the rest blocks energy is about 26-32 kJ. The translational velocity of the blocks at the barrier location varied between 1.9-3 m/s with a dominated velocity of about 2.6 m/s.

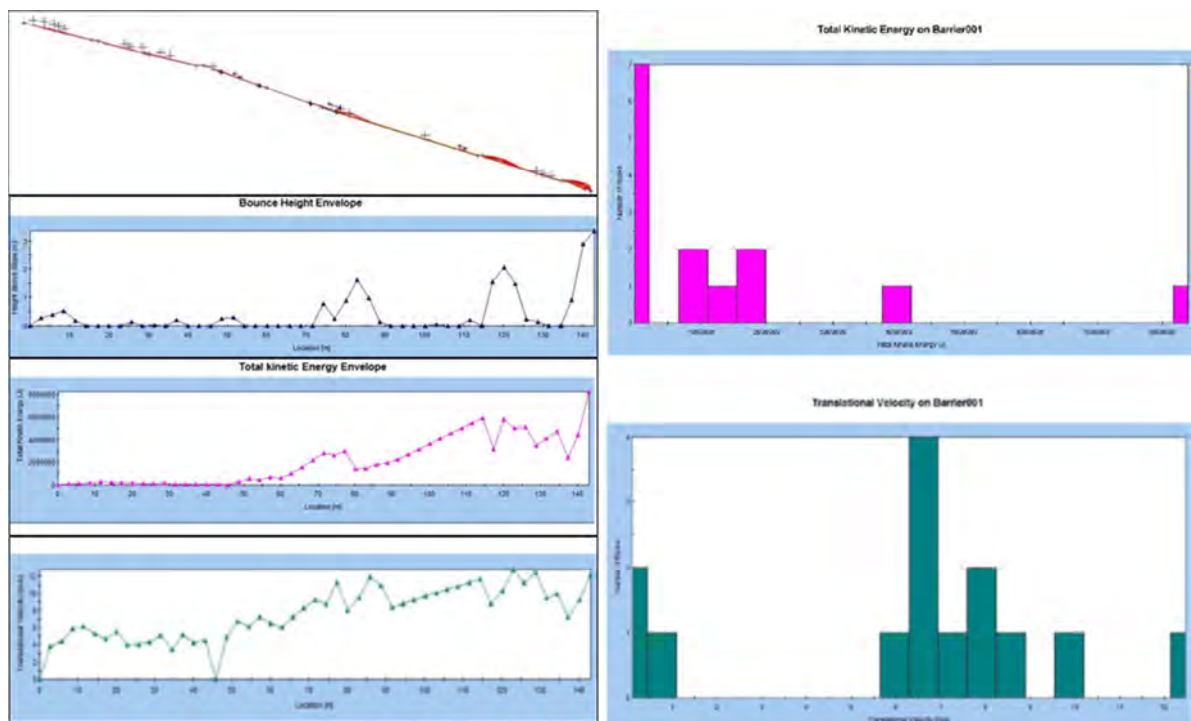
Fig. 10: Summary of rockfall analysis results on profile 3.

Profile 3, which is crossed between zones 4 and 5, was rockfall analyzed and the obtained results were shown in Fig. 10. The bounce height analysis results indicated that some blocks can jump more than 3 m at the end of this slope because of the presence of a ditch and its berm. Nevertheless, in most parts of the route, rolling is dominated type of movement. The total kinetic energy envelope shows that this parameter after crossing about 60 m of the route, is steeply increased and finally reached up to 8000kJ. The kinetic energy of fallen blocks dependent on their masses. Translational velocity variation indicated that this parameter was gradually increased and in some locations was reached up to 12 m/s. based on the three envelopes, the best point for the installation of the barrier was determined around 135 m of the route. The impacts of falling blocks on barrier indicate that 14 blocks ac arrive at the barrier which 50 percent of them have total kinetic energy less than 250 kJ and most of the remains have values between 800 to 1900 kJ and two blocks have high energy around 4000 and 8000 kJ. Also, the translational velocity of the arrived blocks indicated that the average value of the velocity in this zone is around 7m/s. Moreover, a block with a velocity of more than 12 m/s was considered.
