HYDROGEN DEGRADATION OF STEEL-DIFFUSION AND DETERIORATION*

M. FARZAM

Faculty of Petroleum Eng., Petroleum University of Technology, Ahwaz, I. R. of Iran
Email: farzam@put.ac.ir

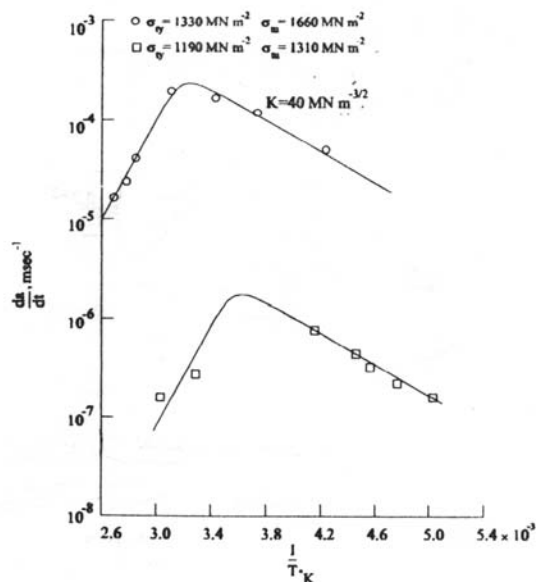
The temperature at which hydrogen will inflict its severest damage is at about 25°C [2]. Figure 1 shows that the crack advance at this temperature is maximum. The figure also shows that the higher the steel's strength, the faster the crack propagation rate. The effect of hydrogen when coupled with static and cyclic stresses will be reflected as stress corrosion, corrosion fatigue or a combination of the two, i.e. stress corrosion fatigue [3, 4].

Fig. 1. Crack advance Vs temperature in AISI 4130 [2]

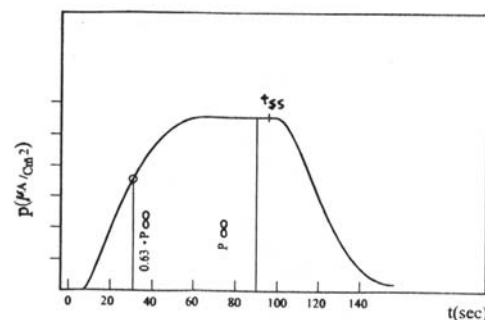
The hydrogen diffusion characteristics previously reported by Devanathan and Stachurski [5] (Fig.2) showed that it takes an incubation period, t_b , before hydrogen reaches the exit surface. The amount of hydrogen reaching the exit side increases and reaches a steady-state with time. Time t_b and the area under the curve is representative of the metal's characteristics.

Fig. 2. Hydrogen diffusion curve [5]

where L is the thickness in cm and $t_{lag} = 0.63 J$ steady-state. From Fig. 2, t_{lag} is measured at the intersection of the vertical line with the tangent of the slope at $0.63P_{s,s}$. Some researchers [6] have used the $0.83P_{s,s}$. Devanathan and colleagues [5] showed that as the voltage decreased, the amount of hydrogen diffused increased and D was not a function of thickness. Detailed research has been conducted on the effect of microstructure on hydrogen diffusion [7]. The concluding remarks on such an effect are that the structural inhomogeneities; line defects, impurities (TiC) or martensitic laths, will trap hydrogen and degrade the microstructure. The lower the hydrogen-defect bonding energy and the less such microstructure inhomogeneities, the less the amount of trapped hydrogen and the less likelihood of hydrogen degradation. Other researchers have reported their findings on the increase of the number of dislocations and therefore the amount of trapped hydrogen and trapping energies [8, 9]. Their conclusions include that having a homogeneous structure reduces the risk of hydrogen damage. Variation of D with microstructure and alloying is definite, and it may be stated that the lower the D , the lower the amount of diffused hydrogen [10]. Therefore, if the amount of trapped hydrogen is lowered, the possibility of hydrogen damage is decreased. It may be suggested that by controlling the microstructure, hydrogen degradation is controlled. Considerable research has been previously conducted on the fractography of fractured surfaces. In a stress corrosion cracking study in H_2S , Huang and Shaw [11] showed that the crack morphology was quasi-brittle and the observed white markings were considered a sign of the presence of hydrogen. As it will be noticed below, almost all findings reported above are reaffirmed in this work and this author accept them.

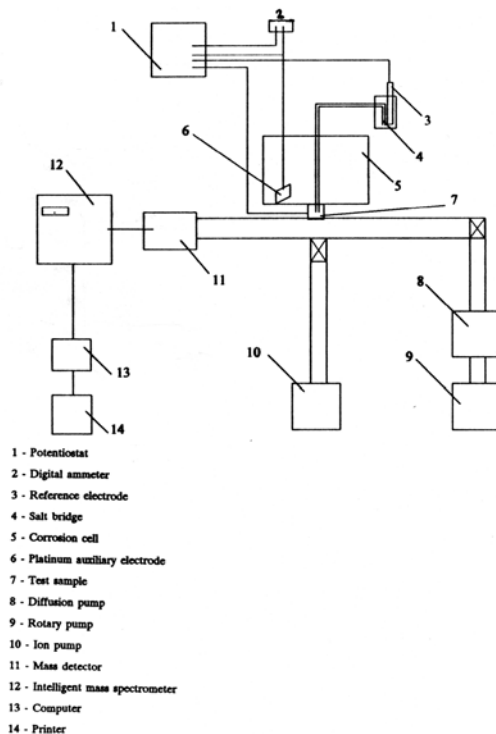
Fig. 4. Apparatus used for electro-vacuum testing

The electro-vacuum testing technique used a cathodic electrochemical cell to charge the hydrogen into steel, and a vacuum (10^{-7} torr) side leading to a mass-spectrometer to detect the amount of hydrogen diffused through, using a computer. Table 1 gives details of the alloying elements of the steels tested by the electrochemical method. The API 5LX65 was used to transport liquid gas. Hydrogen-induced cracking was observed in this steel during service, (as was reported by British Gas) and cracking occurred at positions where the microstructure due to the segregation of Mn ($Mn=2\%$), was martensitic. The steel's structure was similar to BS 4360 (Table 1). There are a few reasons why the alloy used in this paper are in accordance with different standards. Firstly because this work covers more than 20 years research on hydrogen diffusion and degradation phenomena, secondly each metal supplied in different stages was purpose (tailor) made for a specific application. However the reader is kindly referred to Ref. [17] for AISI/ SAE 4340 page 70, for BS 4360 page 202 and for API X65 page 332.

This article represents more than twenty years of intense and continuous research, beginning at Sheffield University (U.K.), then at Heriot-Watt University (U.K.), and afterwards in Iran. The electrochemical technique was used at Sheffield, while a newly invented method by this author, which is a cross technique between the electrochemical and vacuum (gaseous) techniques was employed at Heriot-watt (Scotland, U.K.). The results were then correlated with stress corrosion, corrosion fatigue, and case studies in Iran [16]. Figures 3 and 4 show the apparatus used in the present investigation.

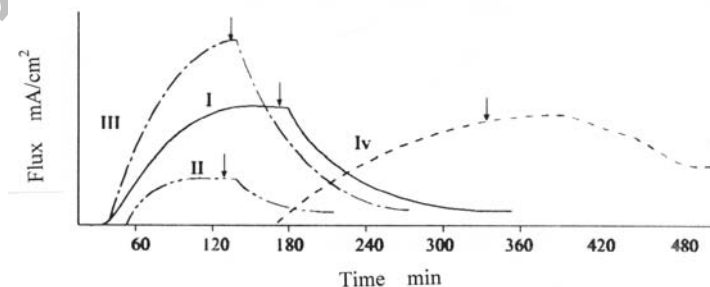
Fig. 5. Hydrogen diffusion measurements conducted by Devanathan's method (2mm thick) (I) X-65 (low S); (II) X-65 (high S); (III) BS 4360; (IV) BS 4360 (quenched)

Alloy BS 4360 with higher Mn when quenched, showed an increased t_{lag} and a decreased D of $0.44 \times 10^{-6} \text{ cm}^2/\text{S}$ (Table 2). This result was attributed to the presence of fine laths of martensite, which is saturated in carbon and is an internally stressed structure (shear-induced transformation). Figure 5 compares the behaviors of X65 and the quenched 4360. The figure shows 4360 to have the longer t_b .

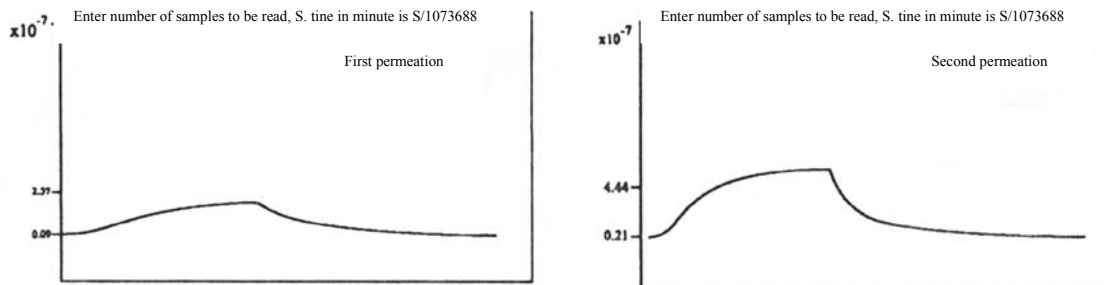
Fig. 6. Hydrogen diffusion measurements by the electro-vacuum testing technique

As the thickness was decreased from 2 to 0.5 mm, D increased from 1.6×10^{-6} to $4.3 \times 10^{-6} \text{ cm}^2/\text{S}$. This change was only due to the kinetics of the electrode's surface. The electro-vacuum tests conducted on API X52 and AISI 4340 (Fig. 6) were made without Pd coating of the test samples.

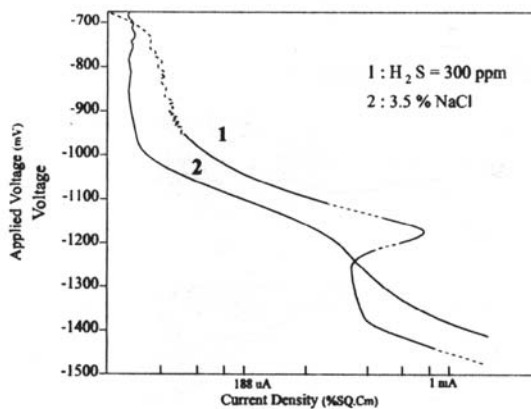
Fig. 7. Linear polarization (cathodic side) in: (1) seawater+ $H_2S = 300 \text{ ppm}$; and (2) 3.5% NaCl solution

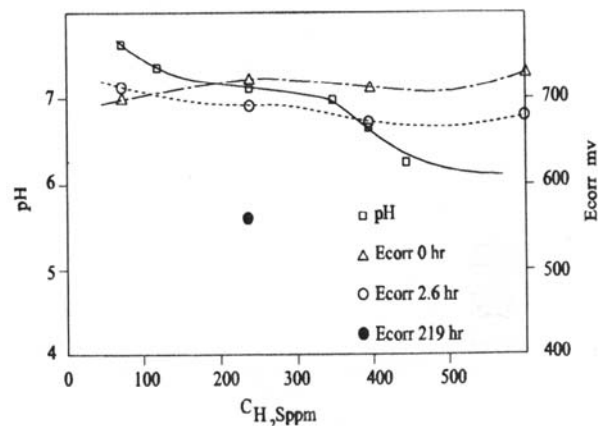
Fig. 8. Changes in E_{corr} in different H_2S concentrations for AISI 1055

The free corrosion potential of steel in the presence of H_2S will change with time. Figure 10 shows that with time (after 219 h) the potential of AISI 1055 increased from -720 to -560 mv. This may be due to the change in FeS stoichiometry, perhaps to FeS_2 . When the corroded surface was cleaned it was noted that pits had formed under the black FeS layer (see Fig. 9).

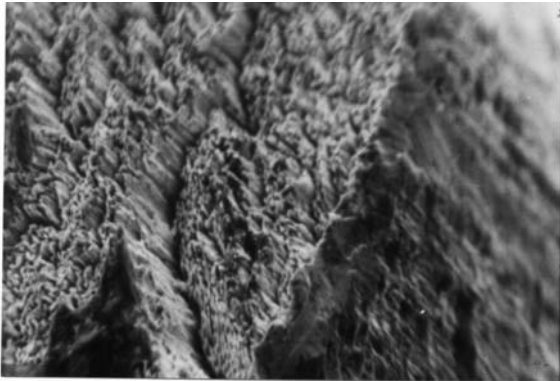
Fig. 9. Pitting corrosion of AISI 1055 in H_2S

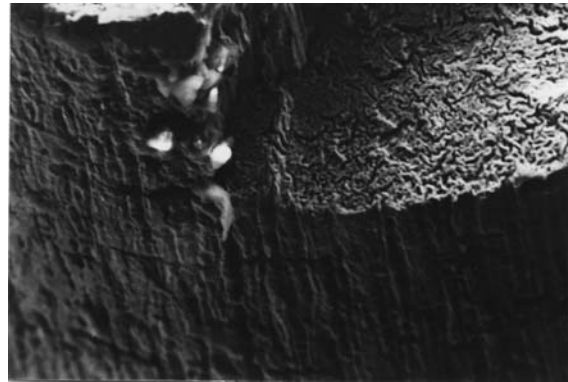
Fig. 10. Initiation of microcracks from surface pits (anodic dissolution)

Corrosion fatigue and stress corrosion tests were conducted on wires and wire-ropes (AISI 1055, 1074, and 50B60) in an H_2S environment. In the fatigue tests, the number of cycles to failure decreased as the maximum stress increased. This was considered as a sign of stress corrosion fatigue failure. Cracks were noted to originate from the corrosion-pits formed under perforated FeS layer (Fig. 10). Thus, one can say

that the crack initiation mechanism is anodic dissolution. White marking, as a result of hydrogen embrittlement was observed on the fractured surface (Fig. 11), also refer to reference No. 11. Thus, hydrogen embrittlement could be the mechanism of crack propagation.

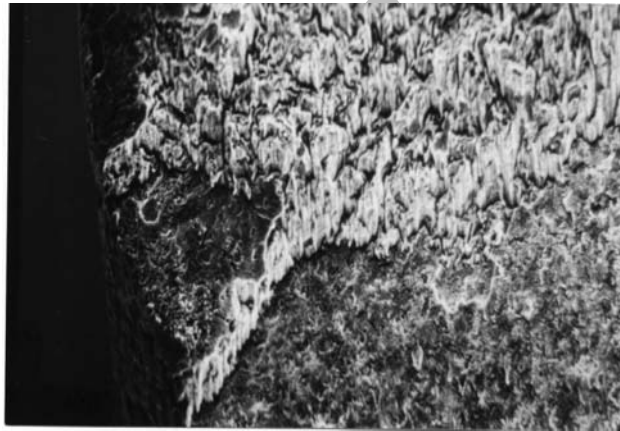
Fig. 11. Signs of hydrogen embrittlement (white markings)
