# Geotechnical Instabilities Occurred During the Bam Earthquake of 26 December 2003

**ABSTRACT:** *This paper describes the geotechnical instabilities such as landslide, liquefaction, and ground subsidence caused by the Bam earthquake. Based on the results of geotechnical investigations, after the Bam earthquake, land subsidence due to collapse of Qanats (underground irrigation tunnels), local toppling, and block slides along riverbanks or man-made channels were the most dominant geotechnical instabilities of the event. These effects will be introduced and discussed in this paper and the distribution of them will be presented based on the study of aerial photos and site investigations. In addition, the geological setting of the area based on field investigations and evaluation of some geophysical data will be discussed.*

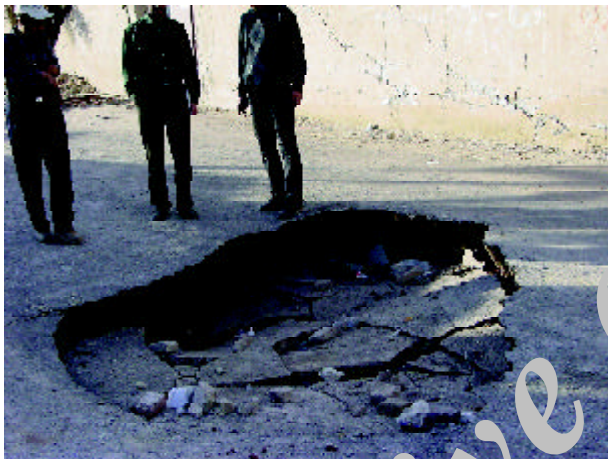
**Figure 19.** Sinkhole induced due to collapse of an old Qanat on one of the bypasses at Baravat.

Figure (19) shows damage to one of the access

roads to Baravat due to collapse of an old Qanat. Such sinkholes could be observed in this area under the main and bypass roads and made some difficulties for rescue and relief teams to reach the area after the earthquake. The main road from Kerman to Zahedan passing south of Bam was also damaged severely because of a sinkhole. At the time of the visit, this sinkhole has been filled but the same sinkholes around the road remained without changes, and one sample is shown in Figure (20). Based on the reports, the sinkhole induced under the main road caused a heavy traffic in this part after the event. Considering the importance of first hours after an earthquake for rescue, it is obvious how such sinkholes can affect these activities.

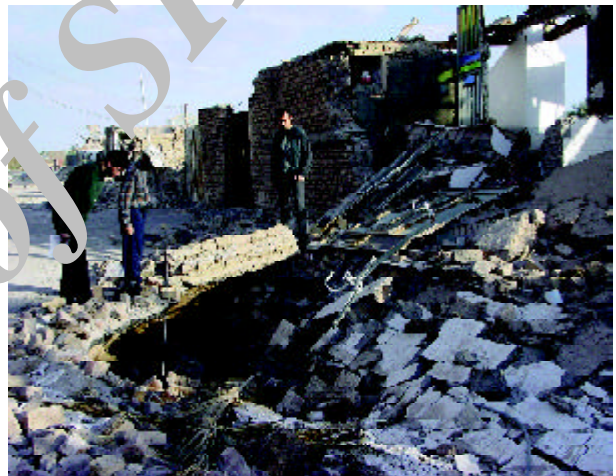
**Figure 21.** Damage to a building due to collapse of an old hidden Qanat (Baravat).

Besides of the effects of sinkholes on roads, there are some damages to the buildings and constructions due to collapse of Qanats specially at Baravat. Figure (21) shows the damage to a building at Baravat due to

collapse of an old Qanat during the earthquake. As it can be observed, this sinkhole caused severe damage to this house.

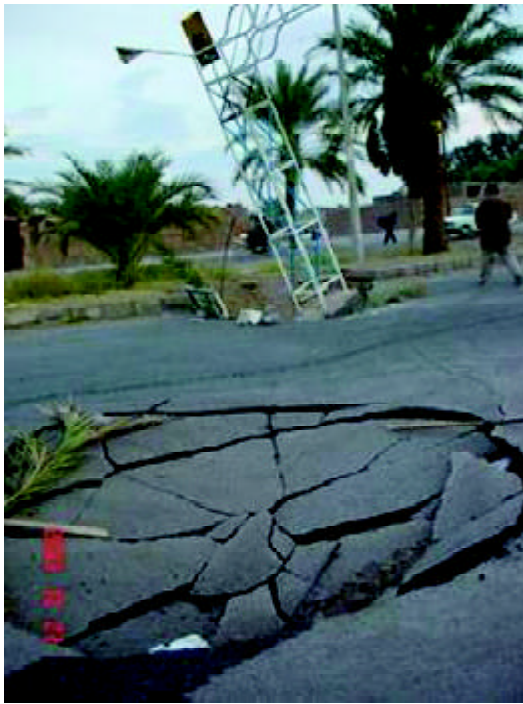
**Figure 22.** Damages to road and a religious arc due to the collapse of a hidden Qanat (Baravat). Photo has been Taken by Dr. M. Zare one day after the event.

Figure (22) presents damage to a religious arc due to collapse of a hidden Qanat under its column. Along the trend of this hidden Qanat, several sinkholes were observed at the area.

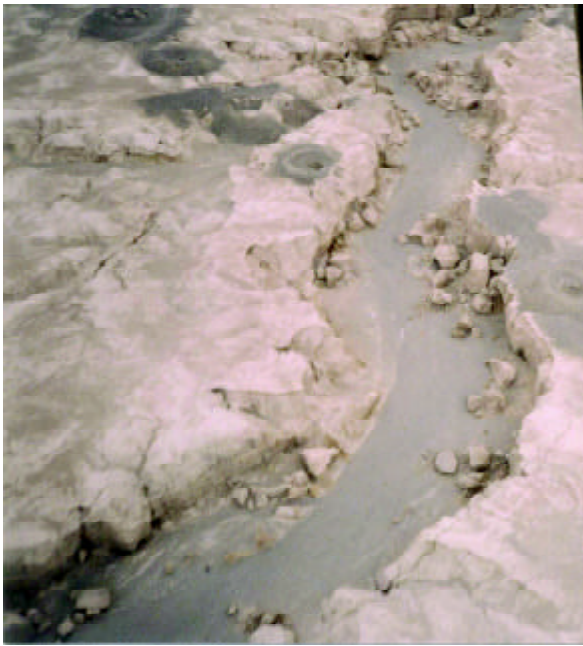
**Figure 27.** Soil block falls triggered by Bam earthquake at west of Baravat. (The photo has been taken during pilot study by helicopter).

The hills located at the west of Baravat and in the east of Bam are extremely susceptible to failure during seismic shaking. In this area, more than 75 percent of the slopes were affected by the earthquake and several shallow disrupted landslides induced as a result. The main characteristics of landslides at this area are their small sizes, shallow deeps and their dry, highly disaggregated material accumulated at down slopes in a flatter area. The volumes of these slides vary from a fraction of a cubic meter to hundreds of cubic meters, see Figure (27).

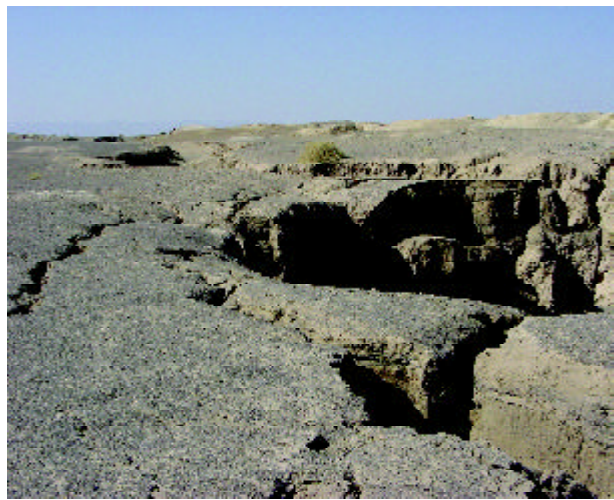
**Figure 28.** Deep tensional crack and soil blocks fall induced during the earthquake, North of Rahamani village.

observed mostly in more competent sedimentary units at Bam and Baravat. In addition several deep landslides were triggered at the north of Rahmani village, see Figures (28) and (29).

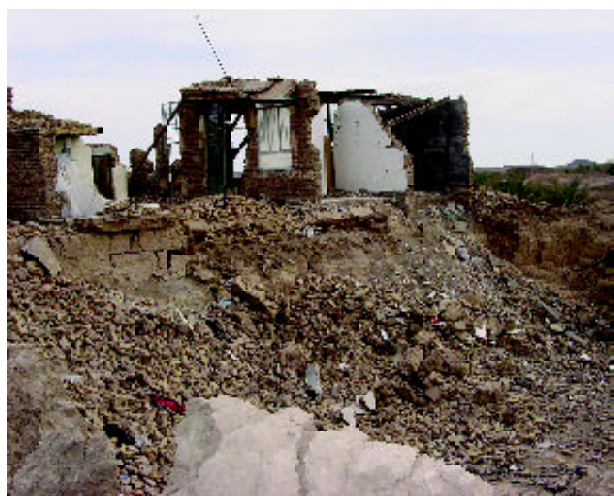
**Figure 30.** Damages to a building located at top of an excavation due to landslide, Esfikan village, Northeast of Bam.

The only damage observed due to the landslide was related to the collapse of a house located at the top of an excavation at Esfikan; north of Bam, see Figure (30).

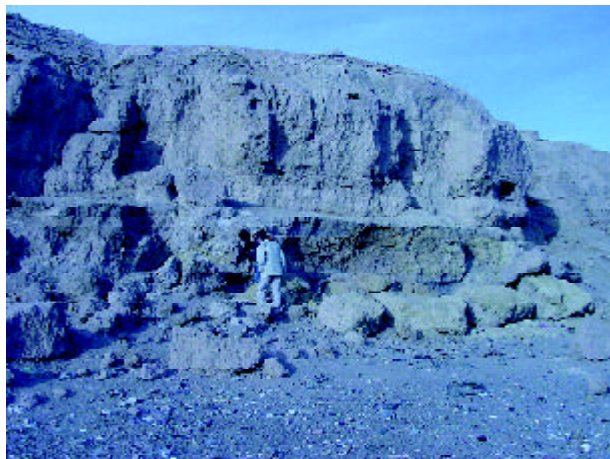
Figure 31. Small pond at Esfikan, Northeast of Bam.

due to existence of small ponds, see Figure (31), or flow of Qanat's water through the channels, but no evidences of liquefaction have been observed in these sites, and this can be due to the small thickness of sand layers and its compaction.
