Performance of Roofs and Floor Slabs During Bam, Earthquake of 26 December 2003

Mahmoud R. Maheri

Civil Engineering Department, Shiraz University, Shiraz, Iran, email: maheri@shiraz.ac.ir

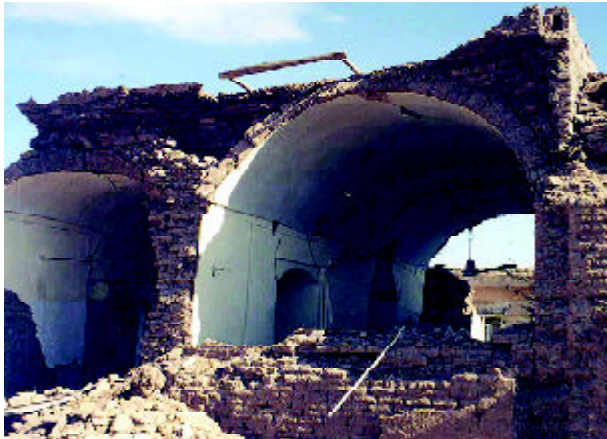
Many of the roofs of these types of buildings were vaults spanning between shared parallel load bearing walls. The typical mode of failure was the partial or total failure and collapse of the weak and heavy load bearing walls followed by the local or global collapse of the roof. These types of non-homogeneous, brittle roofs are not capable of restraining the top of their supporting walls. However, a number of vaulted and domed roofs survived the earthquake. These were in

buildings where the supporting walls had remained in place under earthquake loading, see Figure (4).

Figure 4. Survival of masonry vault roof during the earthquake.

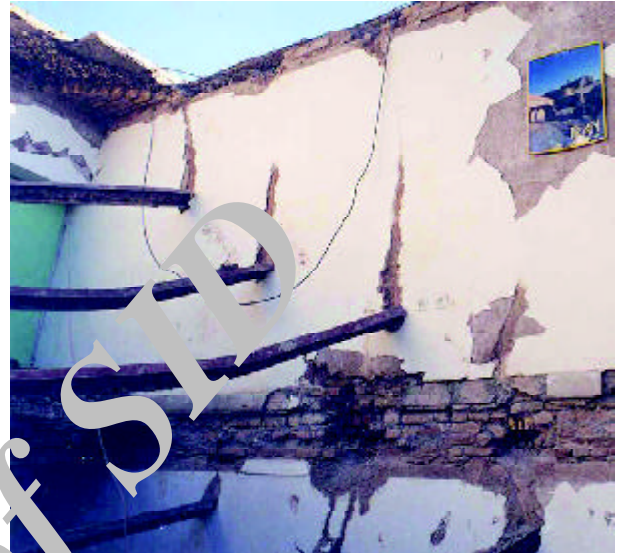
- i) Short bearing length of the slab beams: In many instances it was noted that the bearing length of slab beams over the load bearing walls were minimal, in some cases the ends of the beams were simply resting on the edge of the walls, see Figure (5). This short supported length of beams caused increased concentration of stresses in regions of the walls already highly stressed. At the onset of ground shaking, local support failures under the slab beams resulted in the movement of the beams causing the subsequent collapse of the masonry arches. Also as the unrestrained load bearing walls moved away from the slab under ground shaking, the beams simply separated from their supporting walls and collapsed as seen in Figure (5).
- ii) Use of end walls to support end brick arches: To reduce the construction cost, it appeared common practice to omit the slab beam over the

Figure 5. Collapse of jack arch steel beams as a result of small bearing length.

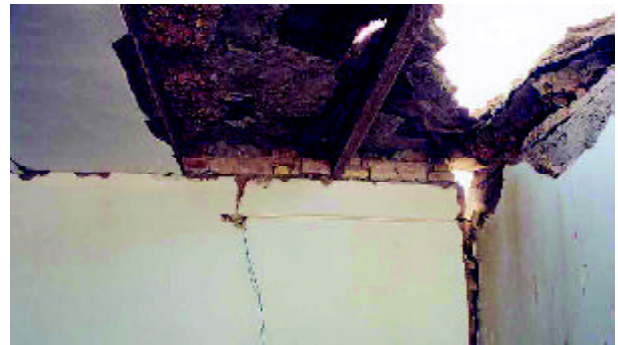
end walls and to use the end walls to support the end jack arches. Since there are no proper connections between the perpendicular walls, separation of the end walls from the load bearing walls was a common mode of failure resulting in the collapse of the end masonry arches as seen in Figure (6).

Figure 6. Collapse of masonry arches due to the movement of end support wall.

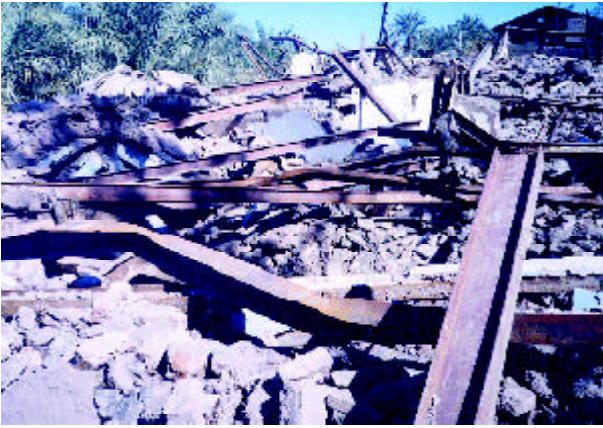
- iii) Inability of the slab to act as a diaphragm: The ill-connected composite form of the unanchored slab does not allow for a diaphragm action as is required for good seismic performance. It was observed that when a part of the load bearing wall or supporting beam failed under earthquake loading, the unsupported section of the slab had also failed. This can be seen in Figure (7) where the collapse of load bearing walls has caused the collapse and disintegration of the composite, non-homogeneous slabs.

Figure 7. Collapse and disintegration of unanchored jack arch slabs.

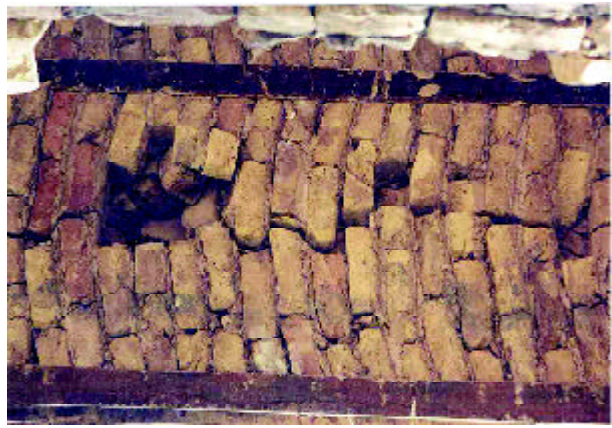
Figure 9. Failure of masonry arch as a result of out-of-plane bending loads.

v) Failure of the masonry arches caused by the out-of-plane forces: Bam earthquake was associated with very large vertical accelerations. The vertical component of the quake had caused large out-of-plane dynamic loading on the slabs. The geometry of the brick arches makes them far stiffer than the steel beams in vertical vibration. Therefore, the vibration-induced stresses tend to concentrate in the stiff brick arches rather than the more flexible and ductile steel beams, resulting in the failure of the former, see Figure (9).

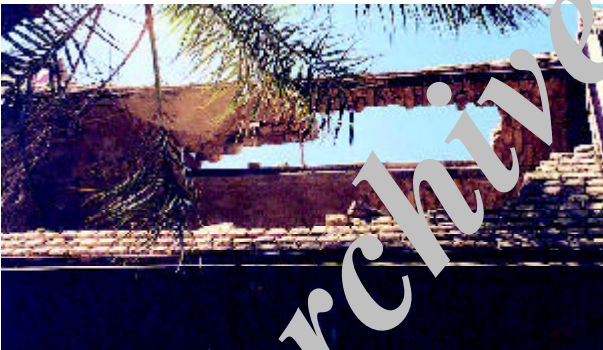
iv) Failure of the masonry arches due to the earthquake induced in-plane forces: In the traditional one-way slabs, the in-plane axial and shear loads are transferred mainly by the brick arches. The brick arches are however ill-suited to transfer these forces. An example of the failure of a masonry arch due to in-plane loads in the direction perpendicular to the main beams can be seen in Figure (8).

Figure 8. Failure of masonry arch due to in-plane transverse loading.

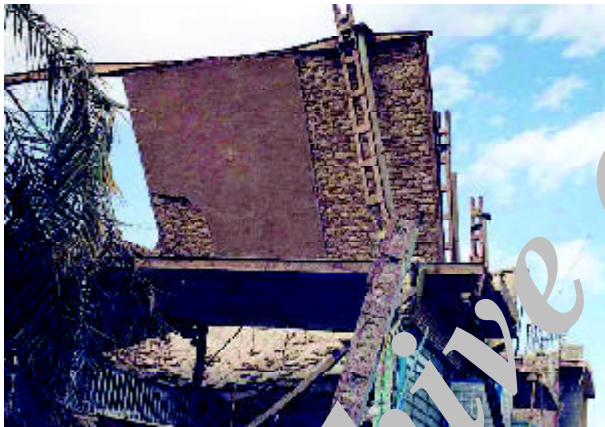
a better seismic performance for the anchored slabs was noted. In fact some observed performances of the anchored jack arch slabs reinforce previous numerical and experimental findings of the author regarding the seismic capabilities and resilience of the anchored slab. A good example of the resilience of anchored jack arch slab can be seen in Figure (10). This figure shows the collapse of the second floor jack arch slab of a two storey steel-framed building due to the failure of the main beam/column connections on one line of support. The slab beams are joined together by transverse beams acting as girders. The confined brick arches survived both the earthquake shaking and the collapse of the slab. Also it is noted in the same figure that the first floor jack arch slab of the building had also survived the earthquake loads and the massive shock caused by the collapse of the upper floor slab.

Figure 10. Integrity of the anchored jack arch slab under earthquake loading and after collapse.

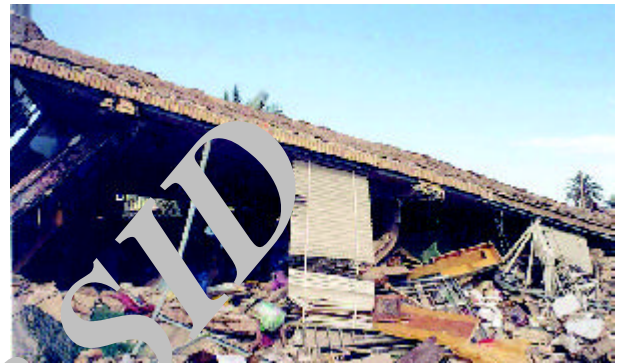
Another example of the ability of the anchored jack arch slab to act as a diaphragm can be seen in Figure (11). The failure of the supporting columns of this building, caused by the excessive sway has resulted in the collapse of the jack arch floor slab. However, the slab has managed to retain its integrity and act as a diaphragm.

Figure 11. Ability of the anchored jack arch slab to act as a diaphragm.

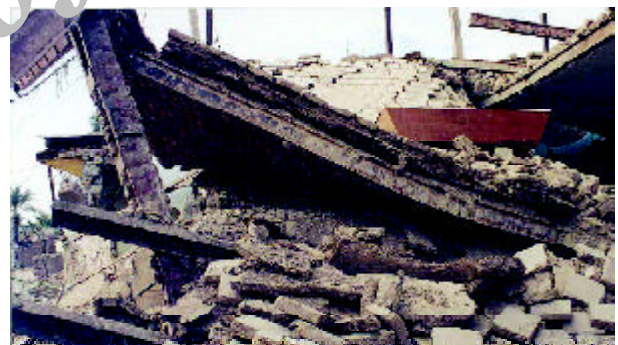
The jack arch slabs have been considered to be non-ductile, brittle composite systems. However, the behaviour of a large number of jack arch slabs during the Bam earthquake showed a different response. It was noted that the masonry arches, when confined, underwent large deformations along with their supporting steel beams and remained intact. An example of this behaviour can be seen in Figure (12) in which the masonry arch shows large deformations

compatible with plastic deformations of the supporting steel beams.

Figure 12. Ability of the anchored jack arch slab to undergo large deformations.

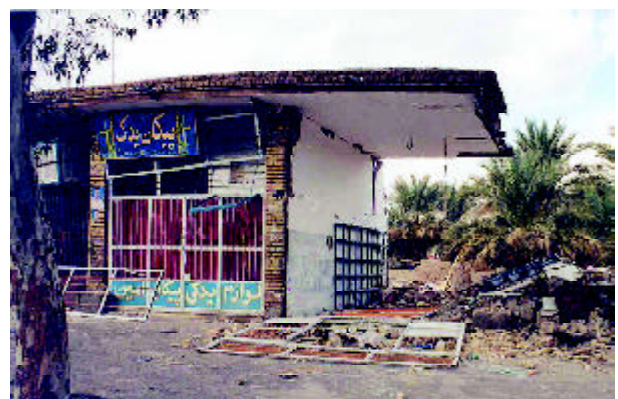
Perhaps the best example of the strength and ductility of the anchored jack arch system is the masonry building shown in Figure (13). The roof of this three-bayed, single-storey building consists of continuous steel beams spanning over the supporting masonry walls and resting on purposely placed concrete blocks. The beams are joined together at

Figure 13. Resilience of anchored jack arch slab in withstanding diverse loading conditions.

their ends by transverse steel beams. Under the earthquake loading the end support wall has completely collapsed leaving the 3.5m span of the slab to act as a cantilever, supported by the remaining load bearing wall. The fact that such a large cantilevered slab was capable of supporting its own weight and the subsequent large out-of-plane earthquake loading is witness to the abilities of the anchored jack arch slabs.

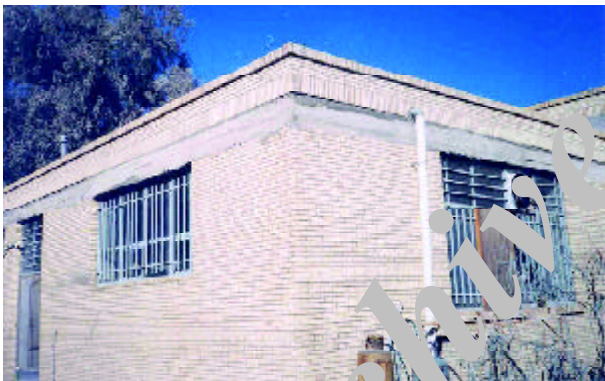
A large number of buildings, which survived the earthquake, had anchored jack arch slabs. In many instances the floor slabs were so intact that even minor failures in the form of cracks in plaster could not be seen. The code-designed single-storey masonry building with concrete ring beams shown in Figure (14) is but one example of such behaviour. Some of the anchored jack arch slabs had construction material and details and workmanship similar to the slabs of the building seen in Figure (15). This unfinished building also survived the Bam earthquake. The brick arches of the slab consist of lightweight

Figure 14. No damage in this code-designed masonry building having ring-beam supported jack arch slab.

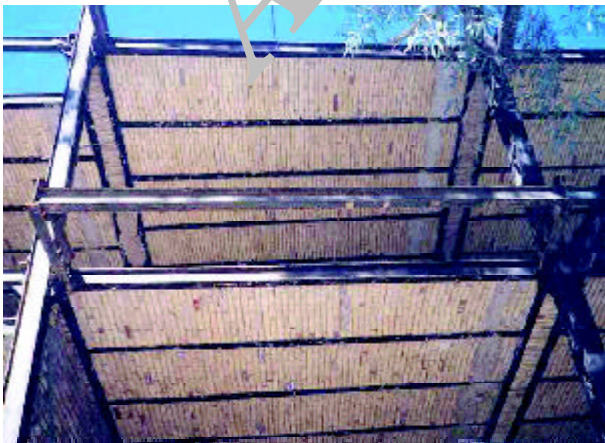
Figure 15. Good seismic performance of anchored jack arch slabs made with lightweight perforated bricks.

perforated brick units and lime/clay mortar. The lightweight perforated bricks are far more suitable for jack arch construction as they reduce the weight of the slab as well as provide better bond between the mortar and bricks. The parallel load bearing beams of the slab are also well restrained by transverse beams at their ends.

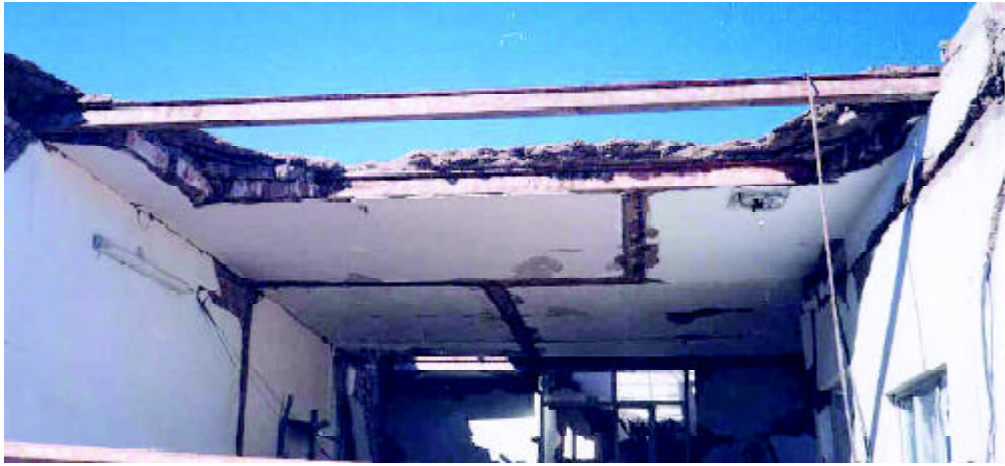
It should be noted that the contemporary jack arch slab construction in Iran is still considered as a non-engineered slab in the Iranian seismic code as there are no particular design procedures for their engineered design. They still suffer from weaknesses in transferring in-plane axial and shear loads as well as the out-of-plane bending loads and the detrimental effects of dynamic interaction between steel beams and brick arches. On the other hand, considering the advantages of this type of flooring system compared to other types of flooring, the author and his colleagues have conducted a number of investigations on the jack arch slabs evaluating their seismic response [7]. Simple methods of increasing the seismic performance of the slab in the form of inter-span transverse beams were then proposed and their effectiveness investigated both experimentally and numerically [8, 9]. Finally, procedures for their engineered design and construction were introduced [10]. Although these design procedures were not applied in the construction of the jack arch slabs in the city of Bam, some existing anchored slabs had details compatible with the proposed engineered version of the slab. An example of the effectiveness of the use of mid-span transverse beams can be seen in Figure (16). It can be seen in this figure that the portion of the slab in which inter-span transverse beams are utilised to join the main beams together, has remained in place, whereas the front section of the slab which lacks similar transverse beams has disintegrated and collapsed.

Figure 16. Effectiveness of inter-span transverse beams in keeping the integrity of the slab.

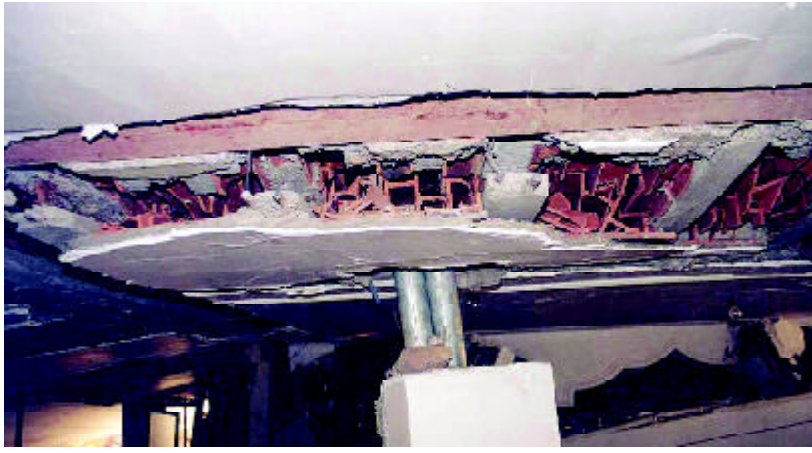
ii) Lack of proper connection between the slab concrete beams and the slab support beams: During construction, the pre-cast concrete beams of the slab are positioned in place with their exposed reinforcements extended into the slab support beams. Some extra bars acting as negative reinforcements are also positioned over the slab beams and the support beams. The support beams are then cast together with the slab so that an integrated slab-support beam is obtained. It is too frequently observed that the slab beam reinforcement extensions are inadequate or non-existent and that the all-important negative reinforcements are altogether omitted. In steel framed buildings, these connection details are even more problematic as the connection arrangement between the slab concrete beams and the steel support beams is difficult to administer. This can be seen in Figure (18) in the form of separation of the slab concrete beams from their supporting steel beam.

Figure 18. Lack of proper connection between the slab concrete beams and the steel support beam.

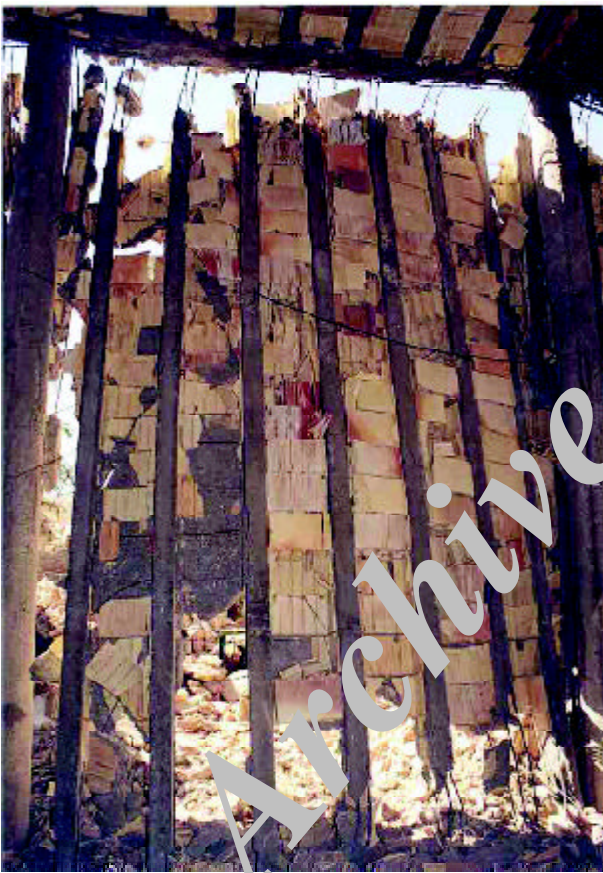
iii) Separation of the slab reinforcement and the overlying concrete: During construction of this type of floors care should be taken to provide enough cover space between the hollow blocks and the slab reinforcement. This construction detail however is often ignored and the slab reinforcement is slackly placed directly over the hollow blocks. In this way the overlying concrete is reduced to an unreinforced cover, susceptible to brittle failures. This can clearly be seen in the collapsed slab shown in Figure (19) in which the slab reinforcements can be seen between the blocks and the overlying concrete and detached from the latter.

Figure 19. Poor workmanship in construction of concrete beam-hollow block slab.
