Internal Jugular Catheter Malposition in a Patient with End Stage Renal Disease: a Case Report

Abstract- A 30-year-old female with end-stage renal disease was a candidate for dual lumen catheter placement. After catheter insertion, O₂ saturation measurement of the aspirated blood from the catheter was similar to that of arterial blood. They referred the patient to our hospital after 48 hours. Diagnostic procedures revealed that the tip of the catheter had entered the pleural cavity. Catheter removal in the CPR room resulted in hemorrhagic shock. The patient was resuscitated and stabilized and sent to the operating room. A laceration found at the junction of right jugular and right subclavian veins and was surgically repaired. The patient was discharged after ten days without any complication.

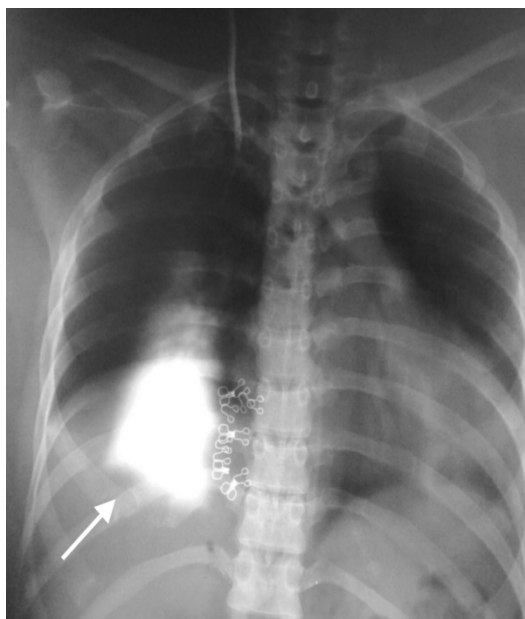
Dye (10cc of Omnipaque®) was injected through each end the catheter and a portable chest X-ray (CXR) was obtained afterwards which demonstrated dye extravasation to the pleural cavity (chest radiography is considered the gold standard for detection of pneumothorax, hemothorax, or cardiac tamponade with injection of contrast media through the central venous catheter (2)). It was concluded that the tip of the catheter had entered the pleural cavity (Figure 2).

Figure 2. Chest X-ray obtained after dye injection shows dye distribution to the pleural cavity (arrow)

Decision was made to pull out the catheter under close monitoring in the CPR room of the ED. The catheter was pulled out, and local pressure was applied. After few minutes, the patient became pale accompanied by progressive dyspnea and low breath sound at the right side of the chest. The patient was intubated immediately, and a chest-tube was placed at the right side of the chest wall which directly drained off 2000ml of fresh blood. Blood pressure dropped down to the point in which no distal pulses were detectable, and the patient suddenly developed cardiac arrest. Cardio-pulmonary resuscitation (CPR) started immediately. With the impression of laceration of the great vessels at the base of the neck, anteromedial thoracotomy was performed by an incision at the right fourth intercostal space to reach the source of bleeding, and it was packed with sterile gauze. Hemostasis was successful, and the patient's heart began beating after five minutes of CPR and she started to breath actively. A femoral catheter was placed for fluid resuscitation as no other peripheral

At the OR, a medial sternotomy approach was used to reach the bleeding site. The incision was continued to the medial border of right sternocleidomastoid muscle. Right brachiocephalic, right carotid and right subclavian arteries were explored in their entire length, and there was no site of bleeding. But at the junction of right jugular and right subclavian veins a laceration with the length of 1cm was found and surgically repaired. The patient stabled hemodynamically and sent to the intensive care unit (ICU). She was discharged without any complication after ten days.
