PERFORMANCE OF TRADITIONAL ARCHES, VAULTS AND DOMES IN THE 2003 BAM EARTHQUAKE

T. Mahdi*

Department of Structural Engineering, Building and Housing Research Center, Tehran, Iran

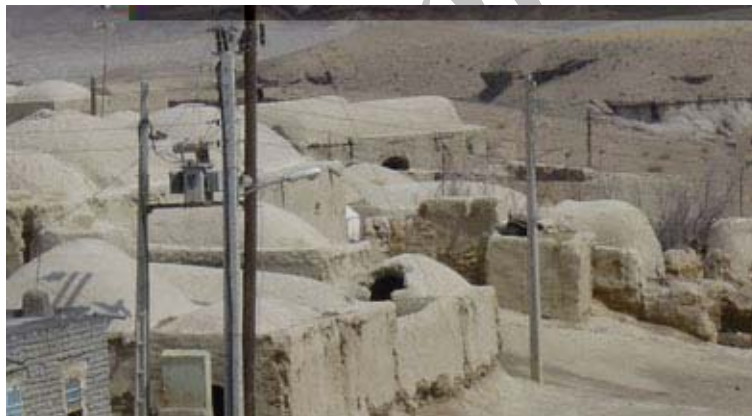
Figure 1. A typical village in eastern Iran with vaulted roofs

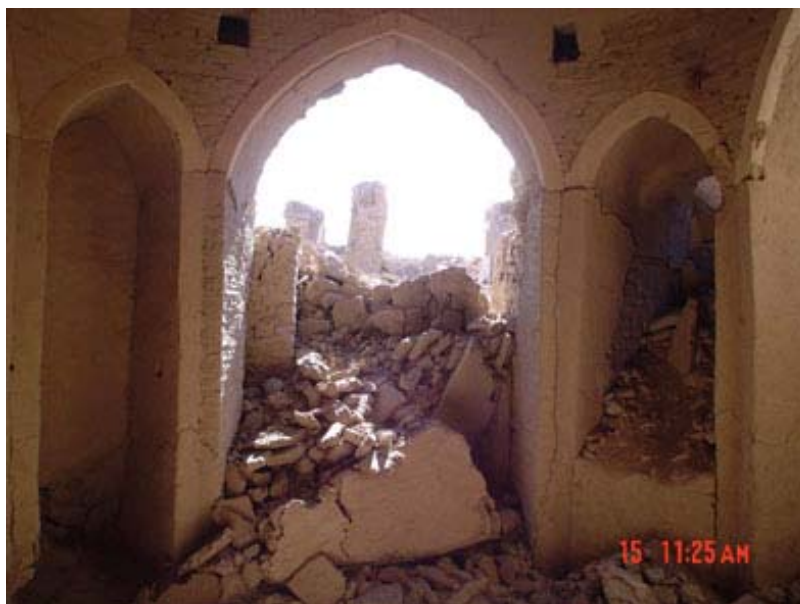
Figure 4. Arches used to transfer loads from a dome to its pillars.

Domes are one of the main features of the city of Bam. They can be seen in different sizes and shapes all around the city and inside the historical monument of Arg-e-Bam. The most noticeable type is the 2-3 m diameter commonly used in humble houses. However, larger domes have also been observed. The methods used to support these domes and transfer their loads to bearing walls are quite different from one place to another. The simplest method used to support small domes is by placing them directly on bearing walls. As it is well known, the existence of openings like doors and windows in these walls destabilizes the dome structure. To overcome this problem, early Iranian architects used arches to transfer stresses from the dome to either side of the opening as shown earlier in Figure 4. This was the start of development of the dome on four arches that later took more complicated forms.

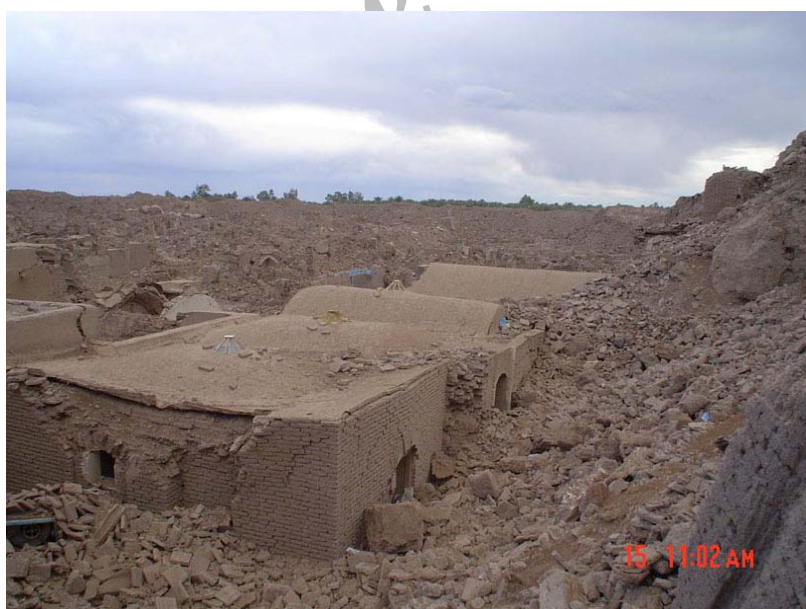
The number of shapes and forms of vaults used in the Bam's area is quite large. The most common types used in residential buildings are in the form of long semi-cylindrical roofs with two plates or semi-spherical caps at their ends. This type of roofs is called locally a "Tharby" roof. Other type of vaults that also widely used is called "Kalil". The later type covers only part of the roof, as shown in Figure 5. In traditional buildings, and due to the lack of ring beams between roofs and walls, walls carry all vertical and horizontal forces.

Figure 5. The two types of vaults that are commonly used in Bam, Tharbi and Kalil

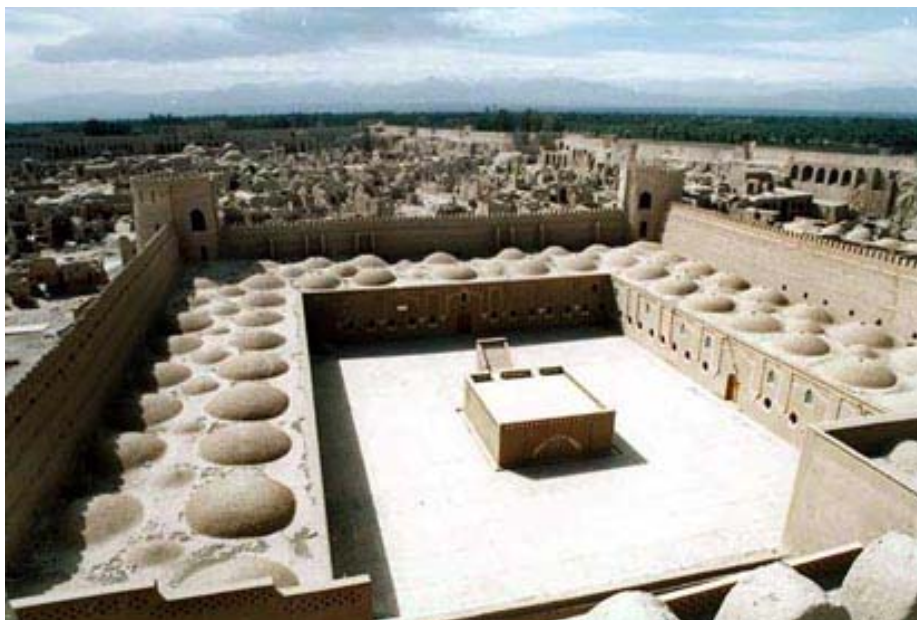
In the majority of cases, a complete destruction of adobe buildings including their domes was observed. However, example of good performance of domes can be also seen as shown in Figure 8. The building shown in the figure is located at Konari neighborhood in Arg-e-Bam and it has two domes. With the exception of some cracks at the Intersection of perpendicular walls, no other failure has been observed. On the other hand, many examples of massive and wide destruction had been observed few meters from the structure of Figure 8. As an example, the stable courtyard inside Arg-e-Bam is shown in Figure 9. Around the courtyard, many surrounding buildings are shown before and after the earthquake. The majority of domes shown in Figure 9a were destroyed completely as shown in Figure 9b. Supporting walls were also destroyed partially or completely. For walls situated parallel to

Figure 9a. A courtyard in Arg-e-Bam before earthquake.
