PERFORMANCE OF TRADITIONAL ARCHES, VAULTS AND DOMES IN THE 2003 BAM EARTHQUAKE

T. Mahdi^{*}

Department of Structual Engineering, Building and Housing Resarch Center, Tehran, Iran

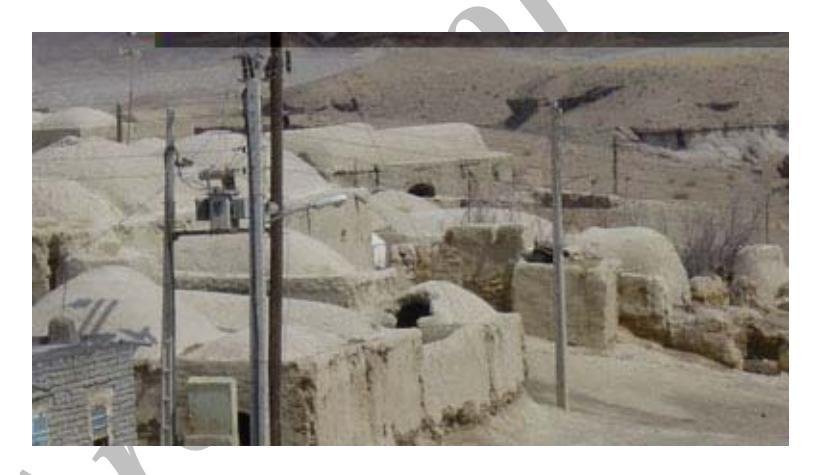
Figure 1. A typical village in eastern Iran with vaulted roofs

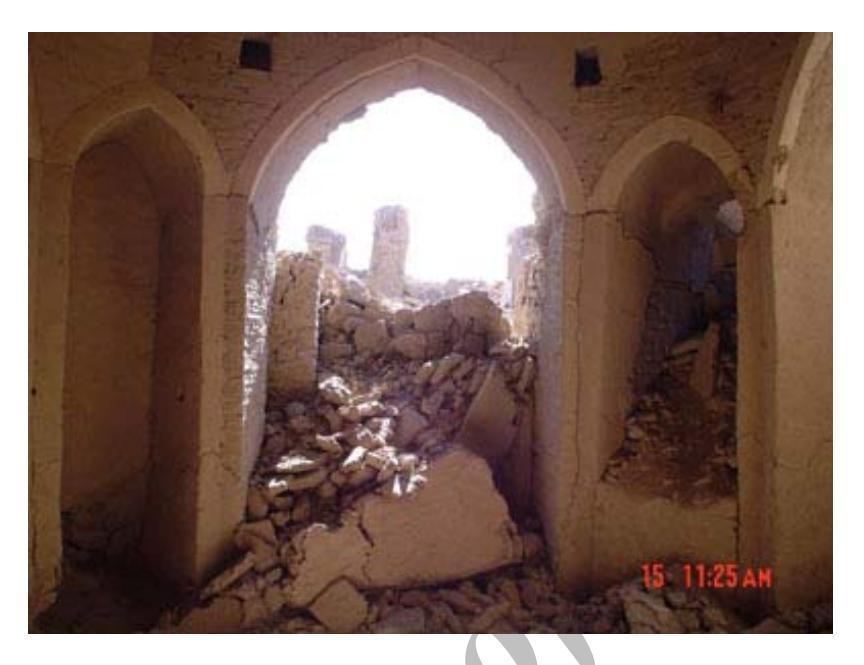
Figure 4. Arches used to transfer loads from a dome to its pillars.

Domes are one of the main features of the city of Bam. They can be seen in different sizes and shapes all around the city and inside the historical monument of Arg-e-Bam. The most noticeable type is the 2-3 m diameter commonly used in humble houses. However, larger domes have also been observed. The methods used to support these domes and transfer their loads to bearing walls are quite different from one place to another. The simplest method used to support small domes is by placing them directly on bearing walls. As it is well known, the existence of openings like doors and windows in these walls destabilizes the dome structure. To overcome this problem, early Iranian architects used arches to transfer stresses from the dome to either side of the opening as shown earlier in Figure 4. This was the start of development of the dome on four arches that later took more complicated forms.

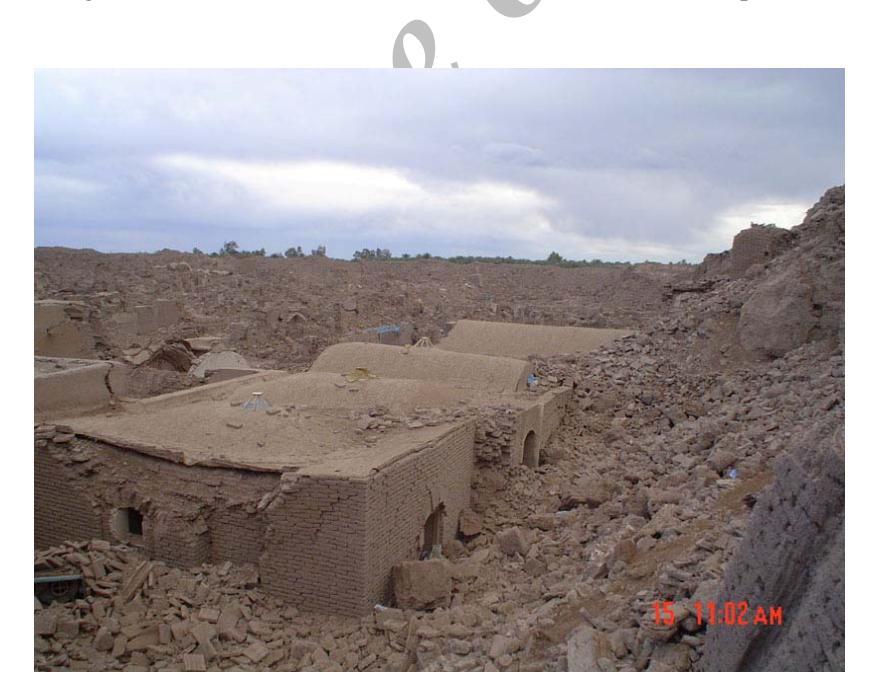
The number of shapes and forms of vaults used in the Bam's area is quite large. The most common types used in residential buildings are in the form of long semi-cylindrical roofs with two plates or semi-spherical caps at their ends. This type of roofs is called locally a "Tharby" roof. Other type of vaults that also widely used is called "Kalil". The later type covers only part of the roof, as shown in Figure 5. In traditional buildings, and due to the lack of ring beams between roofs and walls, walls carry all vertical and horizontal forces.

Figure 5. The two types of vaults that are commonly used in Bam, Tharbi and Kalil
