TECHNICAL NOTE

CAUSES OF CATASTROPHIC FAILURE OF HIGH MN STEEL UTILIZED AS CRUSHER OVERLAYING SHIELDS

S. R. Allahkaram

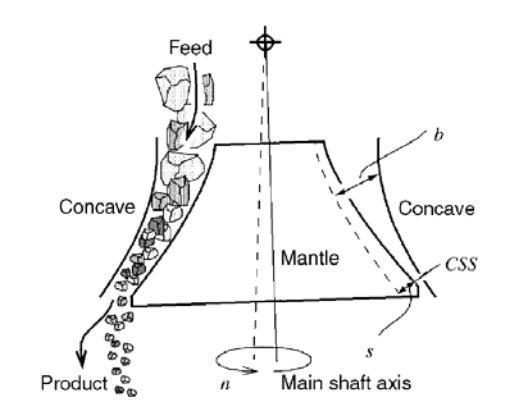
The basic principle of a cone crusher is shown in Figure 1. The main body (concave), mantle (shield) and eccentricity together, form the chamber geometry of the cone crusher.

Figure 1. Schematic of cone crusher basic principle [15].

and main shaft will be a nutating motion, in which case the shield will move cyclically forward and backwards relative to the fixed main body (concave). The failure of these shields usually occurs in the lower part, where the compressive stress field (CSS) due to comminuting rock material is at its highest level.

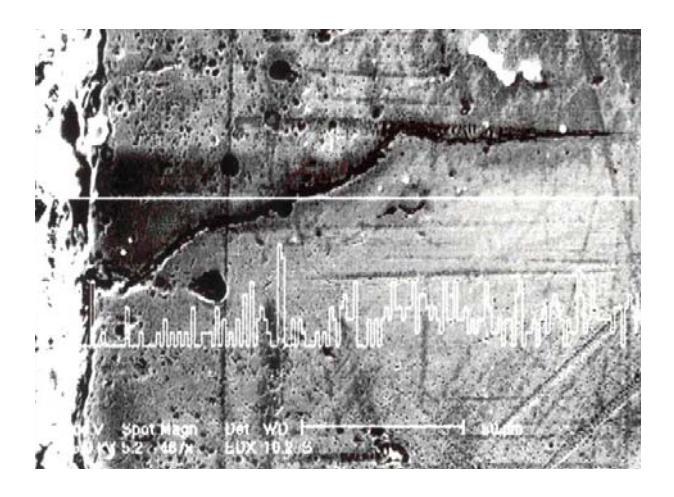
For investigating elemental distributions and variations of their concentration within the material, line-scan was employed. Figures 9 and 10 illustrate the line-scan results for phosphorous taken across a grain and a grain boundary, respectively. It can be deduced from these semiquantitative analytical results that the concentration of phosphorous within the grain boundary is almost twice as much as the concentration in the grain. Baring in mind that the phosphorous concentration in the alloy was found

Figure 10. Phosphorous line-scan taken across a grain boundary.
