Post-Earthquake Quick Inspection of Damaged Buildings in Bam Earthquake of 26 December 2003

A.S. Moghadam and A. Eskandari

Structural Engineering Research Center, International Institute of Earthquake Engineering and Seismology (IIEES), Tehran, Iran, e-mail: moghadam@iiees.ac.ir

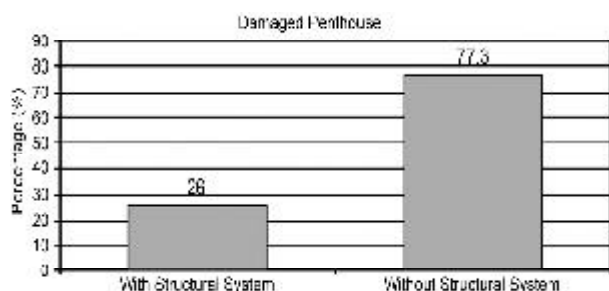
Figure 4. Damage to penthouses.

feature of Bam earthquake. In many buildings the penthouse was built without any structural integrity to the main structure and without any structural system. An item in the inspection form was designed to identify whether the penthouses has structural system or not. Another item in the form shows whether the penthouse has been severely damaged. According to Figure 4, the cause of damage in more than 75% of penthouses was lack of structural system.

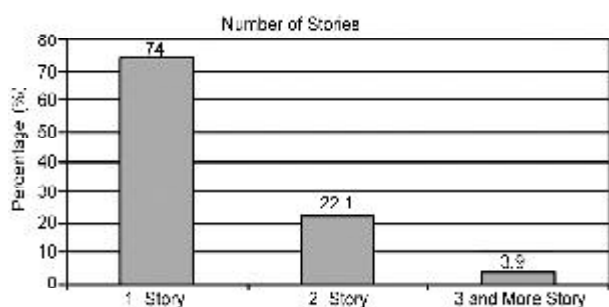
Figure 3. Number of stories for buildings.

Shown on Figure (3) is the number of stories for the surveyed buildings. Almost 75% of surveyed buildings are single story buildings. It can be concluded that most of these building are short period structures.

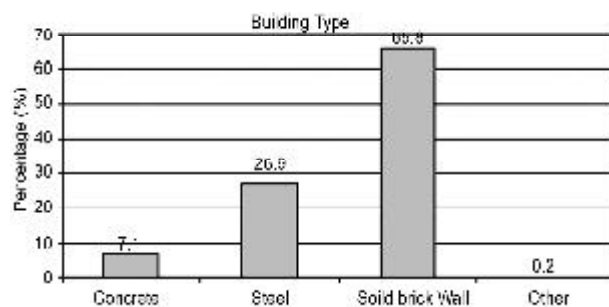
Figure 5. Distribution of building types.

shown in Figure (5) is consistent with the data in most other cities of Iran.

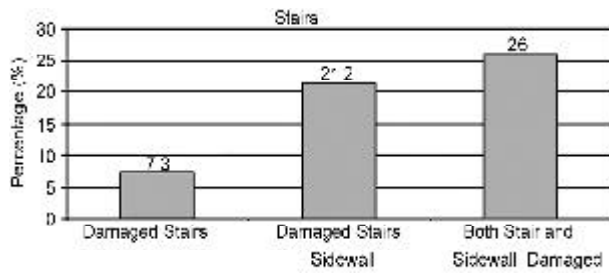
Figure 6. Damage to stairs.

Stairs are important items in any quick inspection approach. A damaged stair causes difficulty for occupants to exit building in an emergency situation. Shown on Figure (6) is the percentage of damaged stairs in the surveyed buildings. According to the figure, in more than 25% of cases, both stairs and its sidewall have been damaged. Also, more than 20% of sidewalls were damaged, while the stair itself was undamaged. On the other hand in less than 10% of cases, the stair has been damaged while its sidewall was undamaged. The high number of damaged stairs

shows some serious flaws in construction practice in Bam.

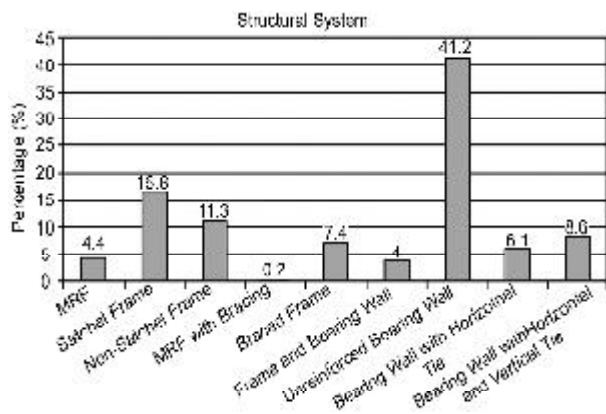
Figure 7. Structural system types.

Shown on Figure (7) is the distribution of structural systems for the buildings surveyed. According to this figure, almost half of the buildings have somehow used unreinforced bearing wall. The use of tie beams as emphasized by the Iranian Building Code [5] is not common. The satchel type of simple framing is the second popular system. According to the Iranian Building Code [5], a satchel frame is a simple frame that can not resist lateral loads and needs bracing. However, in most cases in Bam, no bracing is used.

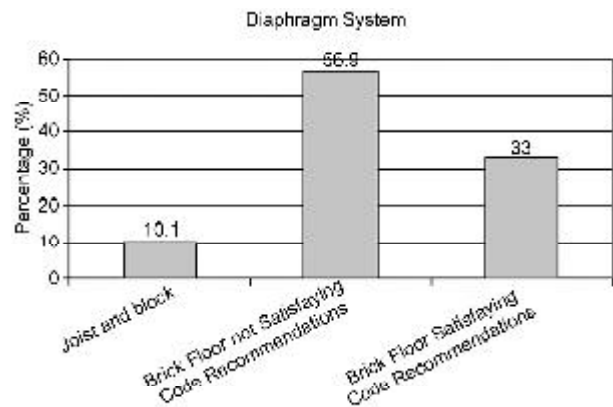
Figure 8. Diaphragm types.

The percentages of diaphragm systems of buildings are shown in Figure 8. Brick floor (archaic) diaphragms are the most common type in Bam; the same is true for other parts of Iran. According to Figure (8), more than half of all diaphragms are brick floor that does not satisfy code requirements with respect to using rods for their integrity. More reliable diaphragms consist of joist and block is accounted for only 10% of cases.

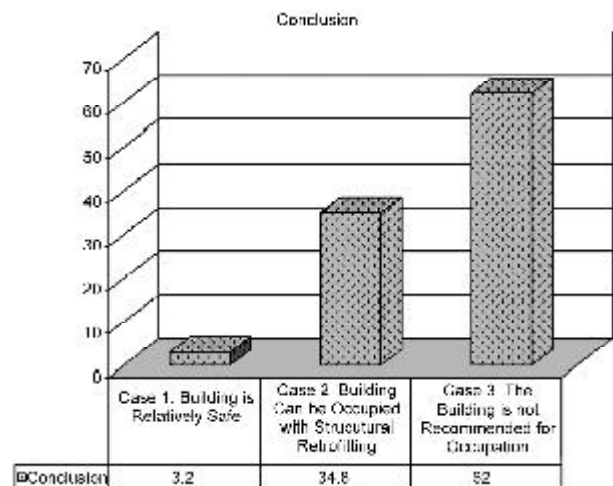
Figure 9. The comparison of results.

the volunteer engineers for familiarizing them to interpretation of form items. The items in the forms are intended to summarize the building characteristics as well as type and extent of damages in a building. They are also designed to compare the building characteristics with the minimum requirements of “Iranian Code of Practice for Seismic Resistant Design of Buildings” [5]. By careful consideration of all aspects, the inspector arrives at the final conclusion. Figure (9) shows the percentage of each case. Unfortunately most of surveyed buildings did not meet the minimum requirements of codes.
