Reconnaissance Report on Building Damage Due to Bam Earthquake of 26 December 2003

Yasushi Sanada¹, Masaki Maeda², Ali Niousha³, and M. Reza Ghayamghamian⁴

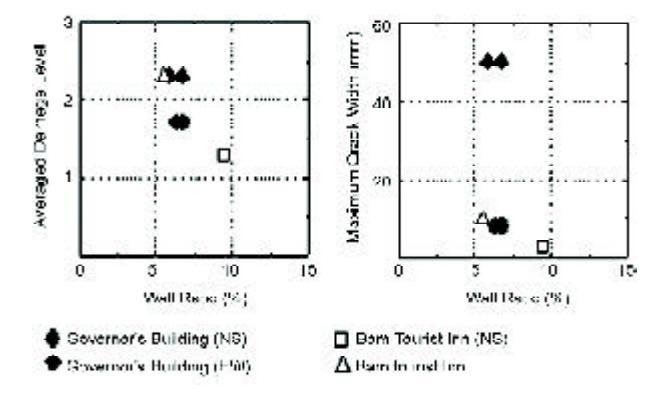
Figure (13) shows the relationships between the wall ratio and the a raged damage level and correlation between the wall ratio and the maximum crack width, respectively. It can be concluded from Figure (13a) that the straged damage levels were larger in case of smaller wall ratio. The maximum crack widths variables are as a smaller wall ratio.

among the *NS* direction of C. ven r's suilding and both directions of Bam Touri. In., as shown in Figure (13b). However, the maxinum crack width in the EW direction of General' Building was much higher than those in the other cases. This may be caused by the tother and remonses due to the horizontal irregularity of Geven and Building, because the larger crack widths were observed in the outside walls. The building damages can not be clarified in detail based on only the wall ratio as mentioned here, however, it can be concluded that the wall ratio is considered to be one of the reliable indexes for evaluating the seismic performance of unreinforced masonry buildings.

Figure 13. Relationships between the wall ratio and the wall damage level.

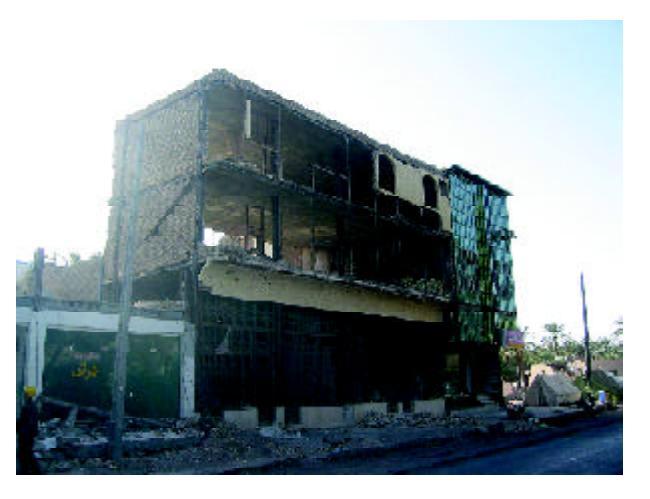
Photo 7. Residence and store building under construction.

Figure (15). Con ns ar erected using coupled I-shaped steel plum, see Figure (16). Steel braces (I-shape, 70*m*, '14*m*, 7*mm* in thickness) are installed in both 'crior frames in *EW* direction. Brick w. ... ich are post-installed in the frame without confining by surrounding steel frame, are not explicitly to contribute for carrying lateral load. I-shape steel profiles are also used for the girders and be ns, the Photo (7).

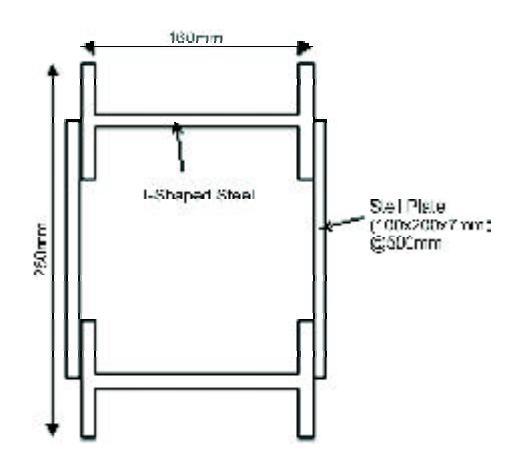
Figure 16. Section of coupled I-shaped steel column.
