Reconnaissance Report on Building Damage Due to Bam Earthquake of 26 December 2003

Yasushi Sanada¹, Masaki Maeda², Ali Niousha³, and M. Reza Ghayamghamian⁴

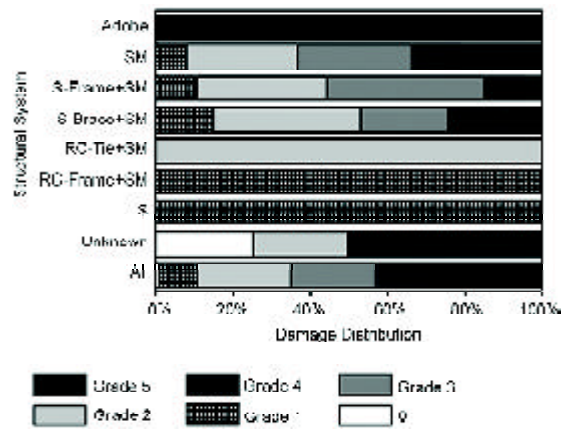
Figure 5. Damage distribution of each structural system.

Figure (5) shows the damage distribution of each structural system. All Adobe buildings were classified into Grade 4 and Grade 5. The sum of the ratio of Grade 4 and Grade 5 in *SM* buildings exceeded 30%, which was much smaller than the Adobe buildings. The damage ratios of *S-frame+SM* and *S-brace+SM* buildings were considered to be much less than that of the *SM* buildings, however, there were no big differences among them. This was caused by brittle fracture of poor welded connections in a few *S-frame+SM* and *S-brace+SM* buildings. On the other hand, the damages of *RC-tie+SM* and *RC-frame+SM*

buildings were quite slight because the connections in these buildings were constructed monolithically with other elements. These results, however, were derived from the only case in each system. The damage grade of the only *S* building, which was the gymnasium structure, was Grade 1.

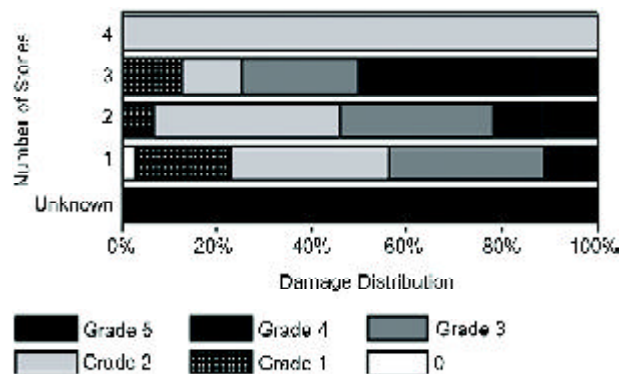
Figure 6. Effect of number of stories on damage distributions.

Subsequently, the relationships between the damage level and the number of stories, the construction age and the location were investigated, however, Adobe buildings were excluded from the data in order to prevent affecting the statistics. The effect of number of stories on damage distributions is investigated in Figure (6). The ratios of Grade 5 and Grade 4 were larger in case of higher buildings except the only four-story building case. Figure (7) shows the damage distributions before the establishment of National Standard code No. 2800 in 1987, from 1987 to the revision in 1999, and after 1999. No big differences were observed among these distributions; however, these results were derived from about half buildings except the unknown ones. This was caused by the technical and social backgrounds in Iran. These results revealed that the

seismic performances of Iranian buildings were strongly affected by partial weak points, in especial the jack arch slab and poor welded connections, and that the seismic code might be not spread in the local areas. In order to investigate the effects of the input directivity (*EW* components > *NS* components in the records) on the building damages, the damage distributions of the buildings along the *N-S* and *E-W* streets are shown in Figure (8). The building damages along the *E-W* street are estimated to be larger than those along the *N-S* street considering the horizontal irregularity due to arrangements of openings in buildings along the streets, whereas the statistics result does not show significant directivity of the building damages.

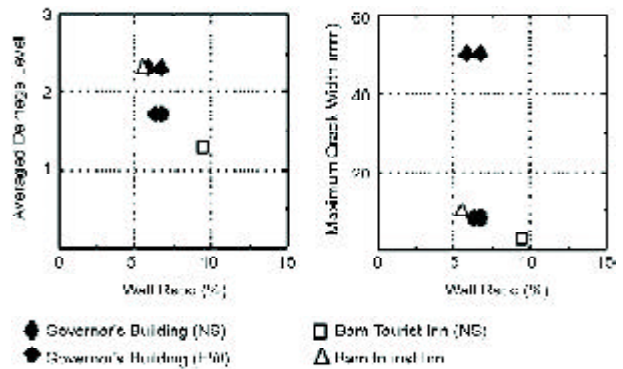
Figure 13. Relationships between the wall ratio and the wall damage level.

Figure (13) shows the relationships between the wall ratio and the averaged damage level and correlation between the wall ratio and the maximum crack width, respectively. It can be concluded from Figure (13a) that the averaged damage levels were larger in case of smaller wall ratio. The maximum crack widths were larger in case of smaller wall ratio

among the NS direction of Governor's Building and both directions of Bam Tourist Inn, as shown in Figure (13b). However, the maximum crack width in the EW direction of Governor's Building was much higher than those in the other cases. This may be caused by the torsional responses due to the horizontal irregularity of Governor's Building, because the larger crack widths were observed in the outside walls. The building damages can not be clarified in detail based on only the wall ratio as mentioned here, however, it can be concluded that the wall ratio is considered to be one of the reliable indexes for evaluating the seismic performance of unreinforced masonry buildings.

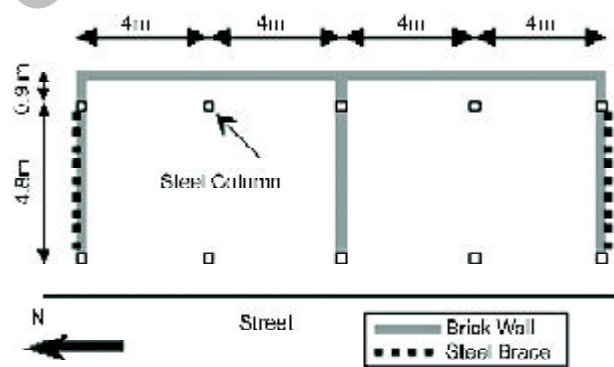
Figure 15. First floor plan.

The under construction building, see Photo (7) is located a few hundreds meter south of Governor's Building. The structural system of this building is quite typical of the buildings along the main streets in the downtown. The three-story steel structure consists of 4 bays in *NS* direction along the street and one bay in transverse direction (*EW*) as shown in

Figure (15). Columns are erected using coupled I-shaped steel column (see Figure (16)). Steel braces (I-shape, 70mm x 14mm, 7mm in thickness) are installed in both exterior frames in *EW* direction. Brick walls, which are post-installed in the frame without confining by surrounding steel frame, are not expected to contribute for carrying lateral load. I-shaped steel profiles are also used for the girders and beams, (see Photo (7)).
