Performance of Batten Columns in Steel Buildings During the Bam Earthquake of 26 December 2003

B. Hosseini Hashemi and M. Jafari S.

Structural Engineering Research Center, International Institute of Earthquake Engineering and Seismology (IIEES), Tehran, Iran, email: behrokh@iiees.ac.ir

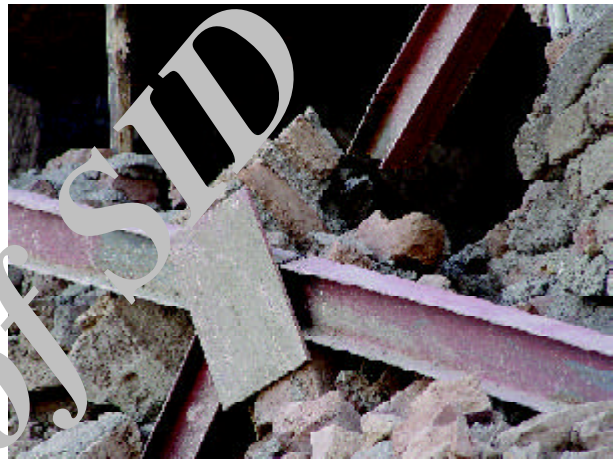
Figure 3. Rupture of connections in concentrically X bracing.

common type of bracing in steel braced frames in Bam. The observed failure modes in these braces were out of plane buckling and rupture of connections. The major reasons for these failures were construction defects and incomplete welding of connections. Some examples of bracing failures are shown in Figures (3) and (4).
