Lessons Learned from Steel Braced Buildings Damaged by the Bam Earthquake of 26 December 2003

N.A. Hosseinzadeh

Structural Engineering Research Center, International Institute of Earthquake
Engineering and Seismology (IIEES), Tehran, Iran, email: hosseinz@iiees.ac.ir

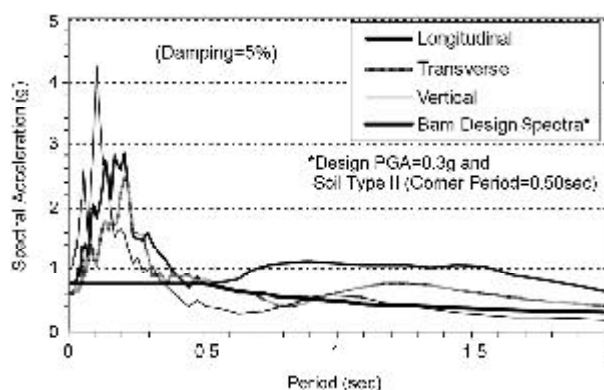
It is clear from spectral accelerations that the dominant period of ground motion in the horizontal and vertical directions are about 0.2sec and 0.1sec,

Figure 1. Spectral accelerations of Bam earthquake and Bam design spectra.

respectively. The maximum spectral accelerations at these periods are 2.85g and 4.25g respectively. Also, the acceleration amplification in these periods are about 4.0 for both horizontal and vertical components. This value is 1.6 times greater than the Iranian seismic code design requirements (standard 2800) [4].

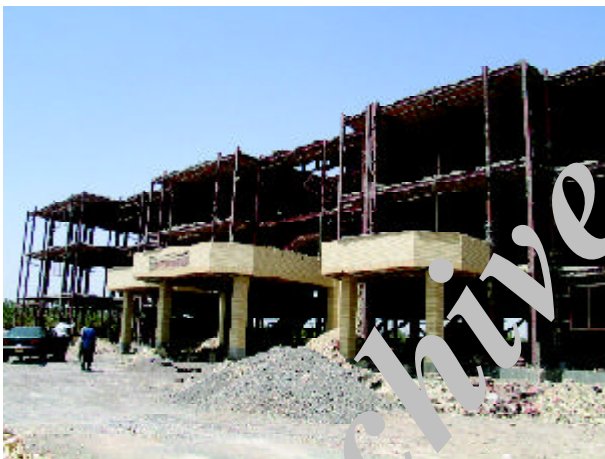
Figure 15. Southern view of nursery building.
