# Performance of Lifeline Systems in Bam Earthquake of 26 December 2003

Masoud Moghtaderi-Zadeh<sup>1</sup>, Farrokh Nadim<sup>2</sup>, and Mohammad Javad Bolourchi<sup>3</sup>

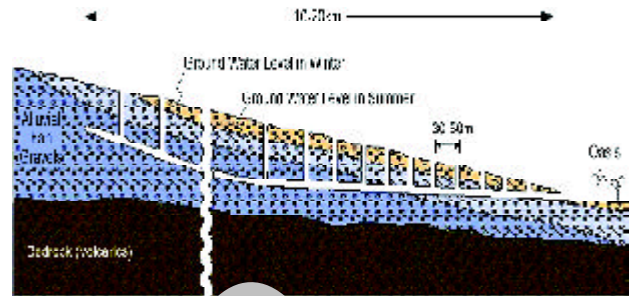
**Figure 2.** Principles of water transport by a qanat.

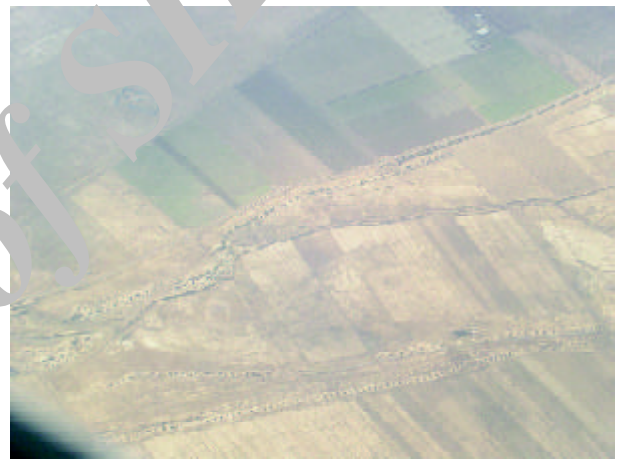
**Figure 3.** Aerial photo of several chains of ancient qanat systems, which typically bring water from foothills of mountainous area to more dried desert towns and villages in Iran.

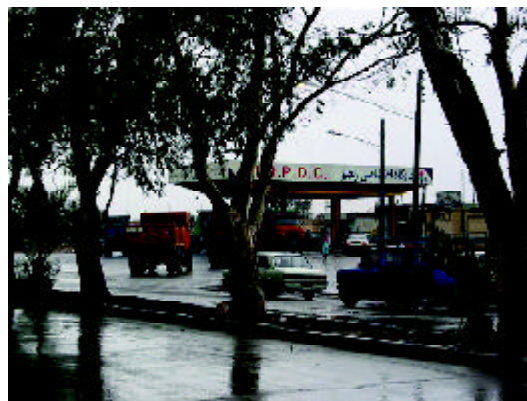
**Figure 14.** Gas stations in the city of Bam were in operation at the time of our visit.
