The Behavior of Special Structures During the Bam Earthquake of 26 December 2003

Sassan Eshghi and Mehran Seyed Razzaghi

Structural Engineering Research Center, International Institute of Earthquake Engineering and Seismology (IIEES), Tehran, Iran, email: s.eshghi@iiees.ac.ir

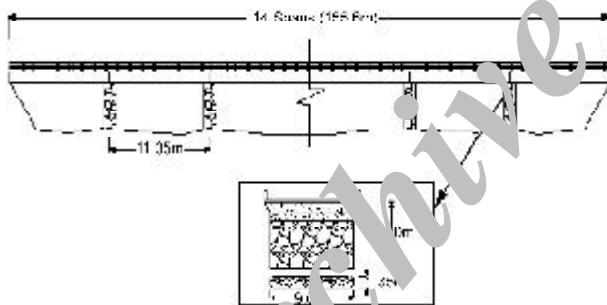
In general, bridges sustained little or no damage. The most affected bridge, Espikan Bridge north of Bam near Arg-e Bam, sustained little damage. Espikan Bridge is a uniform bridge with an RC deck and stone masonry columns and 14 spans across the Poshtrood River, see Figure (10). As shown in Figure (11), the RC bent caps of the bridge cracked with the longitudinal movement of the deck in the north-south direction. No visible damage occurred to

Figure 10. Espikan Bridge.

the deck slab as a result of the pounding of separate parts of the superstructure thanks to sufficient joint width and the bridge was in service after the earthquake.

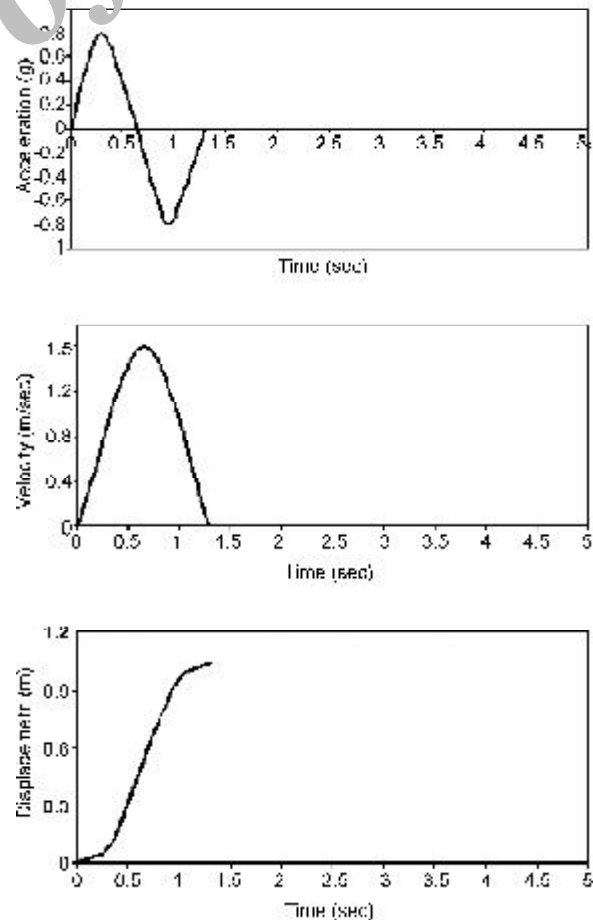
Consider the pulse duration of $T_p = 1.3sec$ and a velocity amplitude of $V_p = 1.6m/sec$, which are approximations of the duration and the velocity amplitude of the first main pulse of the record. The equivalent pulse-type motion is indicated in Figure (29).

Figure 29. Fault-normal component of acceleration, velocity and displacement modeled as a pulse motion.

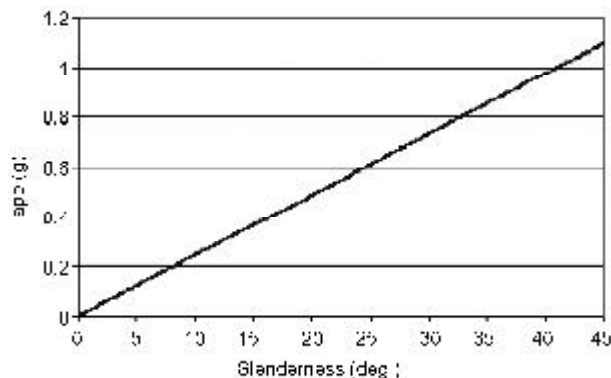
The plot of a_{po} for various slenderness ratios is shown in Figure (30).

Figure 30. Plot of "apo" versus slenderness.

As indicated in Figure (29), the peak ground acceleration required for the overturning of a transformer of $\alpha = 25^\circ$ is $0.61g$, which is less than the *PGA* of the Bam earthquake in the fault-normal direction. It seems that the existence of base rails and connections to the transformers was the main reason for the stability of the transformers in the Bam station.
