# Repair of Earthquake-Damaged Square R/C Columns with Glass Fiber-Reinforced Polymer

Sassan Eshghi<sup>1</sup>, Vahid Zanjanizadeh<sup>2</sup>

**Abstract:** This paper presents an experimental study on seismic repair of damaged square reinforced concrete columns with poor lap splices, 90-degree hooks and widely spaced transverse bars in plastic hinge regions according to ACI detailing (pre.1971) and (318-02) using GFRP wraps. Three specimens were tested in "as built" condition and retested after they were repaired by glass fiber-reinforced plastic sheets. They were tested under numerous reversed lateral cyclic loading with a constant axial load ratio. FRP composite wraps were used for repairing of concrete columns in critically stressed areas near the column footings. Physical and mechanical properties of composite wraps are described. Seismic performance and ductility of the repaired columns in terms of the hysteretic response are evaluated and compared with those of the original columns. The results indicated that GFRP wraps can be an effective repair measure for poorly confined R/C columns due to short splice length and widely spaced ties with 90-degree anchorage hooks. Both

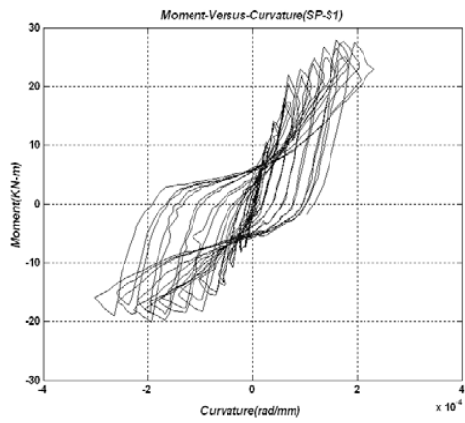
a) SP-S1

During testing of specimen SP-S1 at 1% drift ratio, initial flexural cracks were observed at the column footing interface and at 1.5% drift ratio the same cracks at the column footing

splice length. Some flexural cracks appeared along the splice length during the test but the length and width of these cracks did not increase significantly (Fig.12a).

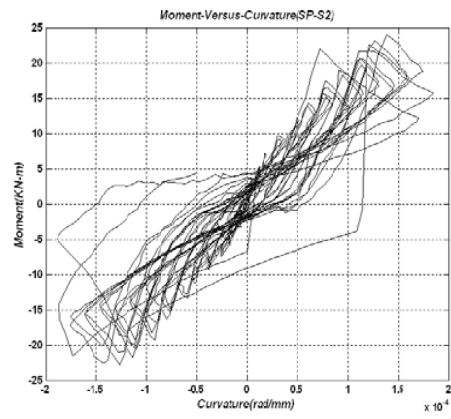
b) SP-S2

In specimen SP-S2 flexural cracks on the column face started as early as at 1% lateral drift ratio. At this time longitudinal cracks were formed at right and left sides of the specimen. During the second cycle at 3.5% drift as fairly large sections of the concrete cover spalled at the column footing interface. The lateral load strength diminished, indicating that bond along the spliced bars was deteriorating. Shear cracking was observed at 2.5% drift but these cracks were not significant throughout the test. Damage in this specimen was severer than that in the

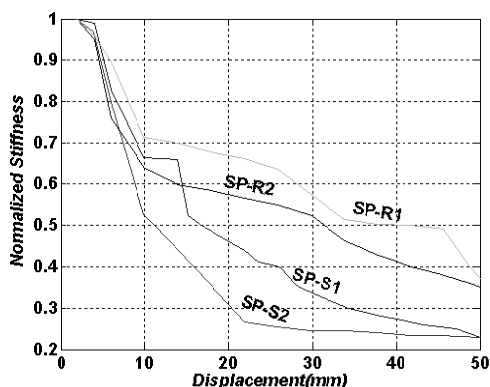
Stiffness for each cycle was calculated as the average of the stiffness for the positive and negative directions. Stiffness for each cycle was normalized with respect to the stiffness of the first cycle and was plotted versus the displacement. Stiffness degradation versus column top displacement after normalization is plotted in Fig.15 and Fig.16.

Fig.15 Normalized Stiffness versus Displacement for SP-S1, SP-S2, SP-R1 and SP-R2

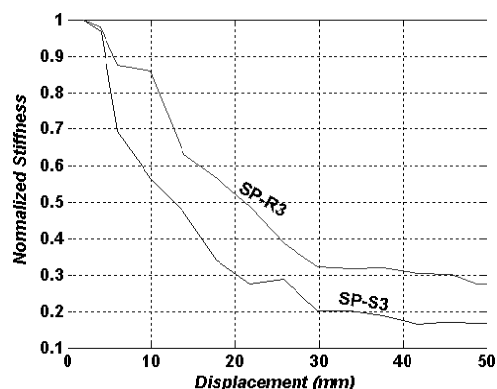
Fig.16 Normalized Stiffness versus Displacement for SP-S3, SP-R3

16% and 14% for SP-R2. These percentages for SP-S3 and SP-R3 were 12%, 113% and 27%. The results of total cumulative ductility and damage indicator for SP-S1, with the same loading condition, were 16% and 50% which were greater than those for SP-S2.
