Repair of Earthquake-Damaged Square R/C Columns with Glass Fiber-Reinforced Polymer

Abstract: This paper presents an experimental study on seismic repair of damaged square reinforced concrete columns with poor lap splices, 90-degree hooks and widely spaced transverse bars in plastic hinge regions according to ACI detailing (pre.1971) and (318-02) using GFRP wraps. Three specimens were tested in "as built" condition and retested after they were repaired by glass fiber-reinforced plastic sheets. They were tested under numerous reversed lateral cyclic loading with a constant axial load ratio. FRP composite wraps were used for repairing of concrete columns in critically stressed areas near the column footings. Physical and mechanical properties of composite wraps are described. Seismic performance and ductility of the repaired columns in terms of the hysteretic response are evaluated and compared with those of the original columns. The results indicated that GFRP wraps can be an effective repair measure for poorly confined R/C columns due to short splice length and widely spaced ties with 90-degree anchorage hooks. Both flexural strength and ductility of repaired columns were improved

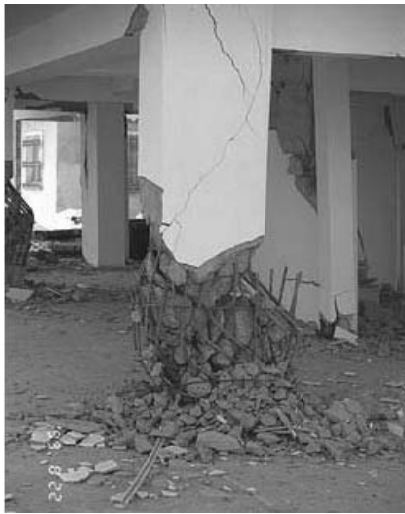
Fig.1 Failure of lap splice due to widely spaced ties with 90° hooks (Izmit-1999)

The most common types of non-ductile details are short splice length and wide ties with 90° hooks. These details had led to considerable damages in recent earthquakes. Fig.1 and Fig.2 show two-column damage in Izmit and Northridge earthquakes due to such detailing.

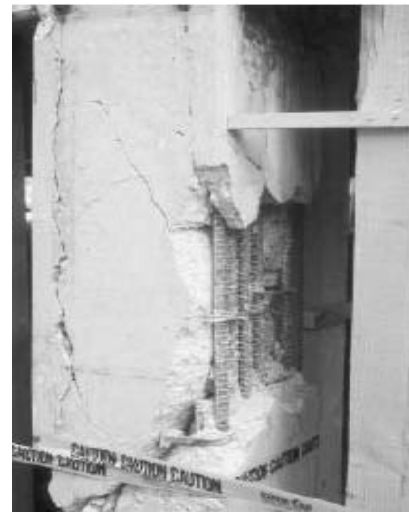
Fig.2 Failure of lap splice due to insufficient splice length and widely spaced ties with 90° hooks (Northridge-1994)

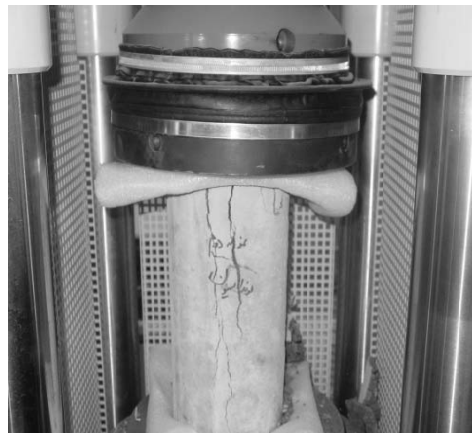
Fig.6 Cylindrical sample under compression test

0.5. Portland cement, Type 2, was used in this study. The average slump was 120.2-mm. Three 152.5×305-mm (6×12 in) cylindrical samples were tested to obtain the concrete compressive strength (Fig. 6).

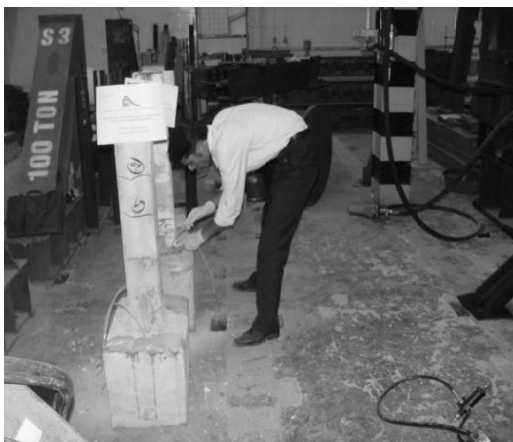
Fig.8 Cleanig surface of the damaged columns

All three specimens in as-built condition were tested and then were repaired by first replacing the loosened concrete with quickset cement then were cleaned with a high pressure gun and completely dried before the vinyl ester was applied to their surfaces (Fig.8). Special measures were taken to ensure that there were no voids between the

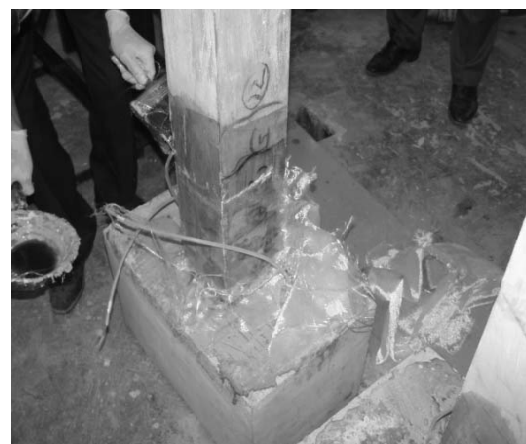
Fig.9 Installation of prefabricated composit sheets

The wrapping of the columns continued to the upper region of the column (Fig.9). All the repaired specimens were cured at least for 7 days to ensure that full strength had obtained before testing.
